SPECIALIZATION PROCESS FOR THE BIOENGINEERING SECTOR IN THE MEDITERRANEAN ENVIRONMENT. ECOMED PROJECT

SPECIALIZATION PROCESS FOR THE BIOENGINEERING SECTOR IN THE MEDITERRANEAN ENVIRONMENT. ECOMED PROJECT PART II. PROTOCOLS AND CASE STUDIES

PART II. PROTOCOLS AND CASE STUDIES

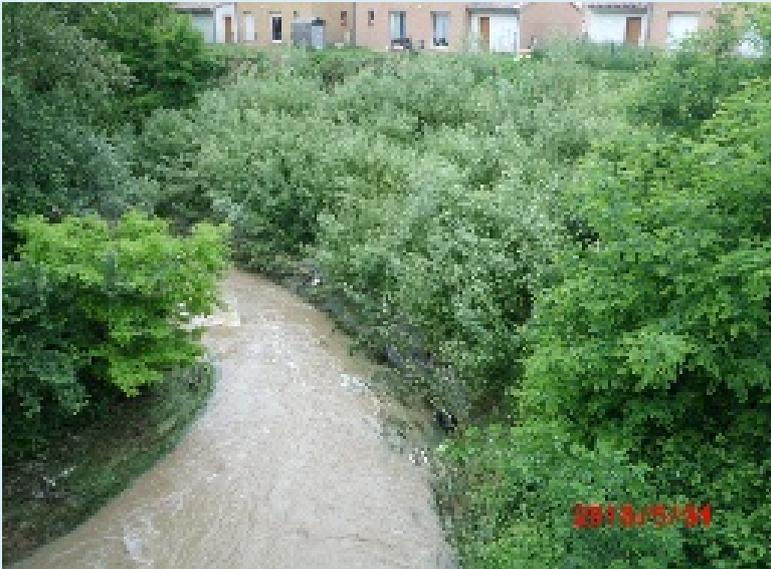
| The bioengineering work failed due to ... | Partially failed due to absence of geotechnical and compaction survey report |
| Salix brush layers during lifetime refixing cycle 2013 up to 2015 | |

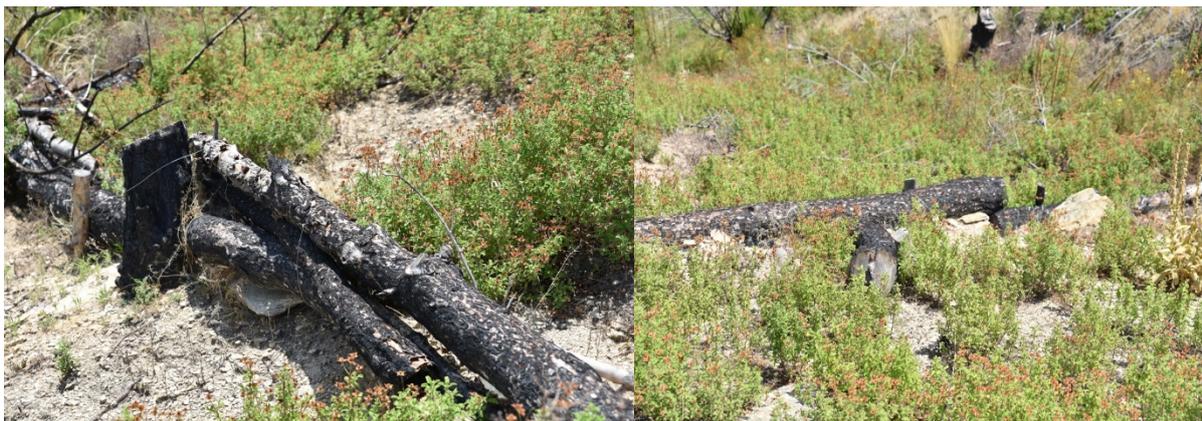
- The diameter of the trees used in the log barriers is relatively small compared to what is typically used.
- PHOTO log barriers

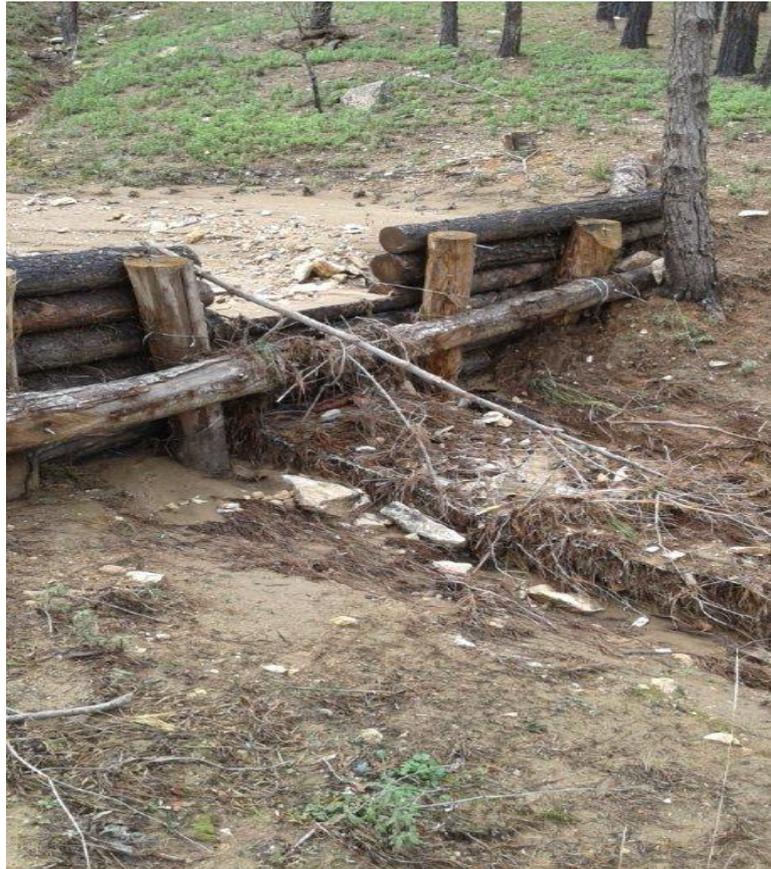
- The location of the works is very localized.
- The location of the works would have been more effective with more field measurements and the use of new technologies and software (GIS)
- More holistic application of the works should have been done
- Different types of works should have implanted to better guarantee the achievement of the targeted function.
- Works should have been applied in the torrent of the burned area (e.g. wooden dams).
- PHOTO wooden dam

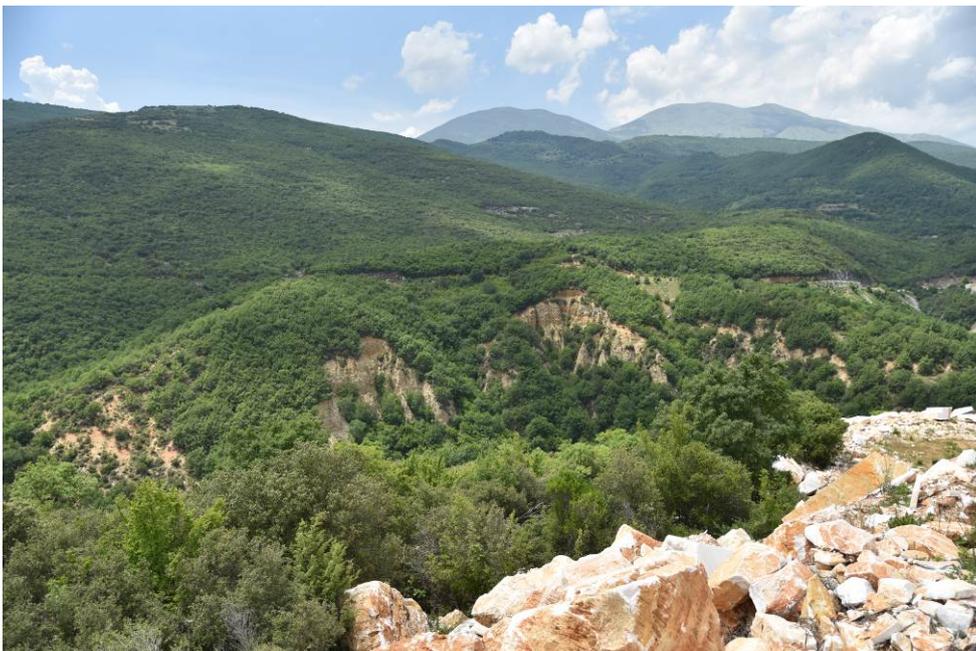
The main effects of the soil bioengineering work were as effective as expected. There are many bare areas and many of the seedlings have died. Non-native species were used that could have negative impacts on the entire area. Additional soil and water bioengineering should be implemented. Initially hydro-seeding should take place and the seedlings and maybe even larger tree should be planted in closer densities. Fencing of the restored areas should also take place to stop disturbances (e.g. grazing). Finally climate change is no a major concern for achieving the targeted conditions.

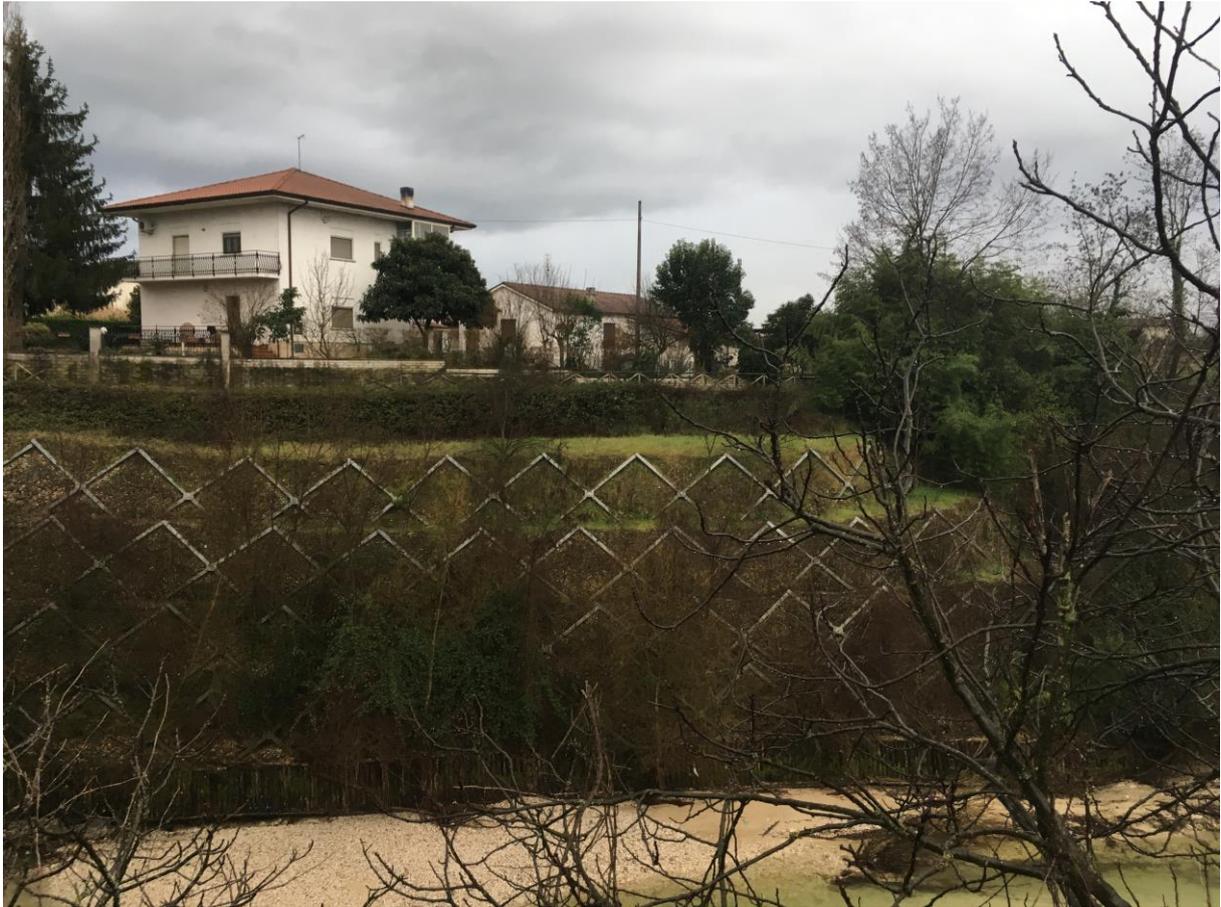
Monitoring in 2018

- Very successful evolution of the work after ten years and after several water flood.
- Climate change couldn't affect the present situation
- If there will be a rain storm with a violent quantity of water it should be resistant but only the time could give the right answers.
- All the initial risks which were present in the intervention are none
- . The vegetation has partially covered the work because the cuttings are inserted only in the down side of the work.

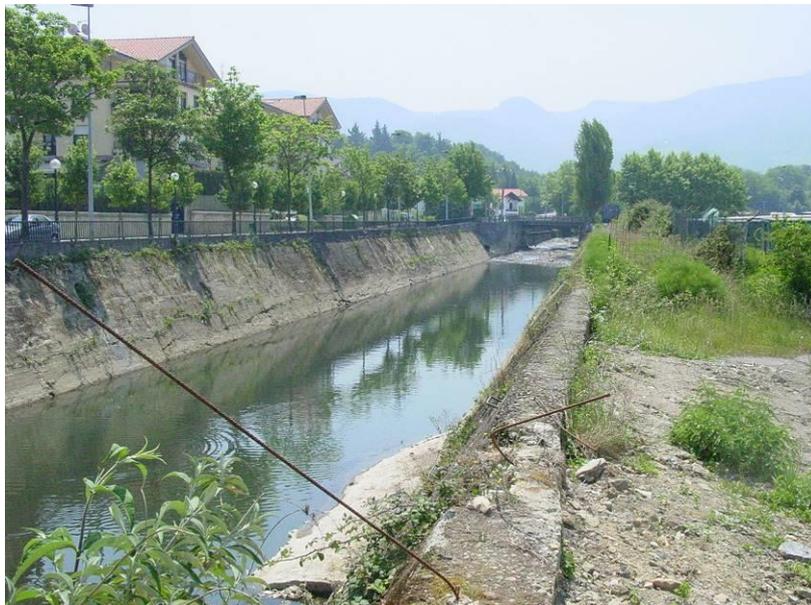
Pre-operational situation. The channel is formed by a trapezoidal cross section made of concrete

Characterization of the vegetation: plant species identification (tree, shrubs and herbs), breast height diameter, root collar diameter, height, vegetation cover of trees, shrubs and herbs.

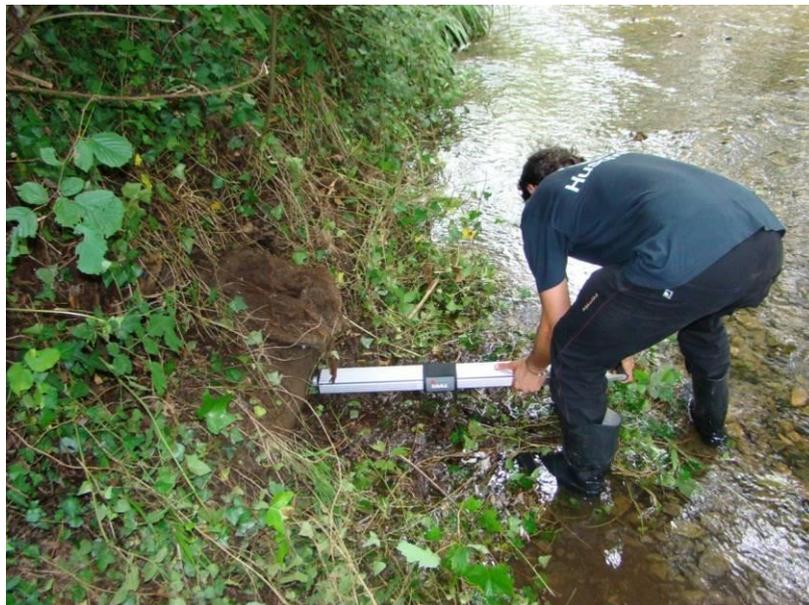
Logs in a direct contact with the water are much better preserved. The further from the water, the more deteriorated the logs are. This is because of the moisture change cycles the logs are subjected to. The part of the log in contact with the ground is much more deteriorated than the log upper part.

Measurements with the resistograph (source: Guillermo Tardio)

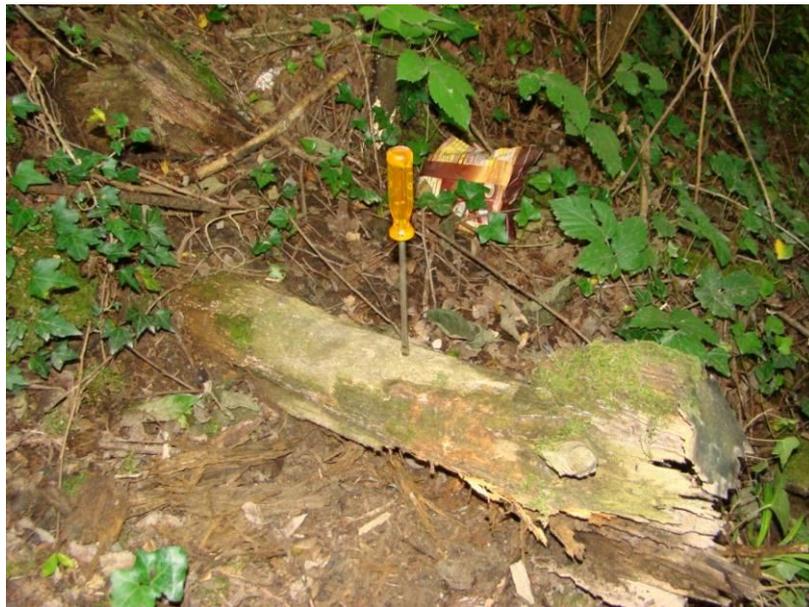
*The part of the log with ground contact is more deteriorate than the log upper part
(source: Guillermo Tardio)*

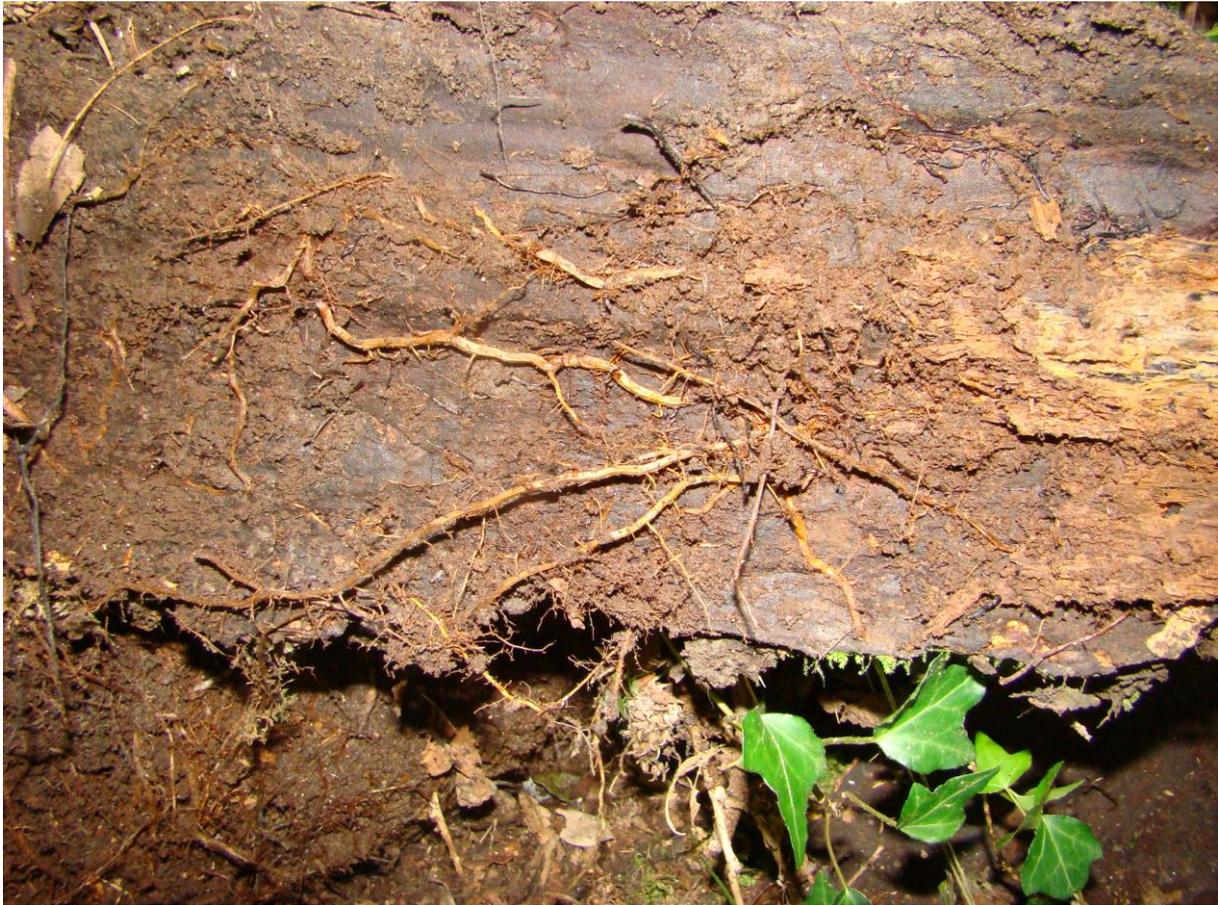
The trunks in ground contact are much deteriorated. The logs are no longer fulfilling any stabilising function. The remaining function is the fertilisation of the surrounding soil. Actually, nowadays the logs just work as a slow release organic fertilizer. The vegetation has already taken over the stabilization function. The volume occupied by the logs is now occupied by the roots and by the formed soil. The soil and water bioengineering approach and strategy has been successfully developed.

Roots occupying the soil volume initially occupied by the logs (source: Guillermo Tardío)

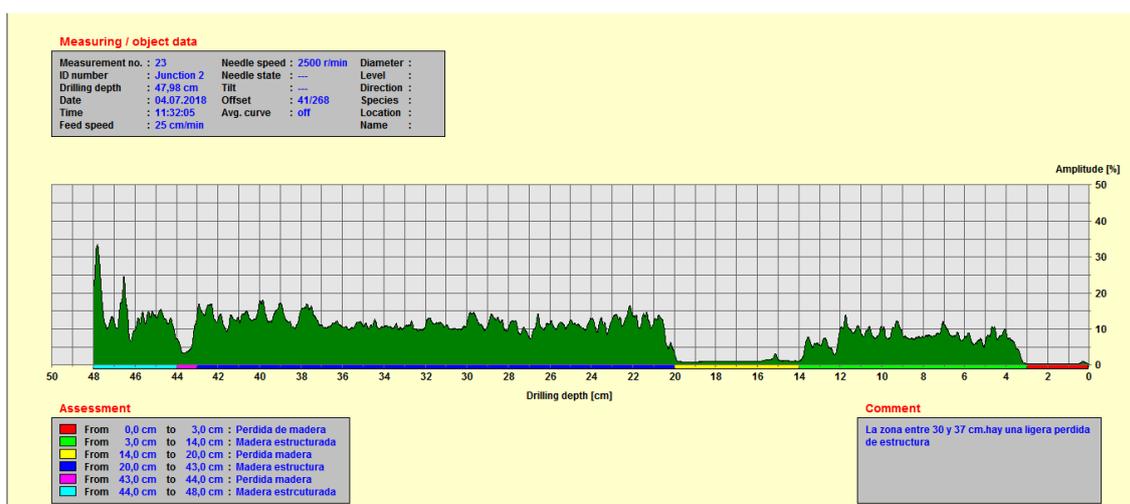
The wooden material utilised during the construction stage were green and barked logs. Because of this situation, the logs had a high water content level and the moisture loss process was very low. Hence, the logs were very vulnerable to the fungi attack from the very beginning of the bioengineering work service life. A minimum seasoning is recommendable to decrease the log water contents before their use in bioengineering works.

Resistograph plot corresponding to a test carried out in one of the crib wall junctions (connection between a header and a face log)

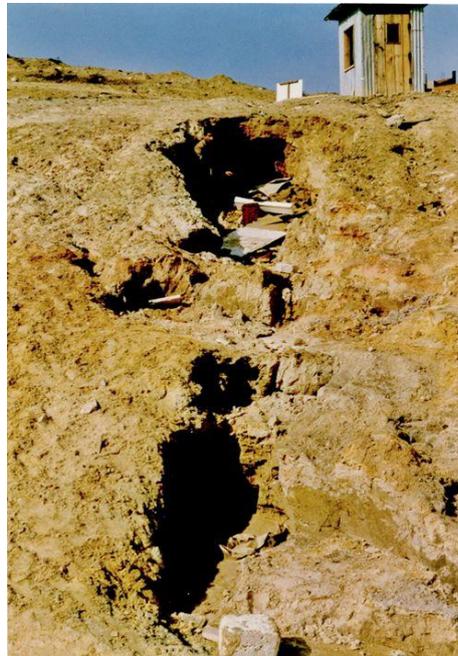
Fig. 1. Gully formation before rehabilitation
