PRELIMINARY DIAGNOSTIC SURVEY OF DETERIORATED PAINT LAYERS AT THE MARITIME STATION OF ROCHA DO CONDE DE ÓBIDOS, LISBON: A MULTIANALYTICAL RESEARCH

Keelie S. RIX¹, Sara VALADAS^{1,2}, Inês CARDOSO³, Luís DIAS¹, Milene GIL^{1,2*},

¹ HERCULES Laboratory, Institute for Advanced Studies and Research, University of Évora, Palácio do Vimioso, Largo Marquês de Marialva, 8, 7000-809 Évora, Portugal.

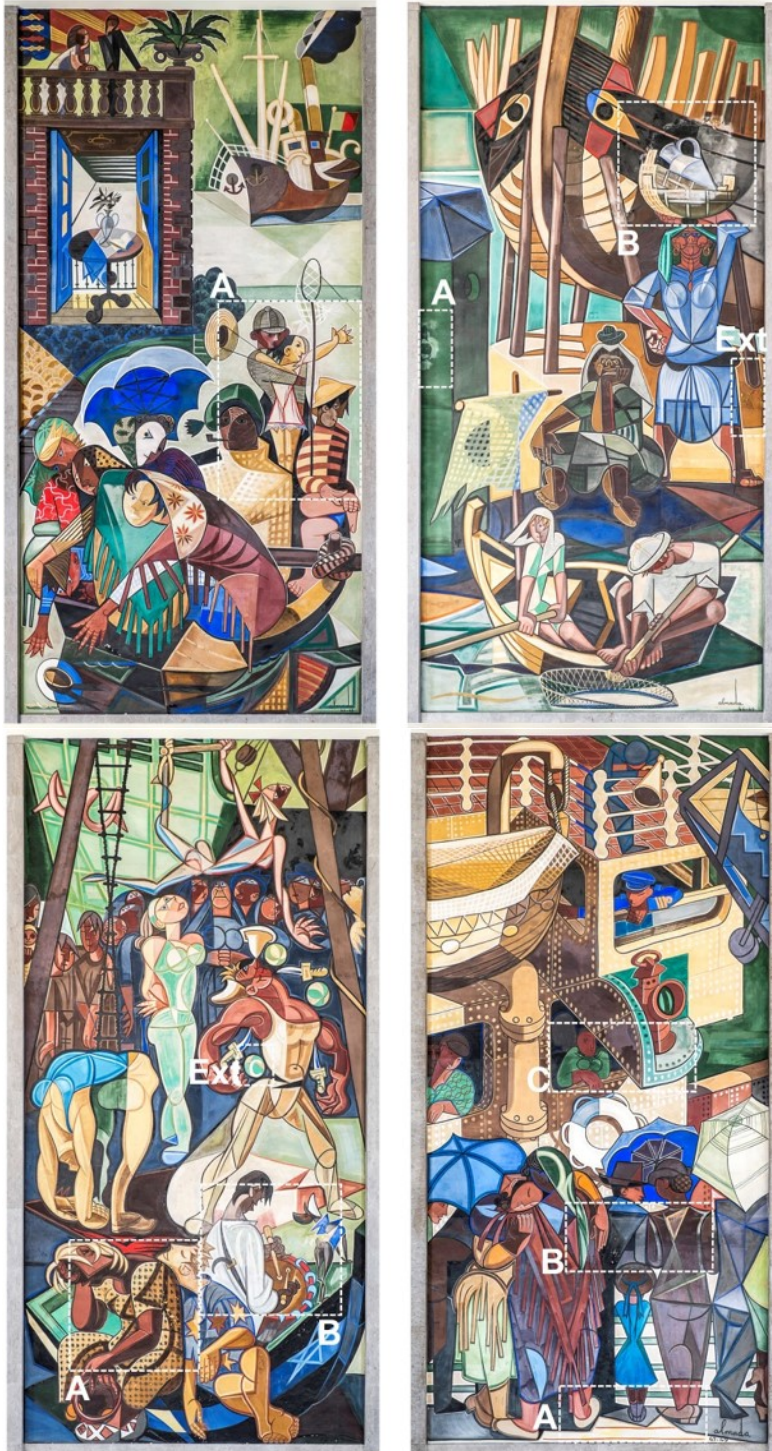
Fig. 1. From left to right, overview of the mural paintings 1, 2, 3, and 4 with approx. 720×380cm. The ten of paint layers analyzed by the analytical setup are indicated by the white squares (photos by CML-José Vicente 2013)

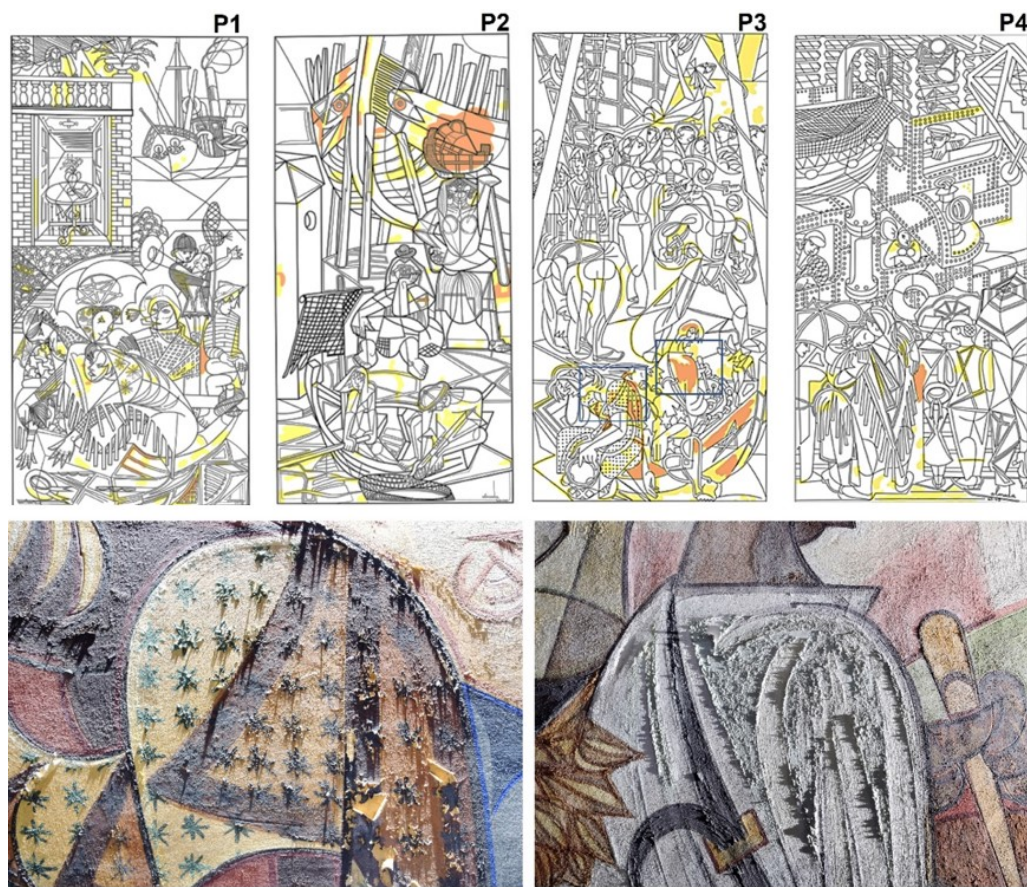
The main deterioration feature noticed in the four paintings under study by Vis and Vis-Rak is the flaking of paint layers, in several degrees of severity, which has contributed to paint

loss over the years. Powdering of paint layers was also noticed, but to a lesser extent and often associated with flaking. The colours most affected are the yellows and browns, the blacks, and the light greens in all murals. The flaking is particularly severe in P2 and 3 of the west walls, showing large areas of decay, as illustrated in figure 2. Three hypotheses were raised regarding the causes of decay: (a) the painting materials and painting techniques used by the artist; (b) the presence and activity of salts; and (c) past intervention products. The following sections address each of these hypotheses individually, although they can all be interconnected and act simultaneously.

Fig. 2. On the top, graphic map of deteriorated paint layers on P1, P2, P3, and P4, with the indication of the levels of decay observed in April 2022 (light to moderate in yellow and severe in orange). On the bottom, two details in Vis-Rak of paint layers on P3 with severe flaking and imminent risk of paint loss. Powdering is also observed in the same areas. (Graphic documentation by K. Rix and photos by M. Ribeiro 2022)

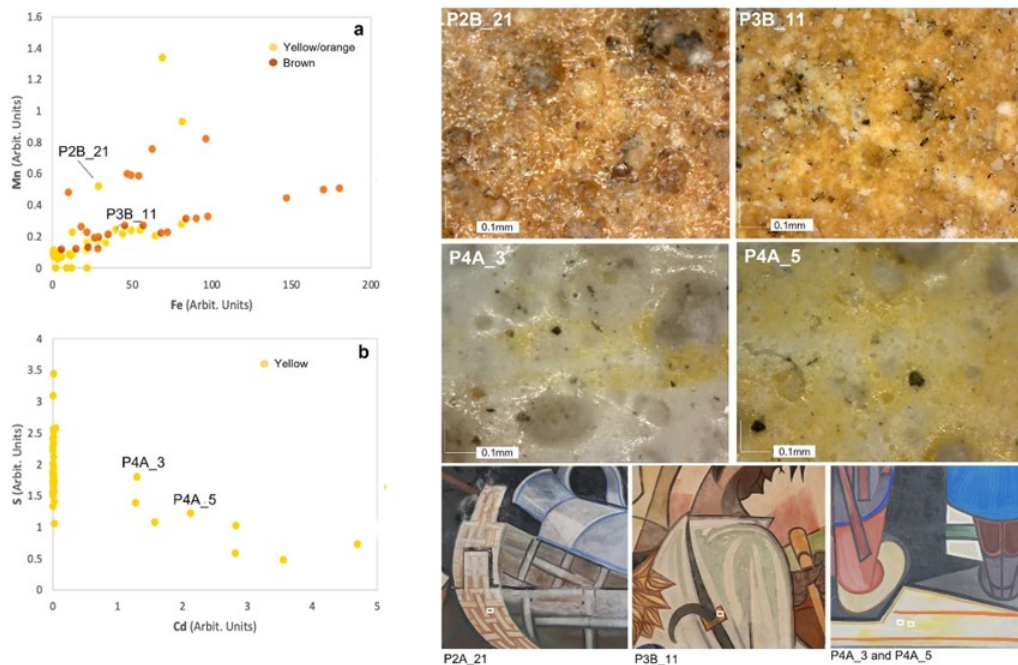
On the yellow and brown paint layers, iron (Fe) was the main chromophore found, along with smaller amounts of manganese (Mn) (Fig. 3a). The Fe and Fe-Mn-based pigments are likely

yellow ochres and brown earth pigments, with the brownish shades tending to have more manganese oxide (MnO_2) in the composition (ex. P2B_21 and P3B_11 of Fig. 3a).

Fig. 3. On the left, an XRF Mn-Fe and S-Cd biplot; on the right, h-OM image details at 435x of yellow and brownish paint layers from P2, P3, and P4, in which the analyses P2B_21, P3B_11, P4A_3, and P4A_5 were carried out

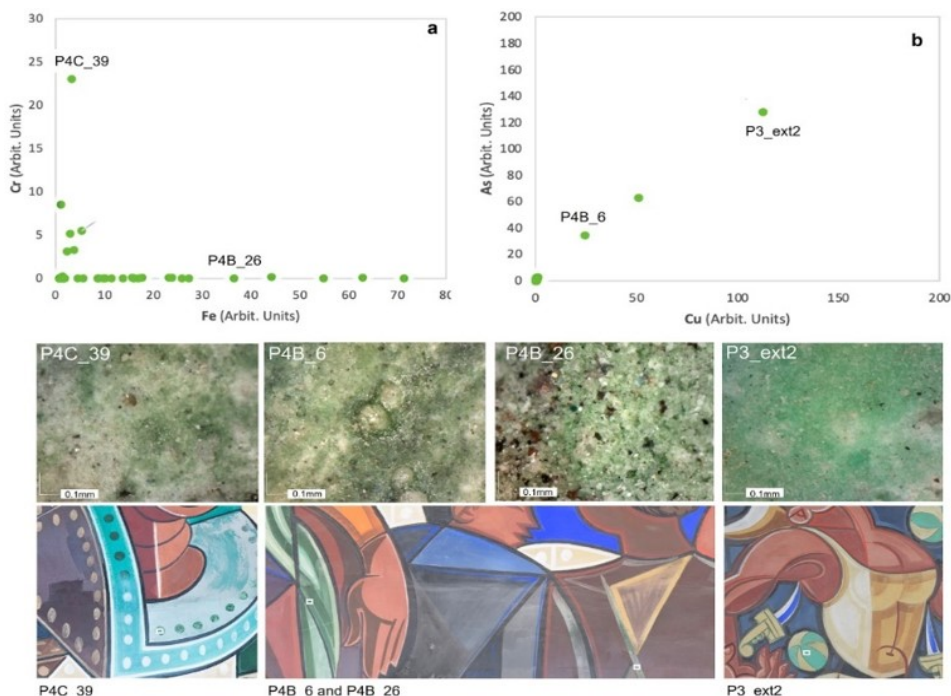
In the green paint layers analysed by h-EDRFXF, the main element identified as a chromophore is also Fe (Fig. 5a). Barium (Ba) and sulphur (S) were also detected in significant amounts in most paint layers, but their presence is most likely related to barium sulphate added as filler to the green pigments, as shown by the SEM-EDS of the coarse grains of Ba on the dark green paint layer in figure 5. The presence of barite (BaSO_4) was also confirmed by μ -XRD on another microsample collected from a bright green background of P2 (P2A_2 from Table 1).

Fig. 5. On the top, the XRF Cr-Fe and As-Cu biplot; on the bottom, the location of the analysis carried out (white squares) and h-OM image details at 435x of green paint layers P4C_39, P4B_26, P4B_6, and P3_ext2 from P4C, B, and P3. On all the paint surfaces, not only the green as the top layer is perceived but also the underlayers of white, brown, and yellowish hues

In figure 5a, the high amount of chromium (Cr) in six green paint layers suggests the presence of another green chromophore. Cr is identified in higher amounts in bright green particles such as the ones in P1A_2 of figure 6, and it is likely related to synthetic chromium oxide (Cr_2O_3) or hydrated chromium oxide ($Cr_2O_3 \cdot 2H_2O$) which have been available as artist pigments since the 19th century [14]. In addition to Fig. 5b, it was also found by XRF that high

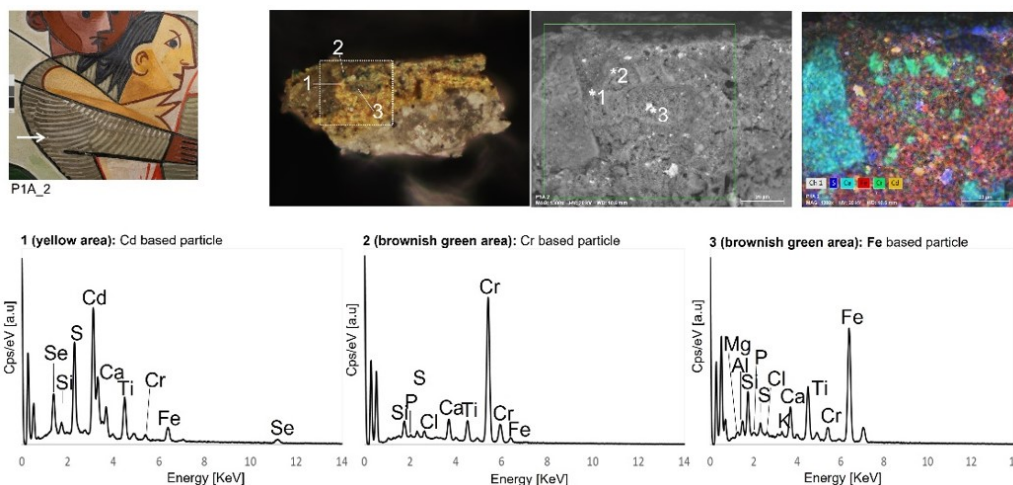
Iron is found in most paint layers with other elements in small or trace amounts, such as K, Al, Cl, Mn, Mg, and Si. The high Fe input can be related to: a) Fe-based green pigments, such as green earths [13], or potentially to Fe-organic synthetic modern pigments such as PG8, or PG1, recently identified at the Maritime station of Alcântara [3]; b) other Fe-brown, red chromophores in mixtures with the greens, or from paint underlayers, as found by SEM-EDS in the cross section of figure 6 or by h-OM in the paint surfaces of figure 4.

Fig. 6. On the top, sampling location of the brownish green paint layer P1A_2; OM-VIS light of P1A 2 cross section; BSE-SEM image and SEM-EDS sulfur (dark blue), calcium (light blue), iron (red), chromium (green), Cadmium (yellow) elemental maps. On the bottom, EDS spectra of Cd, Cr and Fe based pigments particles

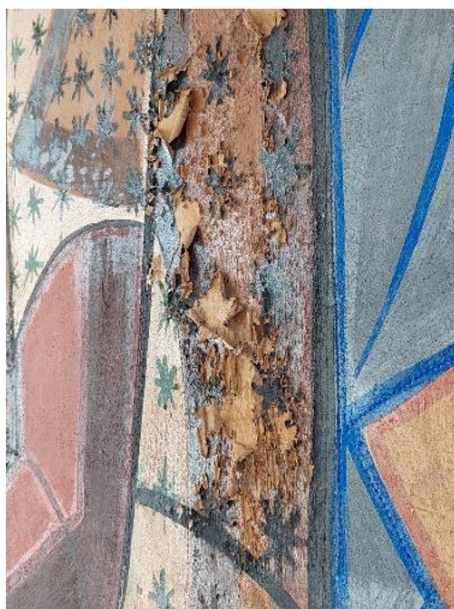
Painting Technique. During the on-site examination, it was noted that the most deteriorated paint layers exhibited a glossy surface, as shown in figure 7. Traditionally, mural paintings rendered in a fresco technique are matte, and all the paintings at the maritime station of Rocha do Conde de Óbidos are classified as such [1].

The gloss is clearly perceived by h-OM in areas of flaking but also in paint layers of the same color around it, in better condition. It is known that most of the paintings have been restored in the past and that adhesives were applied. Could this glossiness be related to past intervention products, or is it somewhat related to the painting technique (or to paint coatings) used originally by Almada?

Fig. 7. Detail of flaking paint layers with gloss on P3 (photo by M. Gil 2022. Project Almada)

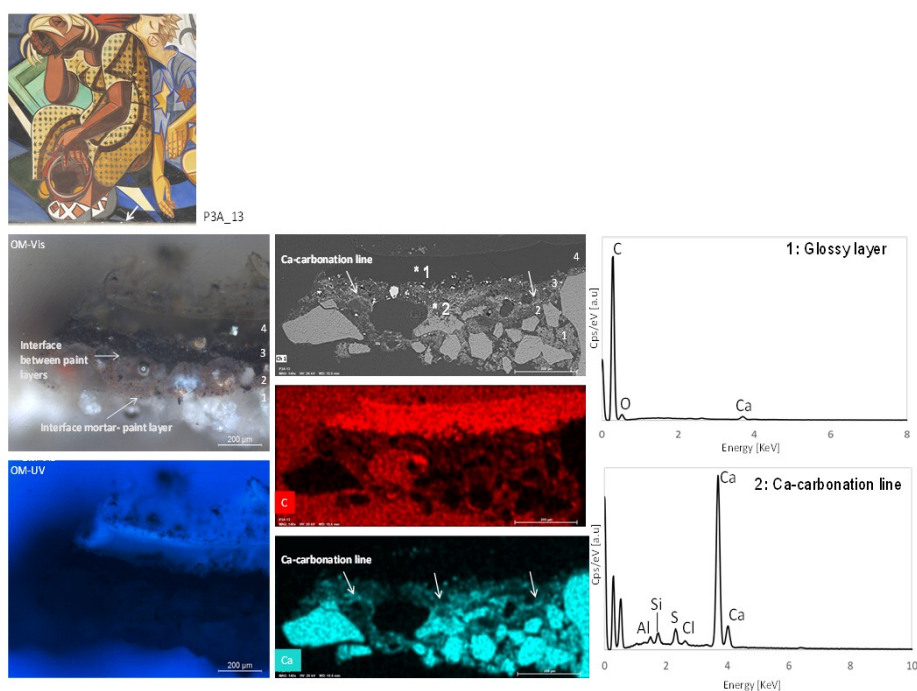
In order to understand whether the glow was restricted to the paint surface or if it was within the paint layer itself, cross sections of some of the microsamples collected from these areas were prepared and visualized by OM in the visible range (Vis) and by ultraviolet radiation (UV). One example collected from a black glossy paint layer on P3 is shown in figure 8. On the cross section obtained, four layers are perceived in the visible range. The first, a white inner layer, corresponds to the mortar used as pictorial support; the 2nd and 3rd are two overlaid paint layers of grey and black hues, respectively; and the 4th is a translucent layer on the surface (Fig. 8). This

layer, which is approximately 152 μm thick, displays a whitish fluorescence in UV mode. This layer is confined to the surface; the two paint underlayers do not exhibit a UV response.

To ascertain the painting technique used by Almada, further analysis was carried out on this microsample by VP-SEM-EDS. By EDS, the high amount of carbon (C) and its widespread distribution on the surface confirmed the organic nature of the glossy layer, whereas the presence of calcium (Ca) and its elemental map distribution suggest a lime-based painting technique on the underneath black and grey paint layers (Fig. 8). On the SEM-BSE image, the absence of a Ca-carbonation line at the interface of the mortar and the grey paint layer reveals a fresco execution. Yet, its presence at the interface of the two paint layers may indicate that Almada has laid down the black paint when the previous one has already dried (Fig. 8). The application of additional paint layers at a later stage may imply the use of *secco* painting techniques with pigments mixed with lime (lime painting) or with an organic material. The presence of Ca in the matrix of both paint layers in figure 8 suggests that lime was a binder in both cases. However, the additional use of organic binders in this sample and in the others collected from deteriorated paint layers cannot be completely excluded and should be further explored by other analytical techniques.

Fig.8. On the left, the sampling location of P3A_13; OM-Vis-UV of P3A_13 cross section with the indication of the 4 layers found. On the middle and right, VP-SEM-EDS analysis with the location of the thin carbonation layer at the interface between layer 2 and 3

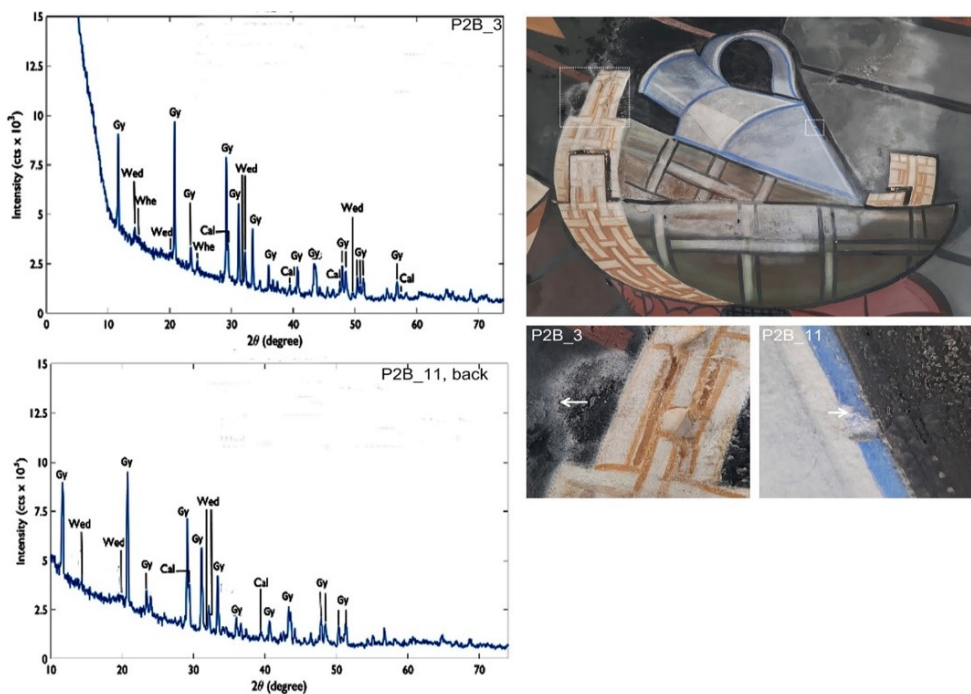
Painting 2, on the west wall, seems to have been particularly affected by water infiltrations, with two active moisture stains with white salt formations clearly visible from the ground (Figs. 1 and 2). Six micro-samples of the most deteriorated paint layers with salt veils and salt efflorescence were collected from the green background and the fish woman basket standing up and analysed by μ -XRD. The goal was to ascertain the main phases present and to compare with the salts already identified in the nearby maritime station of Alcântara. Table 1 reports the phases

Gypsum, a hydrated calcium sulphate, was found in most of the analyses carried out (Table 1, Fig. 9). No other sulphates were identified from the list already reported in 2021 by *M. Gil et al.* [3]. The salts in the Alcântara murals include thenardite (Na_2SO_4), syngenite ($\text{K}_2\text{Ca}(\text{SO}_4)_2 \cdot \text{H}_2\text{O}$), apthitalite ($\text{K}_3\text{Na}(\text{SO}_4)_2$), and anhydrite (CaSO_4), in addition to calcite and gypsum. These salts were not identified at Rocha do Conde de Óbidos, possibly due to the amount sampled being below the limit of detection of the μ -XRD.

Fig. 9. On the right, the sampling locations of microsamples P2_B3 and P2B_11, back collected from P2, are most affected by water infiltration. On the left, the corresponding μ -XRD diffractograms show identified mineralogical phases (Gy – Gypsum, Cal – Calcite, Whe – Whewellite, Wed – Weddellite)

It is known that hydrated calcium sulphate is one of the main and most common salts encountered on carbonated mural paintings [16, 17]. Sulphates are usually found in soils, polluted atmospheres, and sea spray [18–22]. In a building, the formation of sulphates is typically spurred by the wet and dry acid deposition of SO_x in conjunction with water infiltration, which prompts the leaching and migration of dissolved ions into the architectural structure [21]. In this research, the presence of gypsum could be anticipated considering that both stations were a) built with the same building materials (which include reinforced cement [7]) and b) only 1.5km apart, and as such, the paintings were exposed over the years to the same weathering environment (proximity of thoroughfare and the river or sea). The activity of soluble salts, such as gypsum, is one of the main causes of flaking (and powdering) of the paint layers due to the gradually disruptive cycles of crystallisation and dissolution within a porous material.

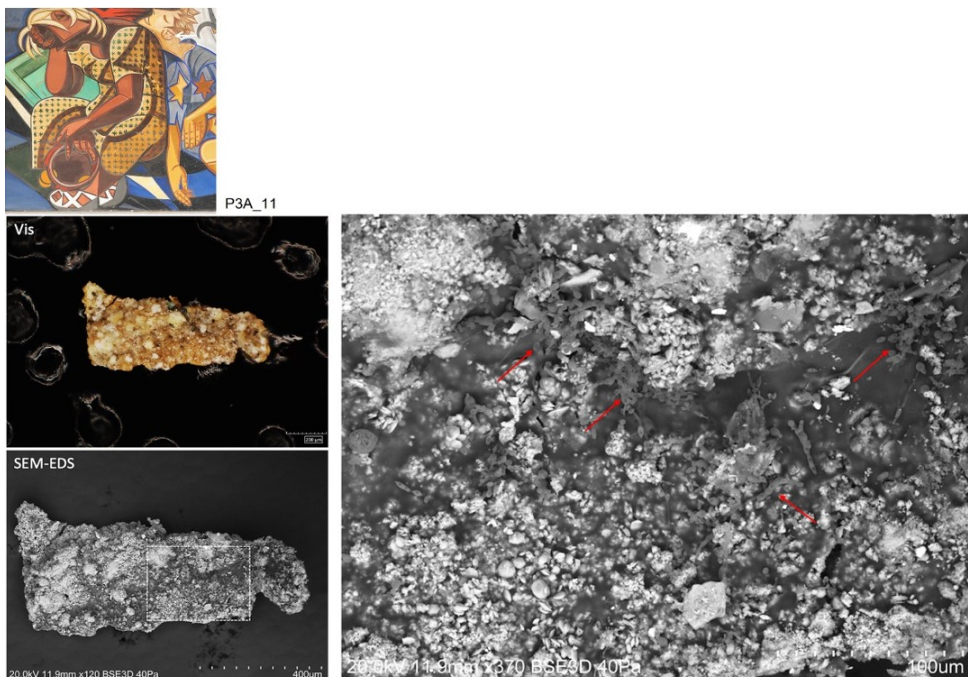
In addition to gypsum, only two other minerals have been identified by μ -XRD that may be actively contributing to the deterioration of paint layers. These are the whewellite and weddellite calcium oxalates found on the front and back of samples P2B_3 and P2B_11 (Fig. 10, Table 1). The origin of these minerals in the paintings may be related to the deterioration of organic binding media, biological activity and metabolism products, or the oxidation of organic materials applied in past interventions [23]. In figure 10, the presence of bioactivity on the paint surface over the glossy carbon-based layer may suggest a combination of the last two hypotheses.

Fig. 10. On the left, OM-VIS (top) and SEM-BSE (below) images of sample P3A_11 collected from a brownish paint layer on P3. On the right, detail of BSE-SEM image of the paint layer surface, indicating biological colonization over a carbon-based layer (red arrows)

Calcium oxalates are considered to be one of the most common and harmful salt contaminants, leading to powdering of the mortar and flaking of the paint layers [24]. According to *T. Rosado et al.* [24], typically microorganism activity on the surface of a mural painting, like fungi, bacteria, lichen, and algae, can serve as a biological substrate, resulting in the development of calcium oxalates [24]. The metabolism of these microorganisms produces oxalic acid ($H_2C_2O_4$) that reacts with calcite on lime-based murals to form calcium oxalate (CaC_2O_4) [23, 24]. In the deteriorated paint layers analysed that exhibit a glossy layer at the surface, the presence of microbial activity may be related to the original coatings used by Almada or to adhesives applied to past interventions. The colonisation of microorganisms is known to be supported by organic and inorganic nutrient sources, and a carbon-based layer can act as such [25].

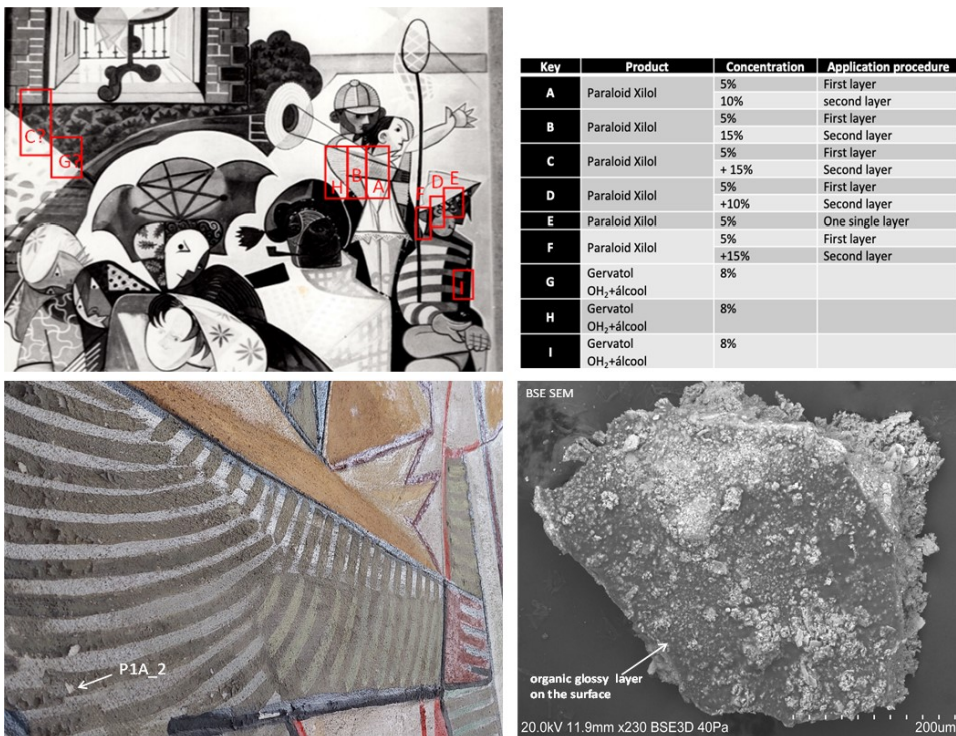
The documentation produced in 1971 and 1995 provides a small amount of context to the past treatments undertaken at Rocha do Conde de Óbidos, and which products used at that time may now be degrading and contributing to the flaking of the original paint materials [26, 27]. The report made in 1971 is particularly important since it specifies the tests made with adhesives on P1 [26] and the location of the different experiments done with Paraloid (the type is not referred to, but it is most likely B72 that was the one most used for this purpose) and Gervatol (Fig. 11). Chemically, Paraloid is an ethyl methacrylate-methyl acrylate copolymer, and Gervatol (or gelvatol) a polyvinyl alcohol. Both were tested in different concentrations diluted in xilol and in water and ethanol, respectively. Paraloid was deposited twice, reaching more than 20% in areas B, C, and F, which may be responsible for the glossy areas observed on-site in April 2022 (Figs. 8, 10 and 11). The results of these experiments are not given, nor is the final product selection, but remnants of adhesive layers are clearly identified in P1 and P2 on deteriorated paint layers.

Fig. 11. On top, documentation from 1971 with the indication of adhesive tests carried out on painting 1 (red squares). The letters A to I on the table correspond to the different test locations signaled. Below, on the left, is the location of the microsample collected from a previously consolidated greenish-brown paint layer. On the right, a BSE-SEM image of the surface of the microsample P1A_2 shows a carbon-based layer on top of the paint layer

Paraloids (in particular B72) are among the most well-known acrylic resins widely used as adhesives and protective coatings in the field of cultural heritage [28, 29]. Paraloids are generally appreciated for their relative stability, reversibility, mechanical resistance, and transparency [29]. But despite their popularity, polymer materials are known to age and deteriorate due to light, heat, acid-base environments, and bioactivity [28]. Moreover, when applied in thick layers, they can produce a hydrophobic barrier that may cause further damage to paint layers affected by moisture and soluble salts. This is the case with the severe flaking paint

layers on P2, where gypsum was identified. The past conservation products applied in this area show a brittle appearance and are peeling together with the paint layer.
