GEOTECHNICAL RISKS IN NATURAL STONE QUARRIES

IV International Workshop
on Natural Hazards

Faial Island, Azores
23 and 24 October 2025

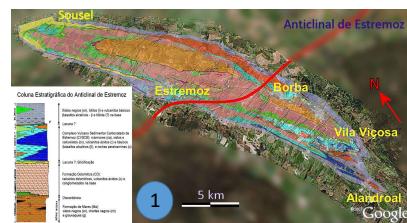
After the landslide of a quarry slope on November 19, 2018, which caused the collapse of the road between Borba and Vila Viçosa, Portugal (2A; 2B), in which five people died, it became imperative to increase surveillance and slope stability studies in quarries in Portugal, and particularly the Estremoz Anticline.

Google image showing the geology of the Estremoz Anticline (1) and the landslide of the quarry slope on November 15, 2018, with a length of 100 meters (2A), which was located next to the M255 municipal road, causing it to collapse (2B) and deep cavities with dangerous vertical slopes, interspersed with increasingly high and visually striking rock heaps Anticline (3).

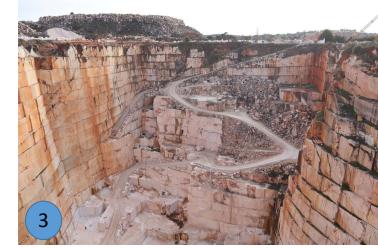
For decades, the marble quarries of the Estremoz Anticline have seen proliferation of somewhat disorganized exploitation, leading to what is now a region with a profoundly modified relief. The predominantly agricultural Alentejo plain has been replaced by increasingly deep cavities with dangerously vertical slopes, intercalated with heaps that are increasingly high and visually impactful (3).
