Investigation of marble limestone biocolonization: The case study of Convento das Maltesas in Estremoz

Sriradha Bhattacharya
m38419

Evora, September 2018

Keywords: Biodegradation/Biodeterioration, biofilms, marble, Maltesas Convent, stone alteration

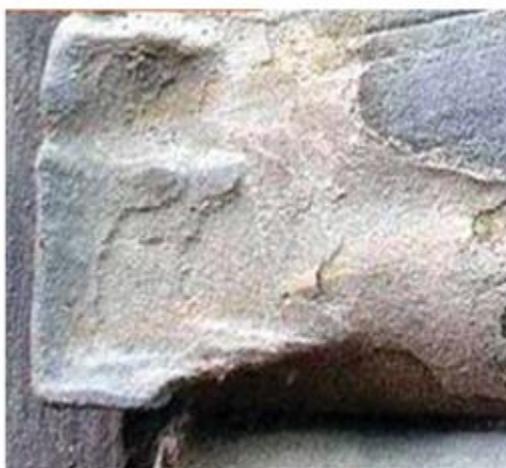
Figure 1. 5: Evidence of flaking on marble building (Adapted from (V.Verges-Belmin, 2008)).

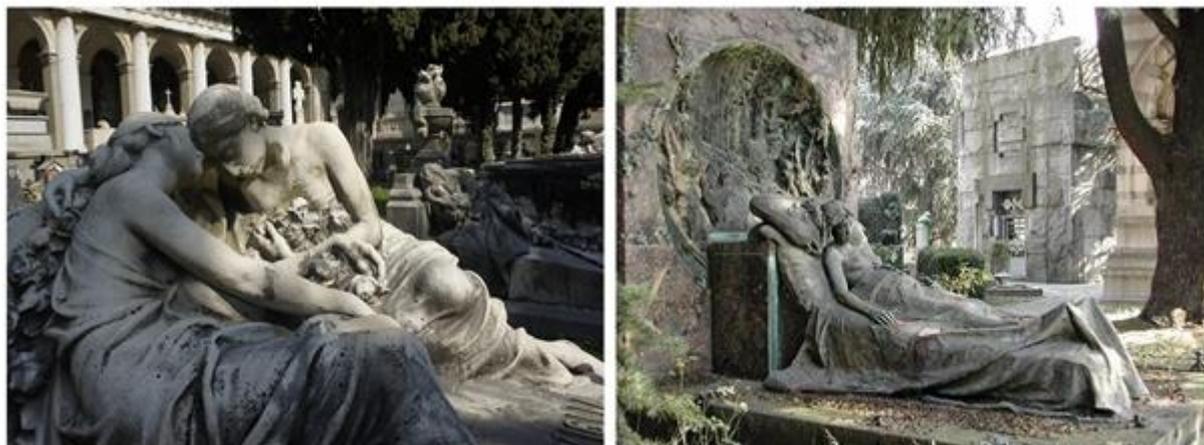
The black crust (Fig.1.6) is essentially formed by the carbonaceous particles formed due to the burning of fossil fuels. These particles contain metal oxides that catalyse the sulphur dioxide oxidation which forms the black crust. It has also been suggested that the black crust is formed owing to biological factors in unpolluted areas. Ortega-Calvo has suggested that the ideal habitat for cyanobacteria is through the steady dissolution of the sulphates, which are formed due to microflora. Mansch and Bock have found that the nitrifying bacteria is also a great cause of stone decay that is associated with air pollution and the formation of black crusts. According to Schiavon, Chairi and Fabbri polycyclic aromatic compounds (organic compounds) are strong markers contributed by vehicular pollution on limestone. Carbon dioxide also plays an integral role in stone decay and is primarily due to climate changes. Nowadays climate change, though not considered by many, is a severe deterrent to cultural heritage especially in areas ridden with droughts, floods, and varying humidity cycles which lets microflora flourish on the stone surface and in turn increases the damages caused by crystallisation of salts (Eric Doehne, 2010).

Figure 1. 6: Black crust formation on marble statues (Adapted from: <https://viajestic.atresmedia.com>).

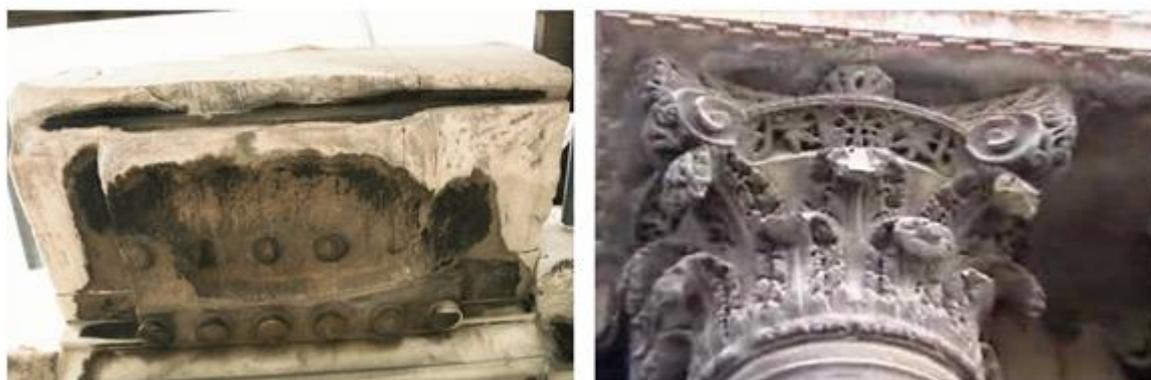
Figure 1. 14: Effects of Sulphation on marble capitals (Adapted from: www.ysma.gr/en/conservation-degradation-phenomena, <https://pubs.usgs.gov>).

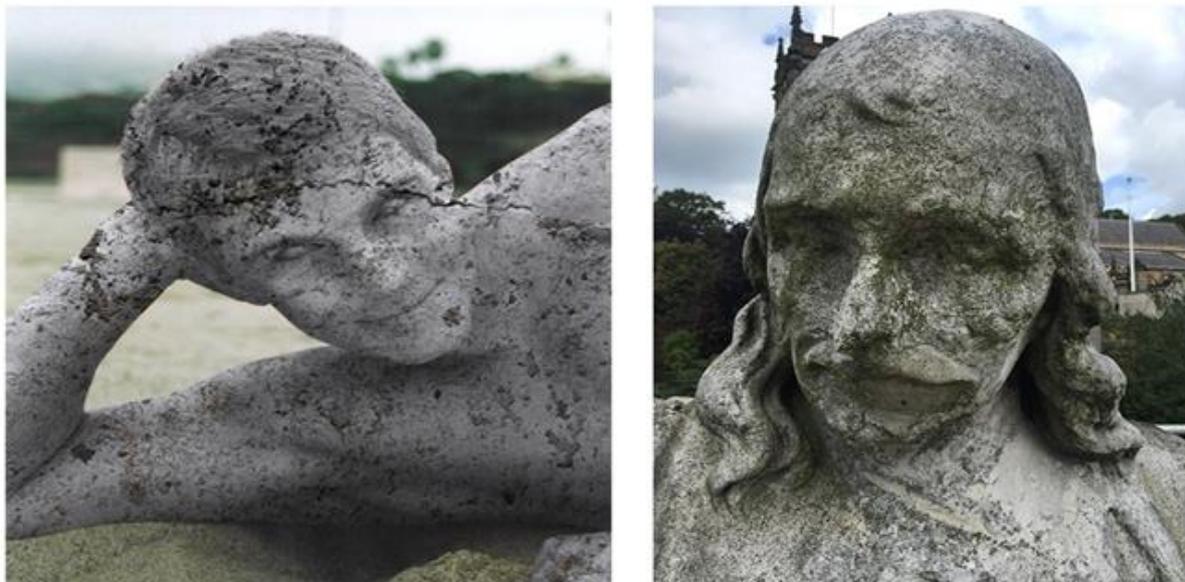
Cracking, is indicated by narrow fissures formed on the marble. These fissures leads to bigger cracks. Cracks can be owing to hard mortar, the corrosion caused by internal ferrous materials and structural issues. Marbles, depending on the impurities have natural veins in them. These veins maybe horizontal or vertical composed of clay, sand, silt or chert which is all present in the limestone before being metamorphosed to marble. These veins have various physical properties and weathering is not uniform and can lead to cracks. The marble crumbles leaving behind loose granules, and generally takes place when the binding material wears off due the dissolution by acidic water, leaving the marble surface looking granular and powdery (V. Rives, 2006). Apart from acidic water and salting, thermal changes are the reason for this damage, which permanently changes the volume, changing the calcite crystalline structure by fracturing it and dislocating the grains of the marble. This allows water penetration into the stone leading the loss of strength of the marble itself and can lead to complete dissolution (C.Gaylarde m. S., 2006). Examples of these effects are shown in the figure1.16.

Figure 1. 16: Effects of cracking and sugaring on stone (Adapted from: www.tutorgrafico.com, www.hirst-conservation.com).

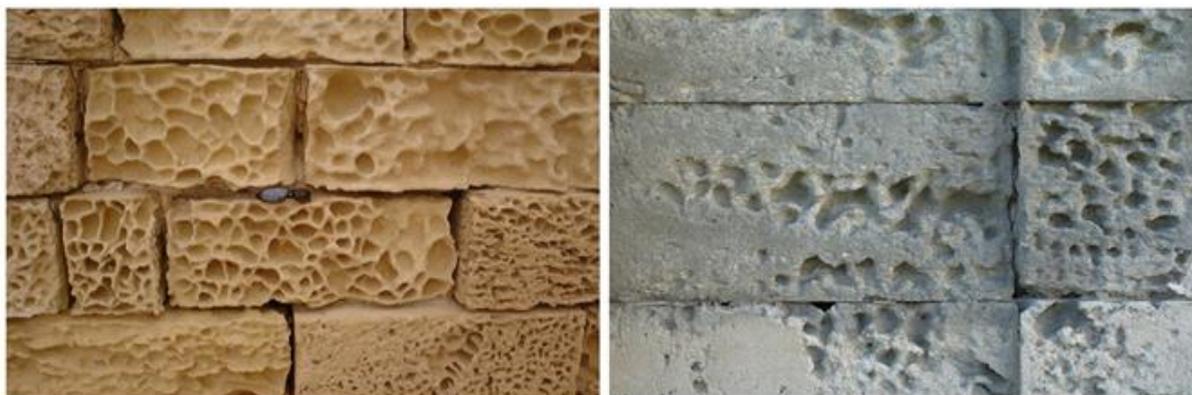
Alveolisation is a kind of differential weathering possibly due to inhomogeneities in physical or chemical properties of the stone. Alveolisation may occur with other degradation patterns such as granular disintegration and/or scaling. In arid climates large alveoles of meter size are frequently formed (e.g., Petra Jordan) When this action takes place the salts deposits in the hollow area of the sheltered areas which is not washed away with rains and these give rise to endolithic microorganisms. It should also be noted that salt formation is capable in these areas as these areas also tend to dry the last and the moisture contents vary greatly in these cavities, thereby aiding the in the erosion in the deepest areas. This kind of erosion is helped by the nearby dust from nearby plays or sea salts.

Figure 1.17: Effects of alveolisation on exterior walls of building (Adapted from: www.buildercorp.pl, www.wikipedia.com).

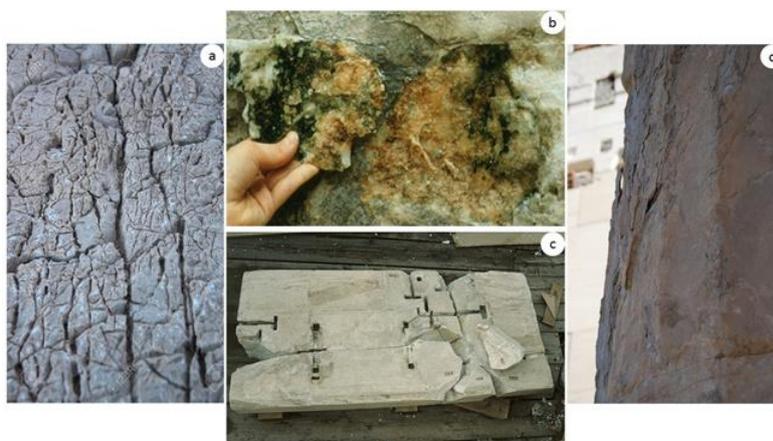
Salts also weather stones containing clay materials. Calcite is a porous material, and these salts can dissolve the calcite and alter biotite, quartz and feldspars. It is also noted that halophilic bacteria are often present in this kind of weathering and sometimes aid the damage. Frost damages are very similar to salt damages (Eric Doehne, 2010). Damages due to salting is mostly physical in nature which leads to blistering, flaking, cracking, scaling and disintegration(Fig.1.18) (Stephanie Scheerer, 2009).

Figure 1.18: Effects of salting a) dislocation, b) breakage and c) flaking (Adapted from:

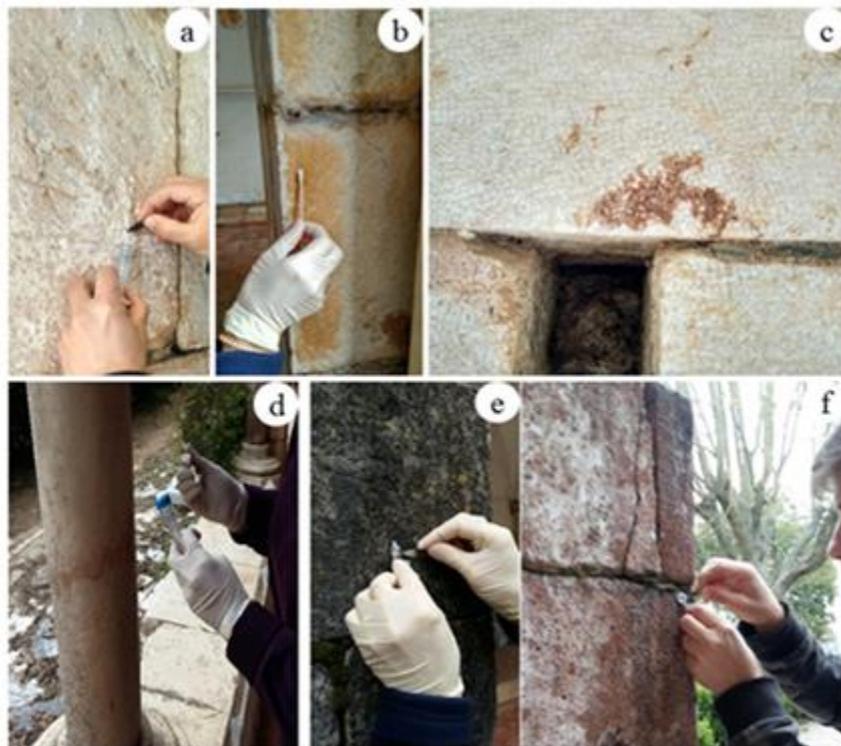
Figure 2. 2: Sampling process performed on Maltesas Convent (a) CM1; b) CM2; c) CM3; d) CM4; e) CM5; f) CM6).

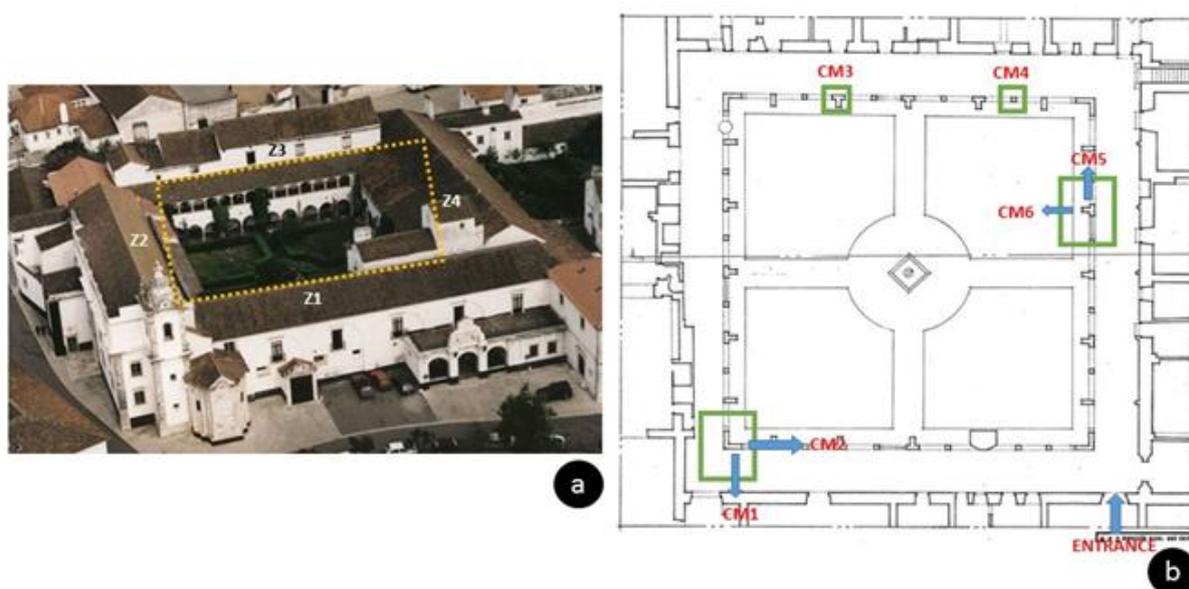
Figure 3. 1: a) Ariel view of the Maltesas Convent in Estremoz, b) Map of the convent and the sample areas (Adapted from <http://www.monumentos.gov.pt>).

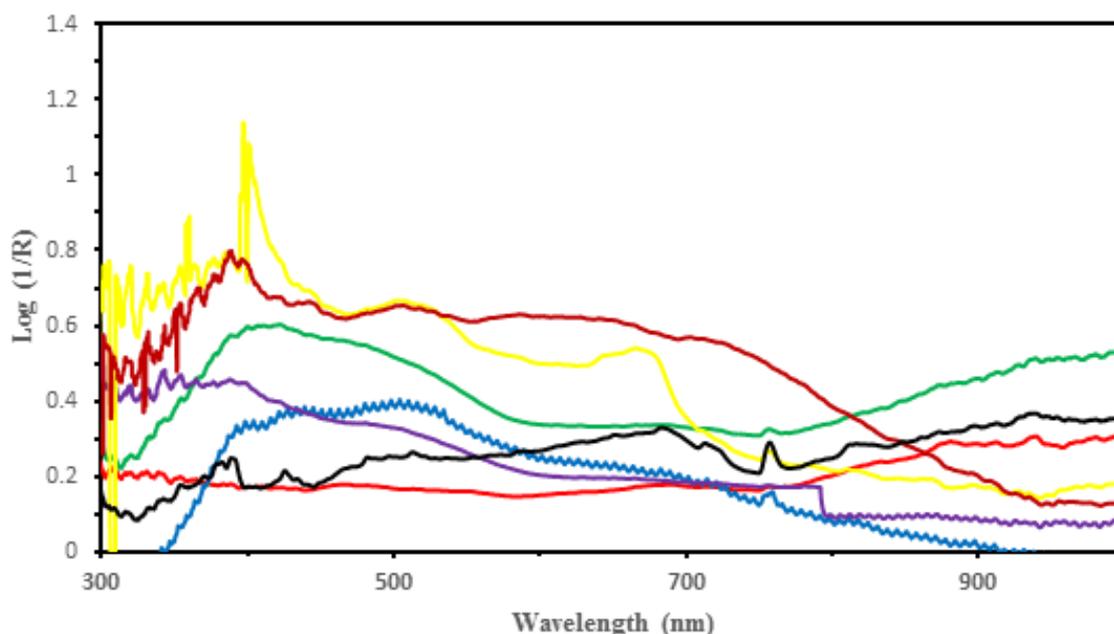
Figure 3. 2: Chromatic observations as observed by Fibre Optic Reflectance Spectroscopy. NA —, CM1 —, CM2 —, CM3 —, CM4 —, CM5 —, CM6 —

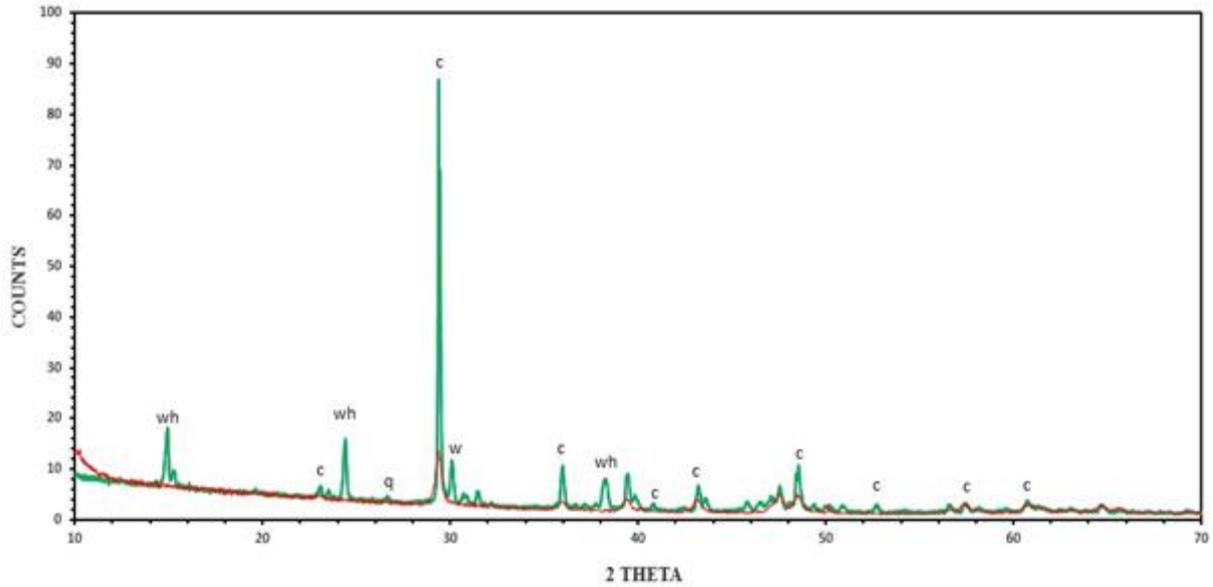
Figure 3. 3: XRD Diffractograms (CM1 —, CM2 —) Calcium oxalate – wheddelite and whewellite as observed on XRD. [c – calcite (CaCO_3), wh – whewellite ($\text{CaC}_2\text{O}_4 \cdot \text{H}_2\text{O}$), w – weddellite ($\text{CaC}_2\text{O}_4 \cdot 2\text{H}_2\text{O}$), q - quartz (SiO_2)].

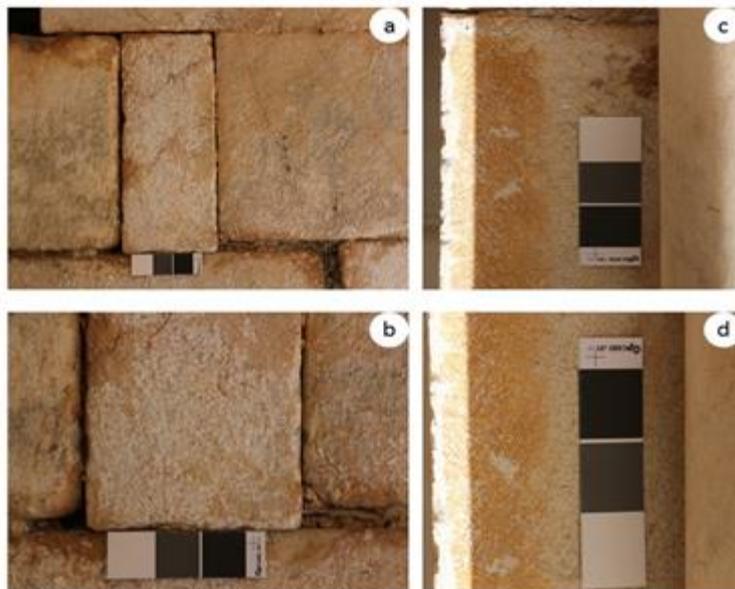
Figure 3. 4: 1 – a) CM1 area showing encrustation and stratification, b) magnification of CM1 area as shown in area a, c) CM2 area showing encrustation and stratification, d) magnification of CM2 area as shown in area c. The images also exhibit a chromatic alteration.

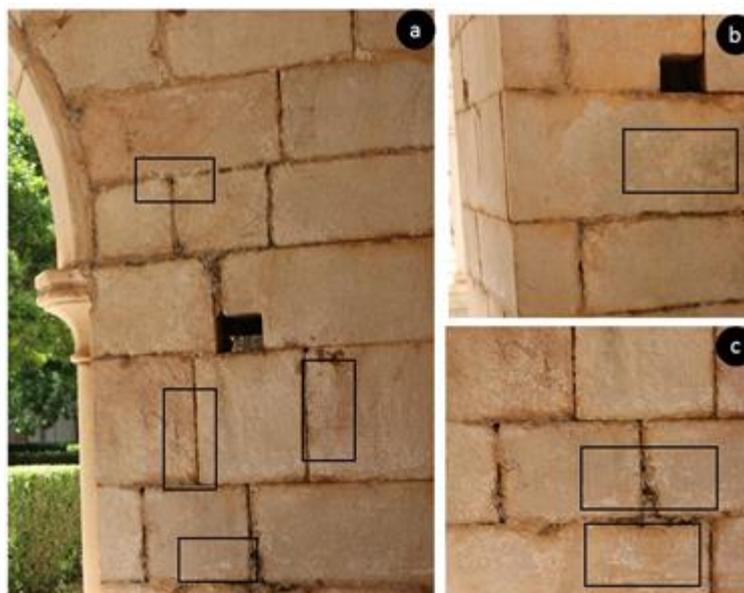
Figure 3. 5: Evidence of lime nodules on the pillars an effort to conserve the convent in CM1

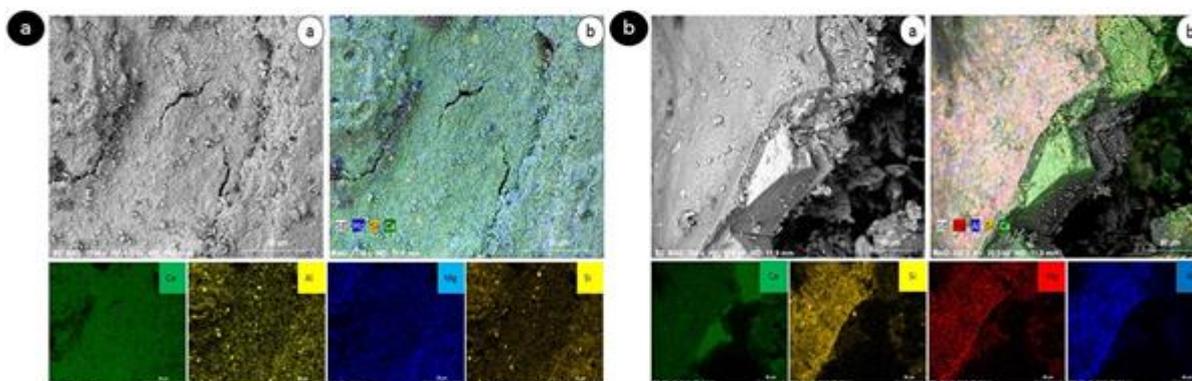
Figure 3. 6: Scanning electron microscopy (SEM) in back-scattered mode (a) and EDS two dimensional(2D) elemental maps of (a, dark circle) CM1 showing the Mg presence due to lime wash and (b, dark circle) CM2 showing the presence of Al, Si confirms the presence of quartz in in the sample in Maltesas Convent.

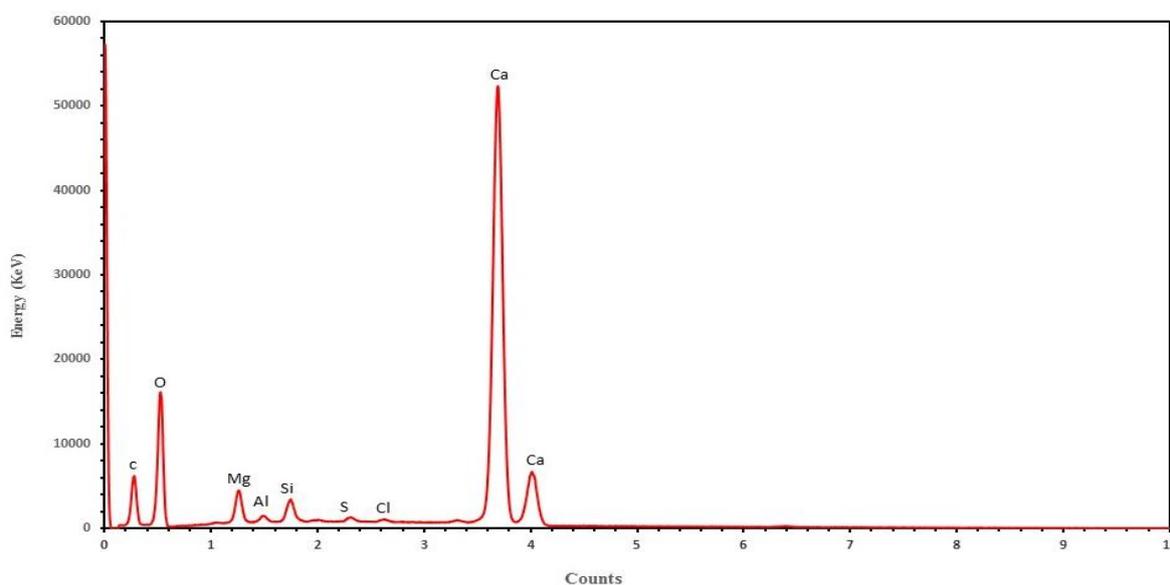
Figure 3. 7: X-ray spectra from SEM-EDS with a small peak of sulphur suggestion of gypsum caused by air pollution.

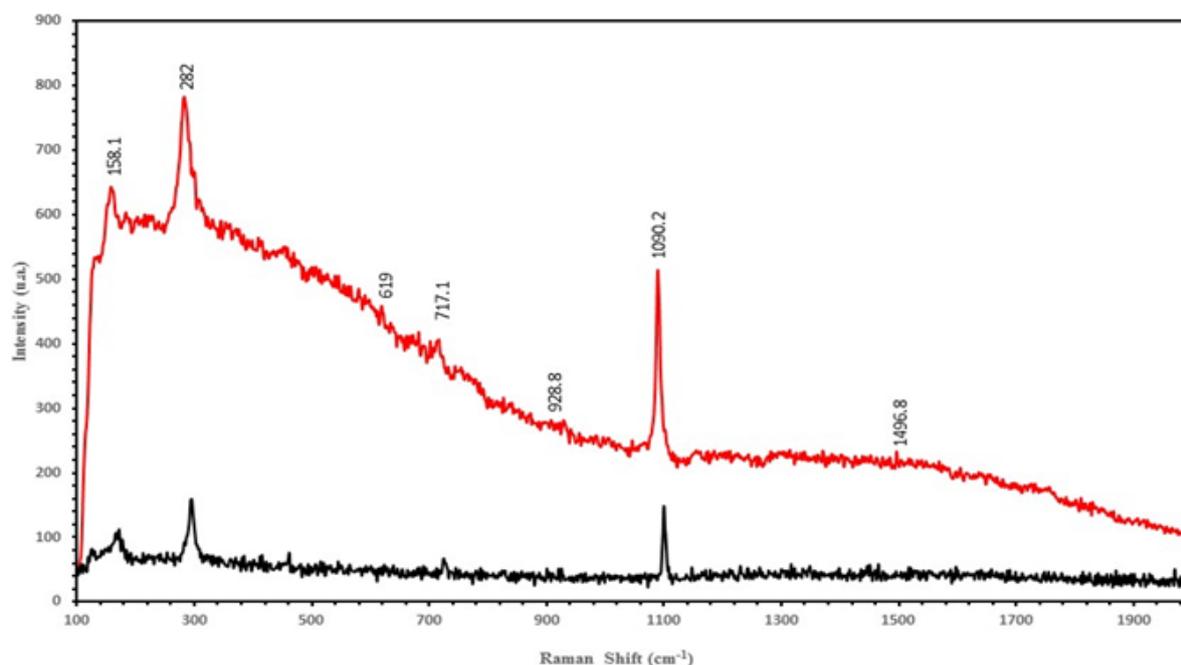
Figure 3. 8: Raman spectra of oxalate presence, identified on CM1 sample (CM1 —, NA —).

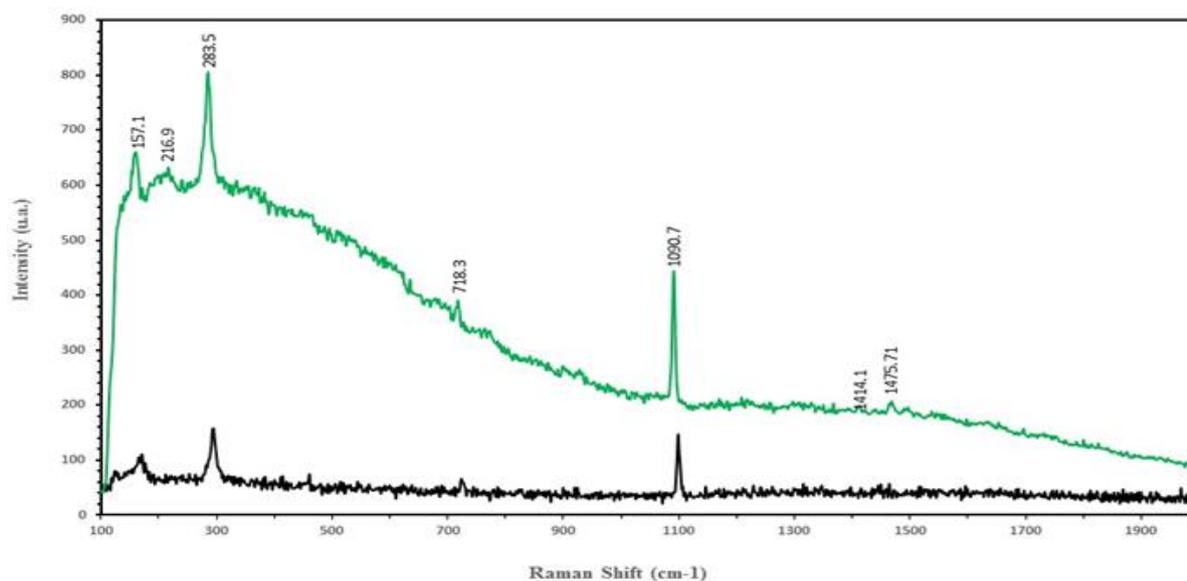
Figure 3. 9: Raman spectra of oxalate presence, identified on CM2 (CM2 —, NA —).

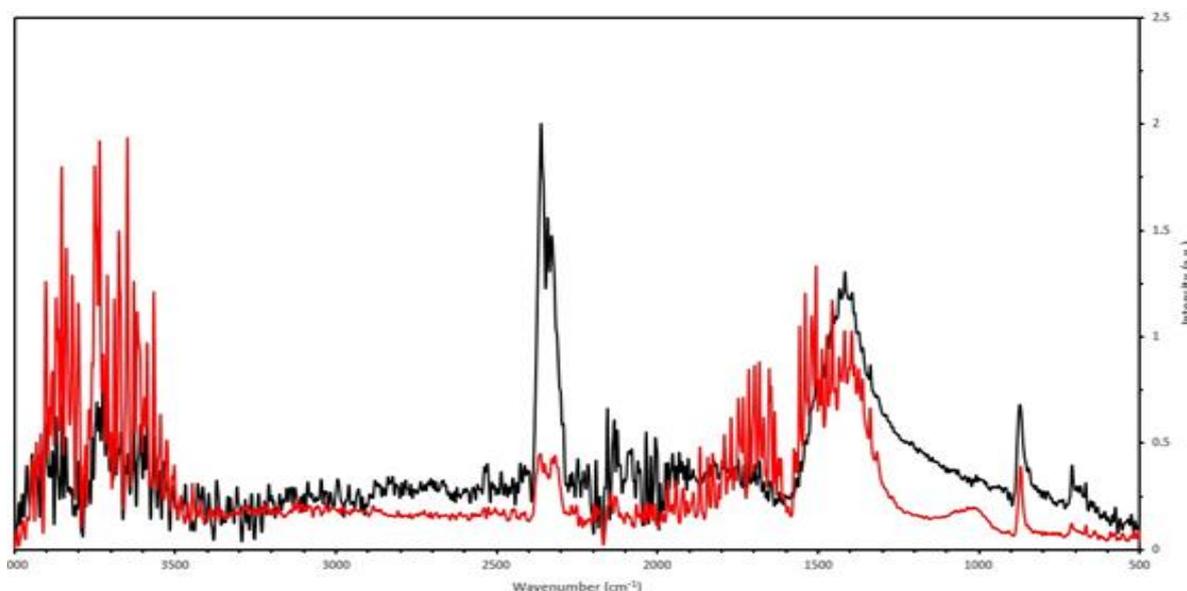
Figure 3. 10: Silicate and calcite detection in CM1 microfragments by fourier transform infrared spectroscopy attenuated total reflection analysis (CM1 —, NA —).

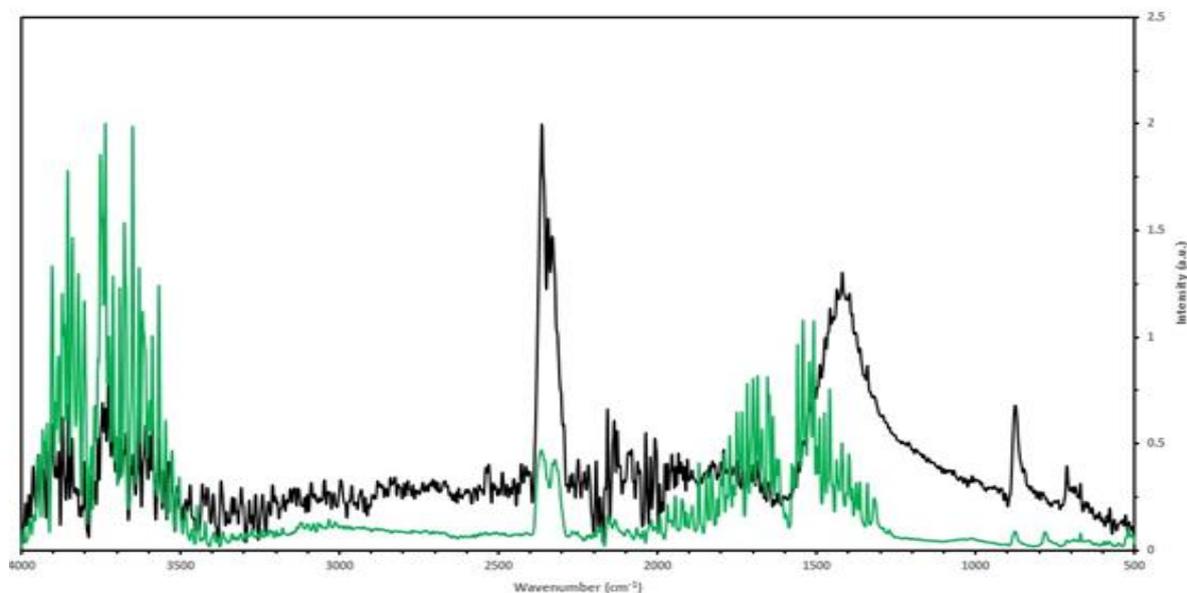
FTIR of CM2 shows oxalates and calcite (Fig.3.11).

Figure 3. 11: Silicate and calcite detection in CM2 microfragments by fourier transform infrared spectroscopy with attenuated total reflection analysis (CM2 —, NA —).

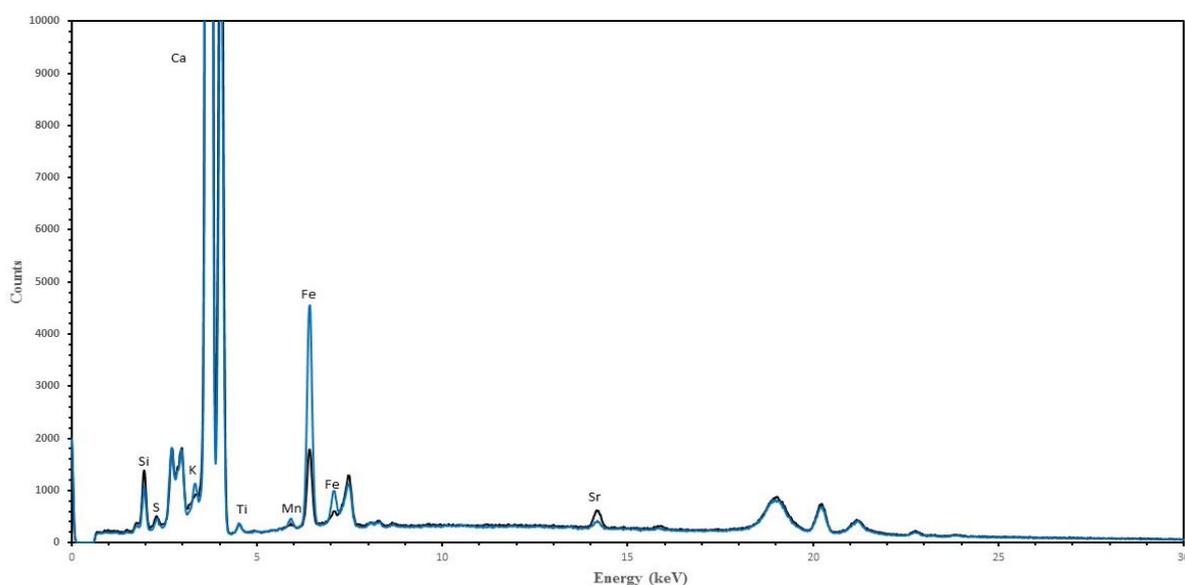
Figure 3. 12: XRF peaks indicating elemental analysis of CM3 showing a high presence of iron (CM3—; NA—).

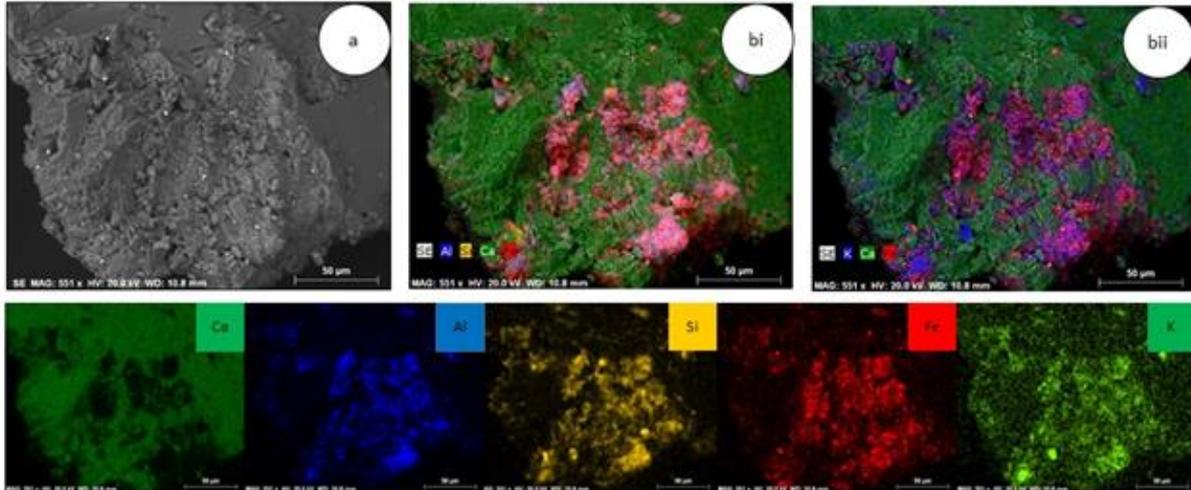
Figure 3. 13: Scanning electron microscopy (SEM) micrograph in back-scattered mode and EDS two dimensional(2D) elemental maps of CM3 showing abundance of iron (bi) CM3 showing Al, Si Fe, Ca, and (bii) CM3 showing Al, Si, Fe, Ca in the sample in Maltesas Convent

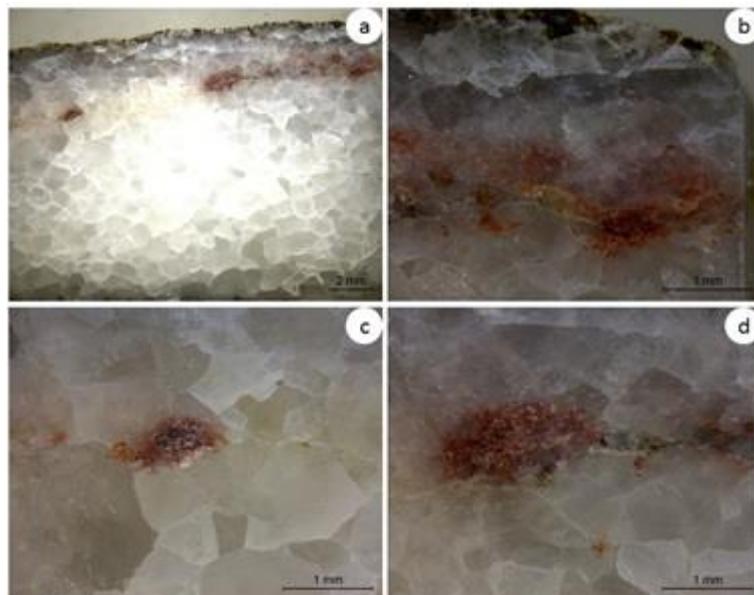
Figure 3. 14: Presence of iron inside the iron as observed on Optical Microscopy. a) The complete image of the iron degradation b), c), d) Magnification of iron degraded areas from image a.

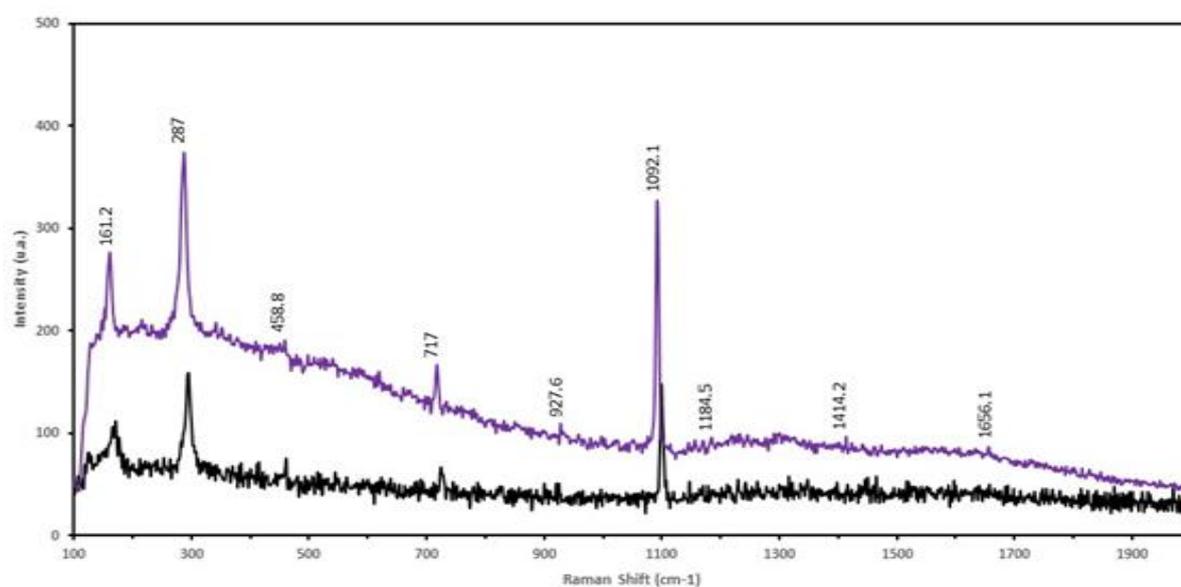
Figure 3. 15: Carotenoid compound detection in CM4 microfragments by Raman spectroscopy (CM4 —, NA—).

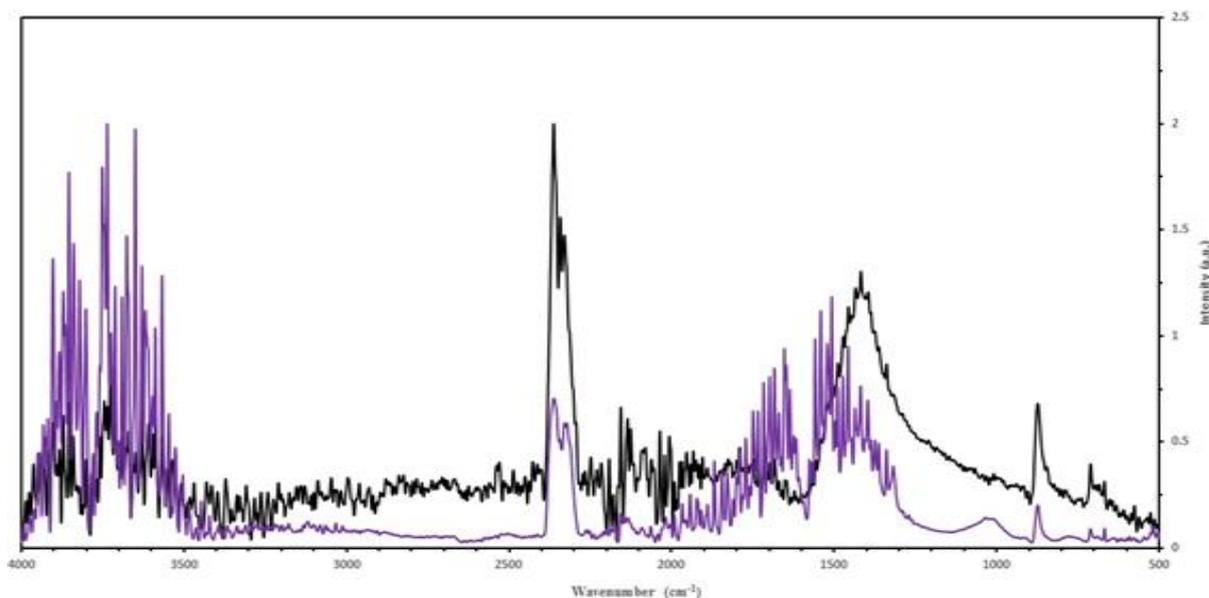
Figure 3. 16: Silicate and calcite detection in CM4 microfragments by fourier transform infrared spectroscopy attenuated total reflection analysis (CM4 —, NA —).

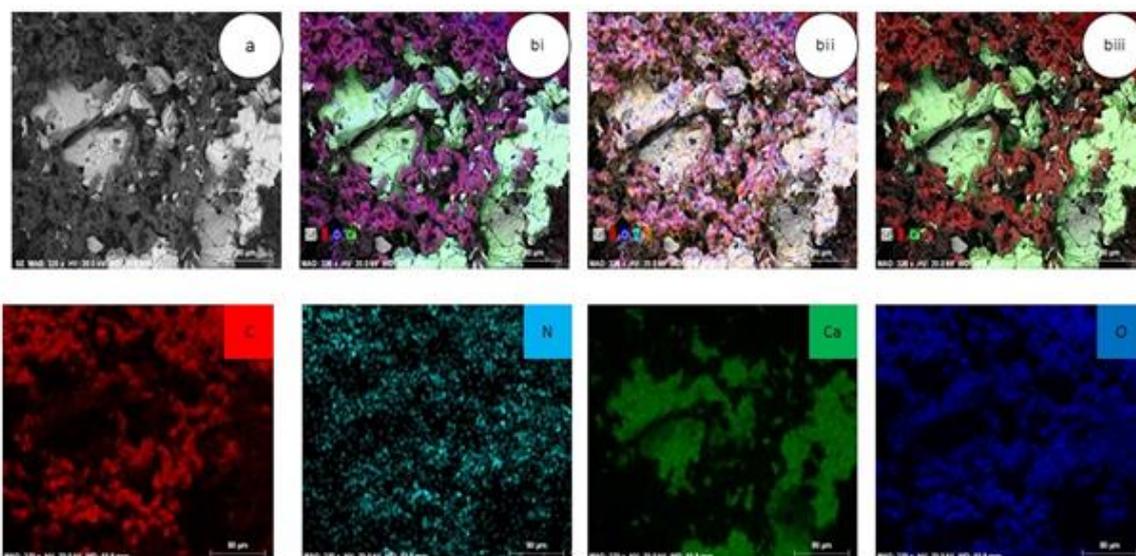
Figure 3. 17: Scanning electron microscopy (SEM) micrograph in back-scattered mode and EDS two dimensional(2D) elemental maps of the sample CM5 exhibiting microbial proliferation on the sample. Presence of C,N,O which are indicators for organic remains in Maltesas Convent.

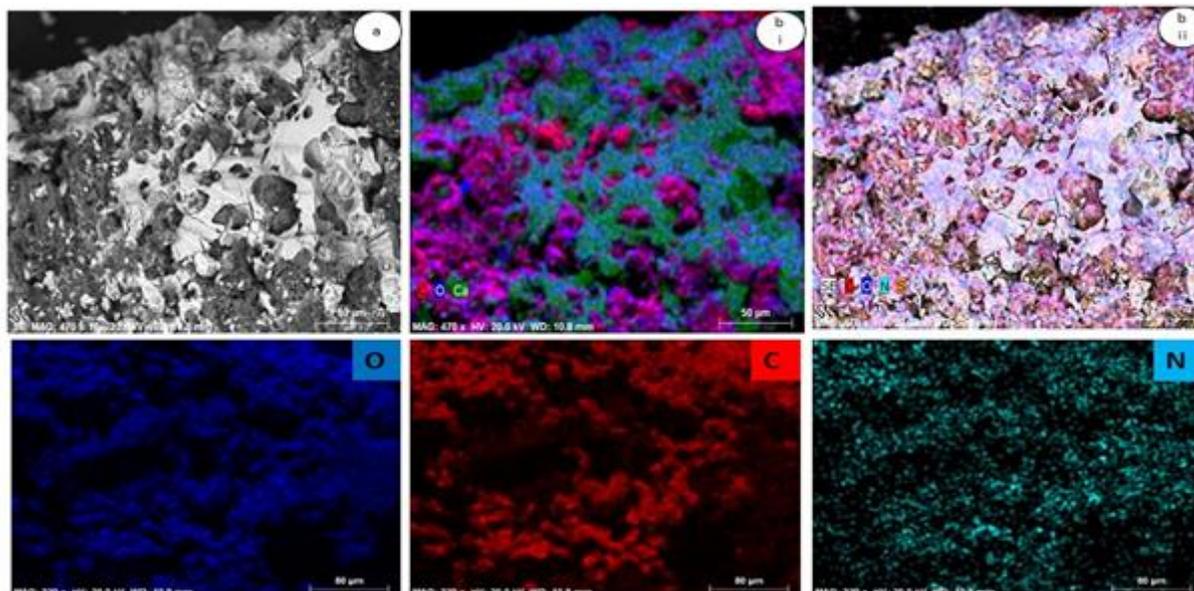
Figure 3. 18: Scanning electron microscopy (SEM) micrograph in back-scattered mode and EDS two dimensional(2D) elemental maps of the sample CM6 exhibiting microbial proliferation on the sample. Presence of C, N, O are indicators for organic remains in Maltesas Convent.

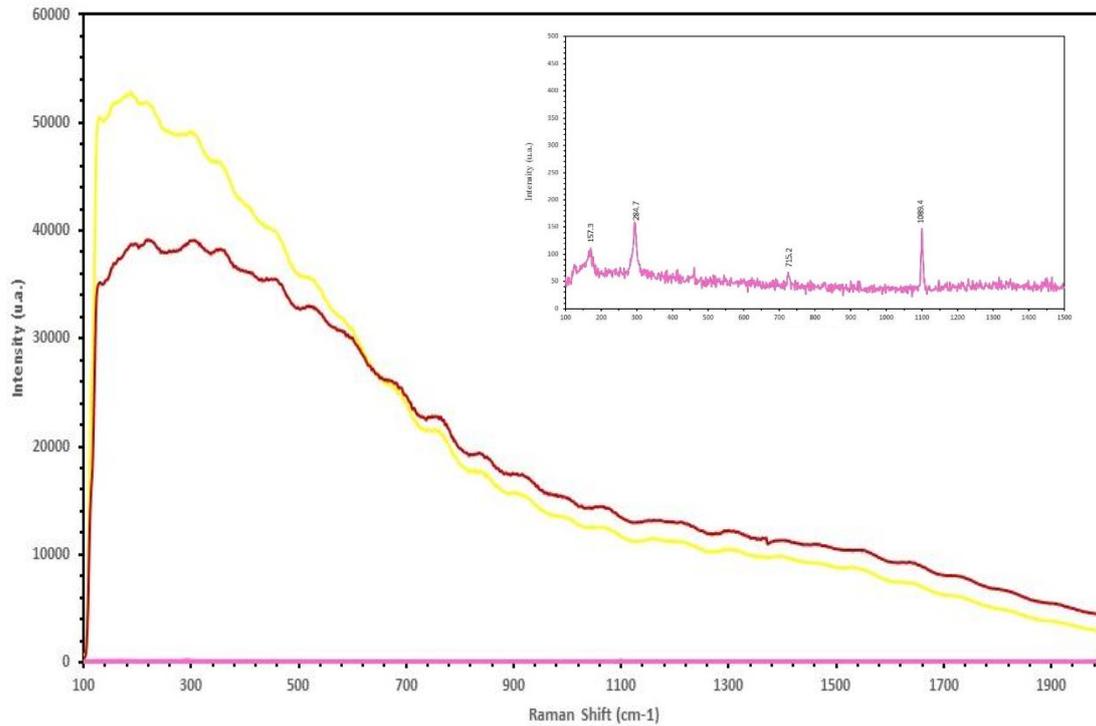
Figure 3. 19: Microbial proliferation detection in CM4 and CM5 microfragments by Raman spectroscopy (CM5 —, CM6 —, NA —. Insert magnification of N.A. area).

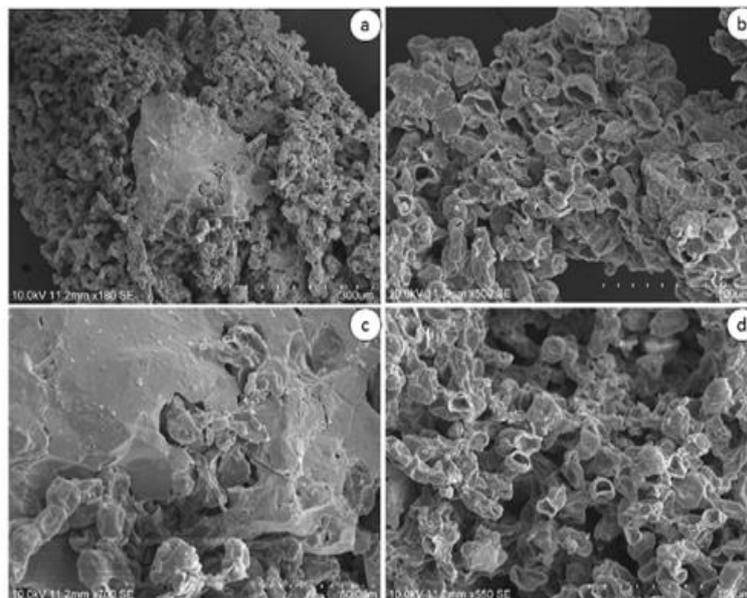
Figure 3. 20: Scanning electron microscopy (SEM) micrograph CM5 exhibiting microbial proliferation on the sample (a) Microbial proliferation – filamentous fungi surrounding the substrate. (b,c,d) Magnified area a showing filaments of the fungal proliferation.

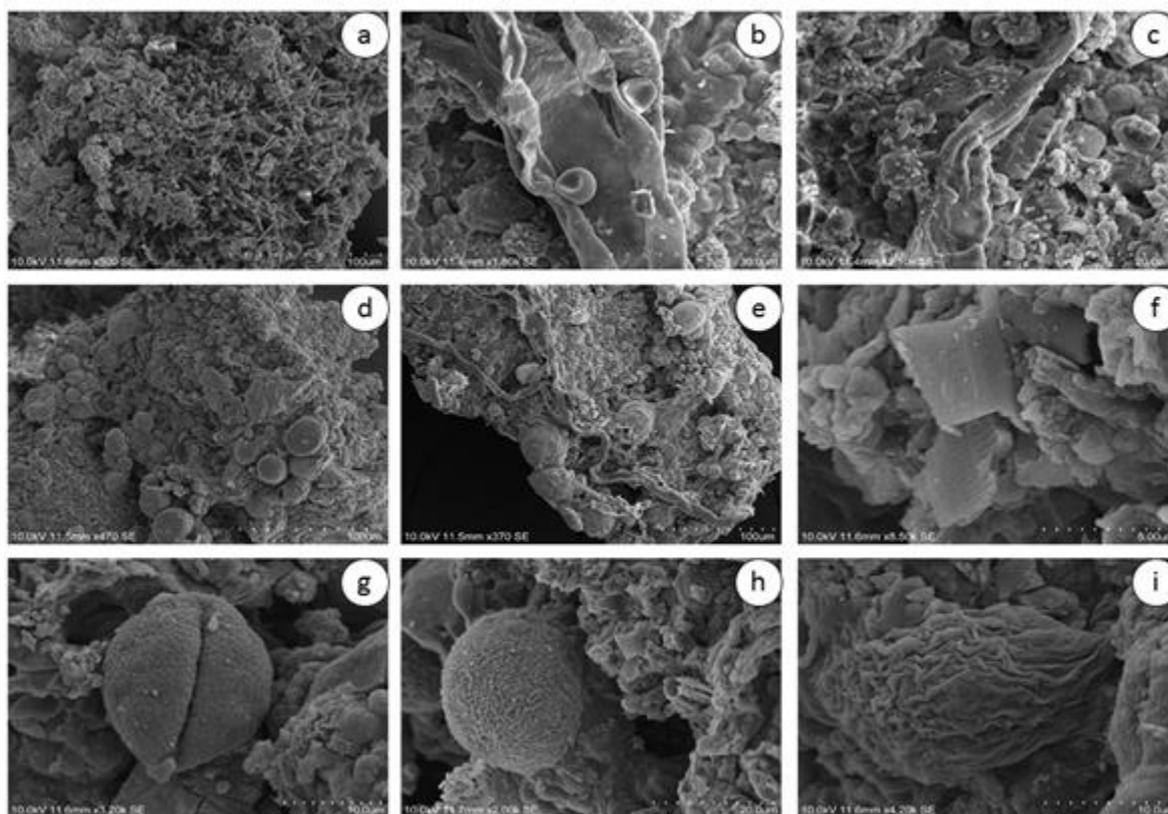
Figure 3. 21: Scanning electron microscopy (SEM) micrograph of CM6 (a-e) exhibiting different types of microbial proliferation on the sample,(f)Presence of diatom, (g-i) unidentified structures in the black biofilm.

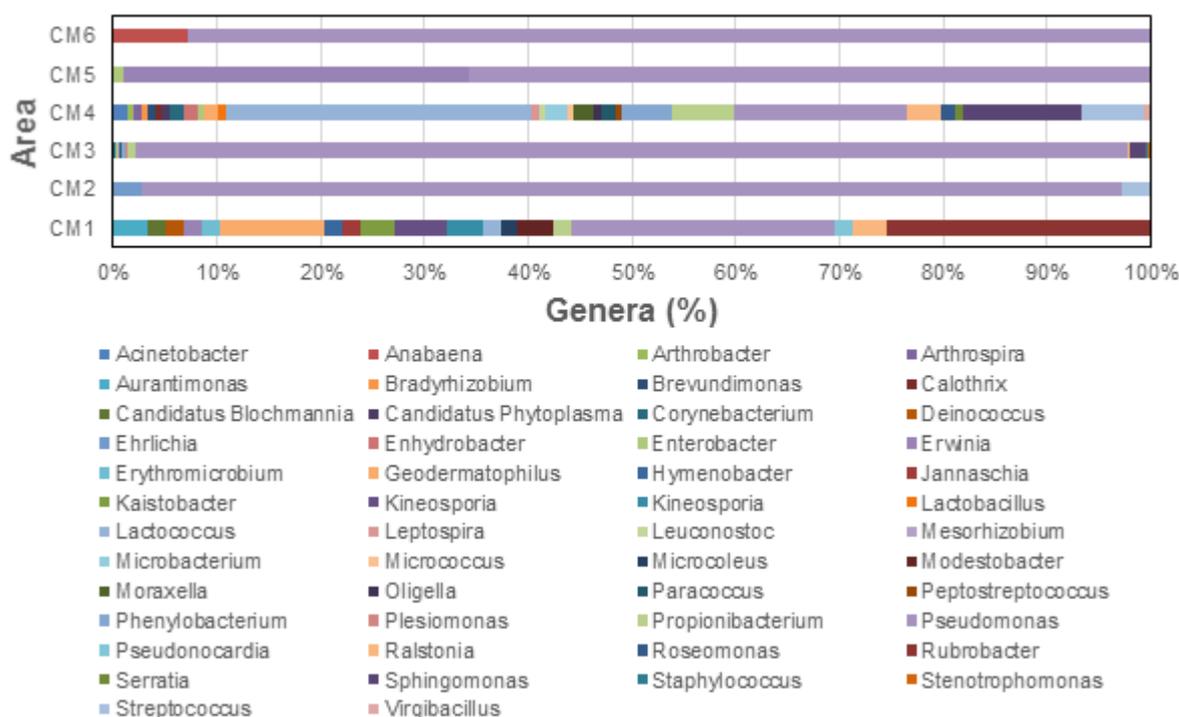
Figure 3. 23: NGS results of Prokaryotes proliferating on Maltesas Convent.
