Mestrado em Ciência dos Materiais Arqueológicos (ARCHMAT)

Dissertação

**Estudo de protetivos hidrofóbicos e amigos dos ambiente  
para proteção e preservação de pedra carbonatada**

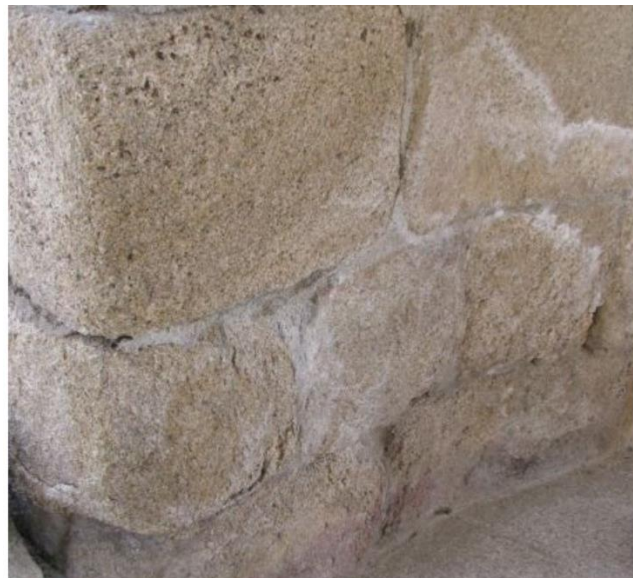
*Figure 1.2 Salt efflorescence (the whitish powder) on granitic stones of a window from a historical structure in the town of Chaves, Portugal (Alves, C., et al., 2021).*

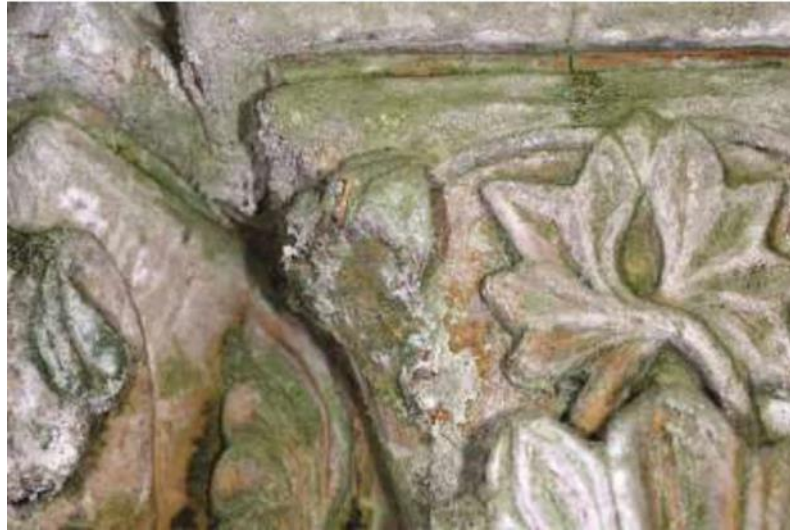
*Figure 1.3 effects of microorganisms and biodeterioration on limestone (Pinheiro, A., et al., 2019)*

The injurious effects promoted by the development of microorganisms and plants on the surface of the stones are referred to as biodeterioration (Figure 1.3) (Charola, A., 2016). A combination of physical, chemical, and aesthetic damage to stone material is involved in

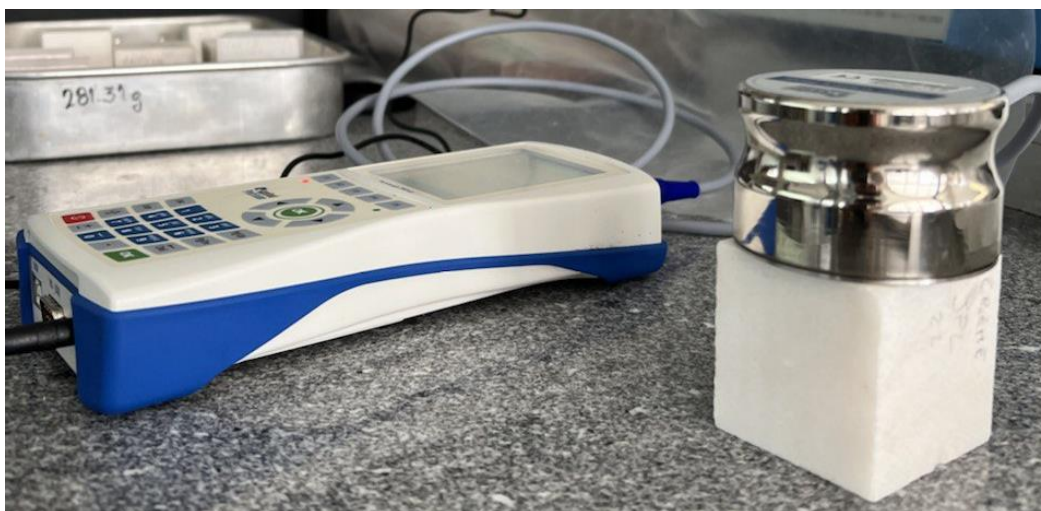
*Figure 2.4. Heat Transfer Analyser ISOMET 2104 with the metal measuring probe on top of the stone sample*

In this study, thermal conductivity was measured in ten selected stone samples using an ISOMET 2104 Heat Transfer Analyser (Figure 2.4). The thermal probe used to make the measurements has a range between 2.00 and 6.00  $\text{W/mK}$ . The average values and standard deviation for the thermal conductivity of each sample were achieved by placing the probe in three different places on its polished surface.

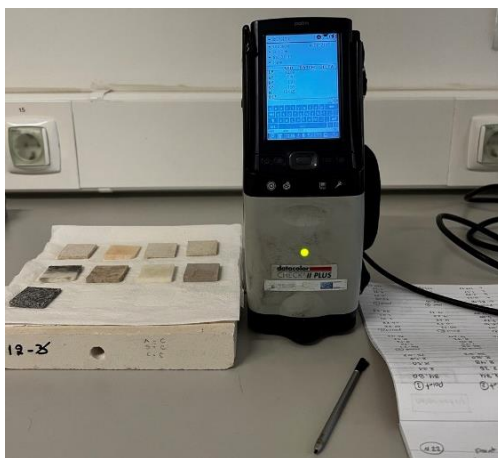
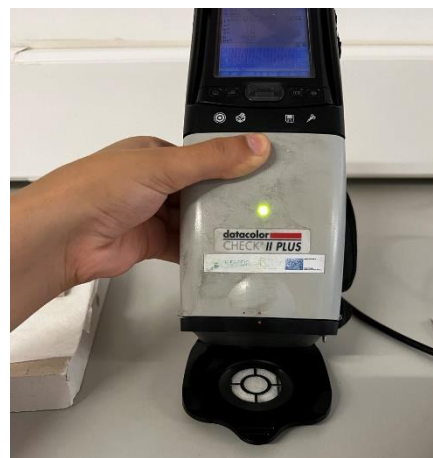
Figure 2.5. The Datacolor Check II Plus (a while processing the colorimetry measurements of stone specimens, (b measurement with LAV aperture).

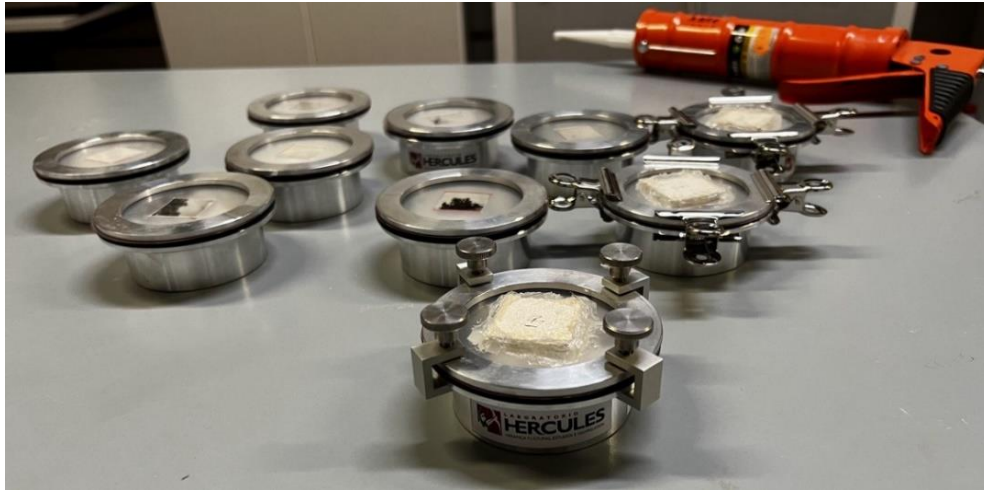
*Figure 2.6. The sets of containers, wet cotton, and the specimens glued to the plastic covers.*

specimen was weighed (in milligrams), and it was then put within Aralab FitoClima 600 stability test chamber with 20°C temperature and 40% of relative humidity. The test was weighted continually every 24 hours after it started. When the sets acquired a mass difference of 0.1%, the test was concluded.

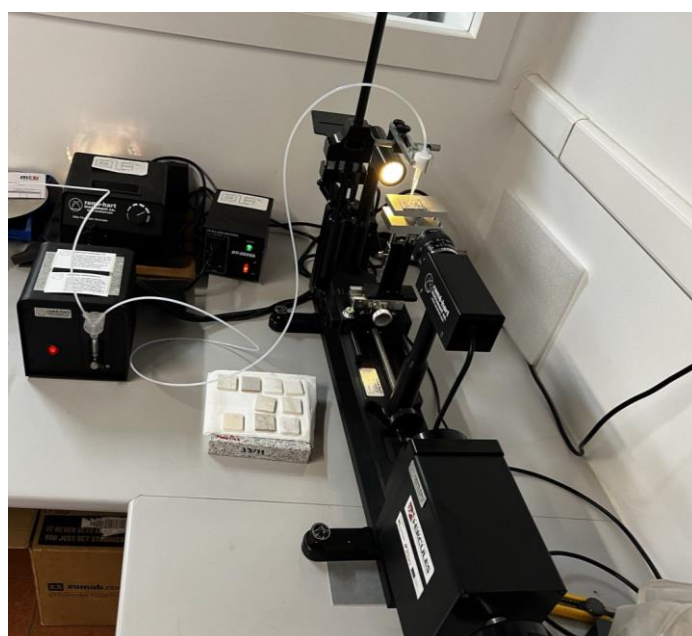
*Figure 2.6 ramé-hart Model 210 Goniometer/Tensiometer during static contact angle measurement on a sample*

measuring the static contact angle on stones samples, before, after the treatment, and after the weathering simulation. Measurements were done by using a ramé-hart Model 210 Goniometer/Tensiometer. In this procedure, a pipette was filled with deionized water and a dropper was placed on a sample holder, and the test surface was in a horizontal position (Figure 2.6). To have a good average appraisal, the contact angle of the drop deposited on a stone surface was measured between 3 to 10 seconds for each sample. 12 drops on each sample surface were performed and for each drop 4 measurements have been considered. Obtained values were averaged and the standard deviation was calculated. The obtained images and data were processed with DROPImage software.
