**Universidade de Évora - Instituto de Investigação e Formação Avançada**

Tese de Doutoramento

**Diagnosis and characterisation of mortars and concrete materials in buildings awarded with the Valmor Prize for Architecture - State of conservation and contributions for their safeguard**

Luís Filipe dos Santos de Almeida

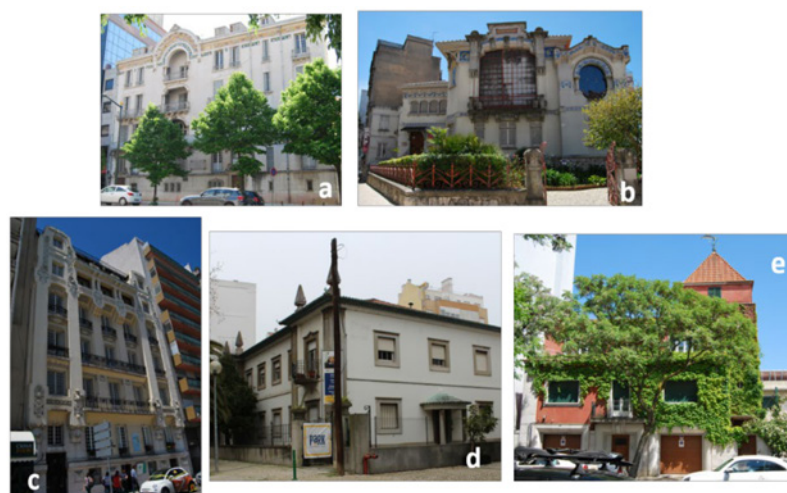
**Figure 1.** PRCBs case studies (acronym and award-winning year): (a)—CVT (1903); (b)—CMAG (1905); (c)—AR49 (1923); (d)—CBP (1939); (e)—AAC (1944).

Case studies were divided into two main groups according to the construction historical context and typology: the pre-reinforced concrete structure buildings (PRCBs) and the reinforced concrete structure buildings (RCBs), which, in this case, include the buildings whose structure is entirely of reinforced concrete (Figures 1 and 2).

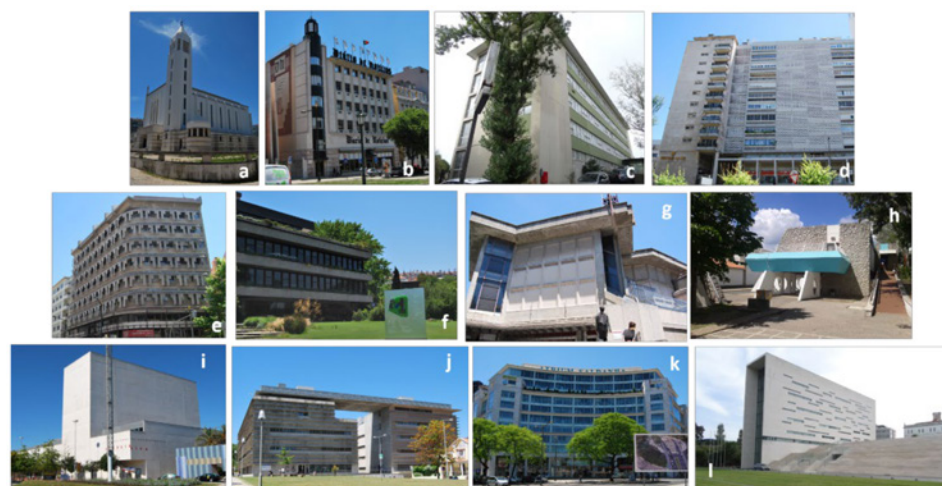
**Figure 2.** RCB case studies (acronym and award-winning year): (a)—IRF (1938); (b)—DN (1940); (c)—LIP (1958); (d)—EUA53 (1970); (e)—FRAN (1971); (f)—FCG (1975); (g)—ISCJ (1975); (h)—JRP (1987); (i)—PCV (1998); (j)—C8 (2000); (k)—AS (2001); (l)—UNL (2002).

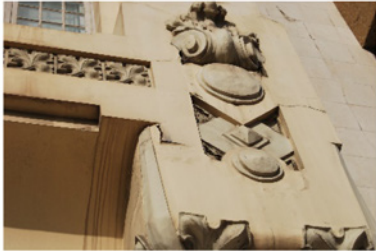
| Case Study | CVT (1903) | | | CMAG (1905) | | |
|---|--|---|--|--|--|---|
| Detected anomalies | Capillary rising water | Cracking, stains | Water infiltrations; cracking; detaching and efflorescence | | | |

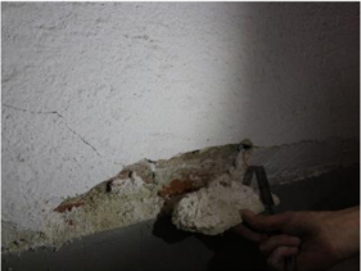
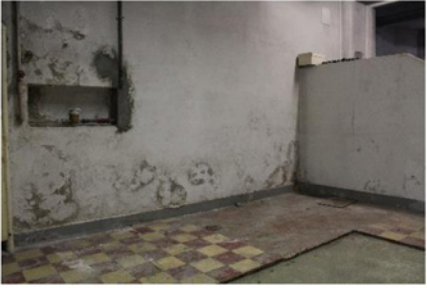
| Case Study | CBP (1939) | | | AAC (1944) |
|---|--|--|--|---|
| Detected anomalies | Capillary rising water | Capillary rising water; cracking; cryptoflorescences; detaching | Capillary rising water; cracking; efflorescence | Stains, biological growth |

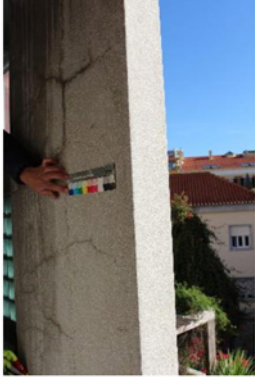
| Case Study | CBP (1939) | | | AAC (1944) |
|---|--|--|--|---|
| Detected anomalies | Erosion; capillary rising water; stains and biological growth | Stains | Cracking; stains | Disaggregation |

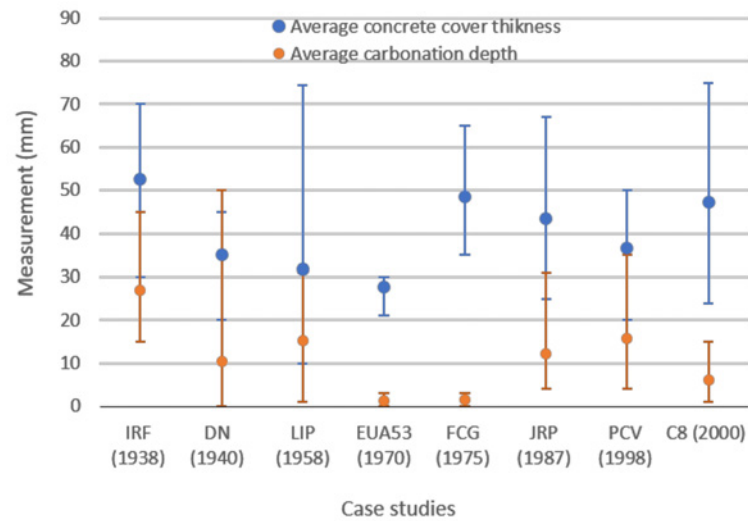
**Figure 6.** Relationship between concrete cover thickness and the carbonation depth in NAC sampling zones. Range of results: minimum to maximum.

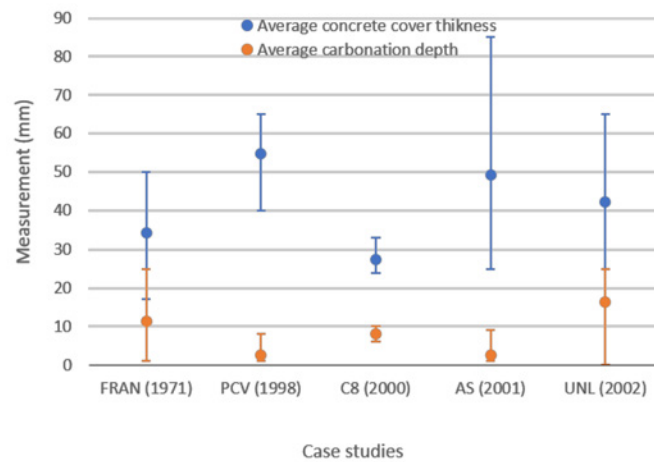
**Figure 7.** Relationship between concrete cover thickness and the carbonation depth in architectural concrete sampling zones. Range of results: minimum to maximum.

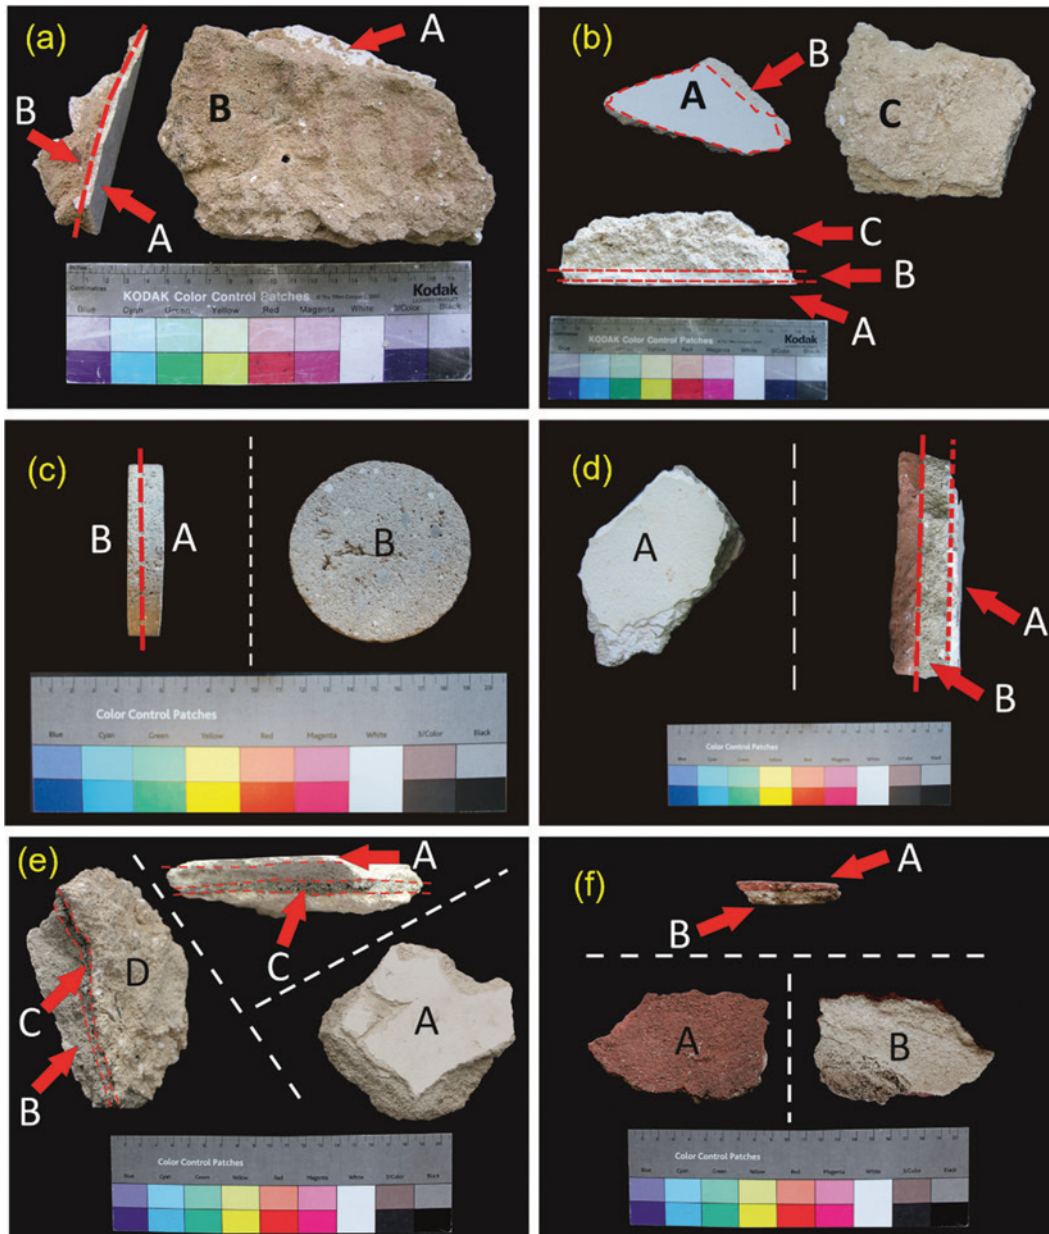
**Figure 1.** Multi-layered samples from six case studies. (a) A - CVT3A, B - CVT3B; (b) A - AR49-15A, B - AR49-15B, C - AR49-15C; (c) A - IRF7A, B - IRF7B; (d) A - CBP4A, B - CBP4B; (e) A - DN19A, B - DN19B, C - DN19C, D - DN19D; (f) A - AAC1A, B - AAC1B.

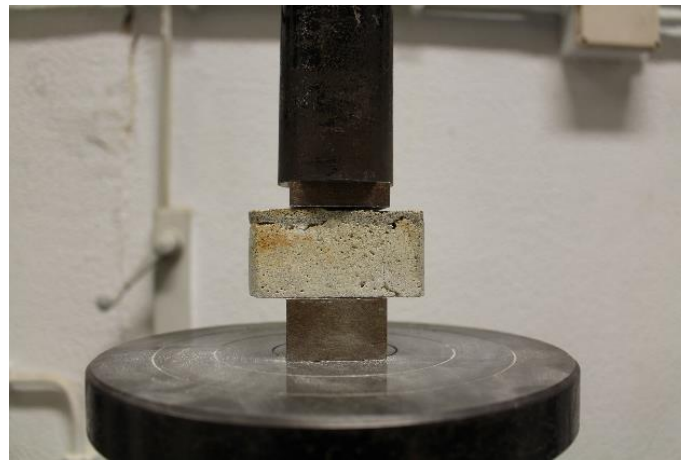
Figure 7. Compressive strength test.

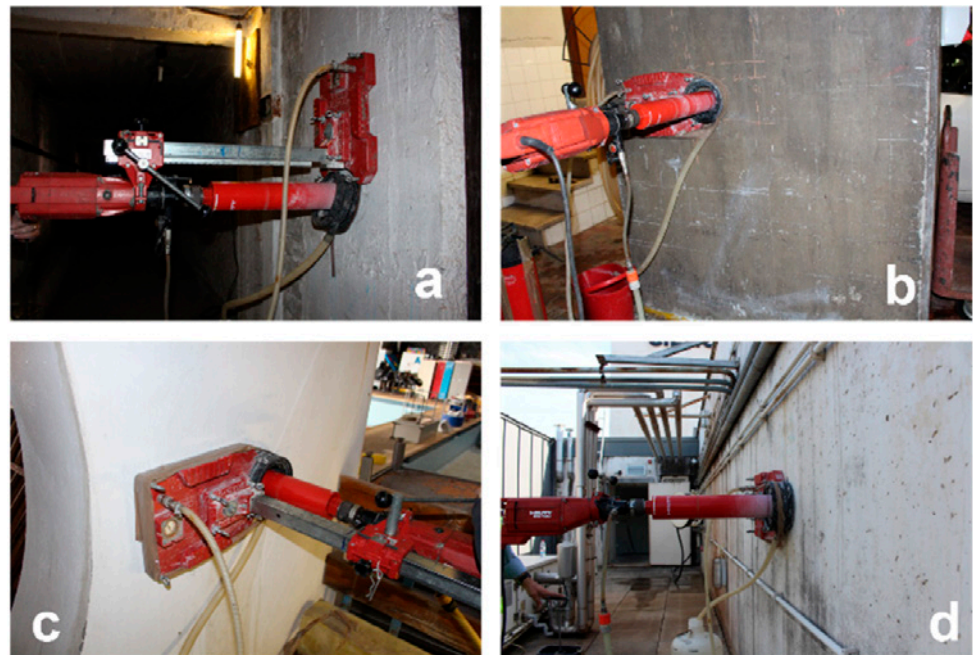
**Figure 1.** Images of concrete sampling campaign: (a) IRF (1938); (b) FRAN (1971); (c) JRP (1987); (d) PCV (1998).
