SPECIALIZATION PROCESS FOR THE BIOENGINEERING SECTOR IN THE MEDITERRANEAN ENVIRONMENT. ECOMED PROJECT

SPECIALIZATION PROCESS FOR THE BIOENGINEERING SECTOR IN THE MEDITERRANEAN ENVIRONMENT. ECOMED PROJECT PART II. PROTOCOLS AND CASE STUDIES

PART II. PROTOCOLS AND CASE STUDIES

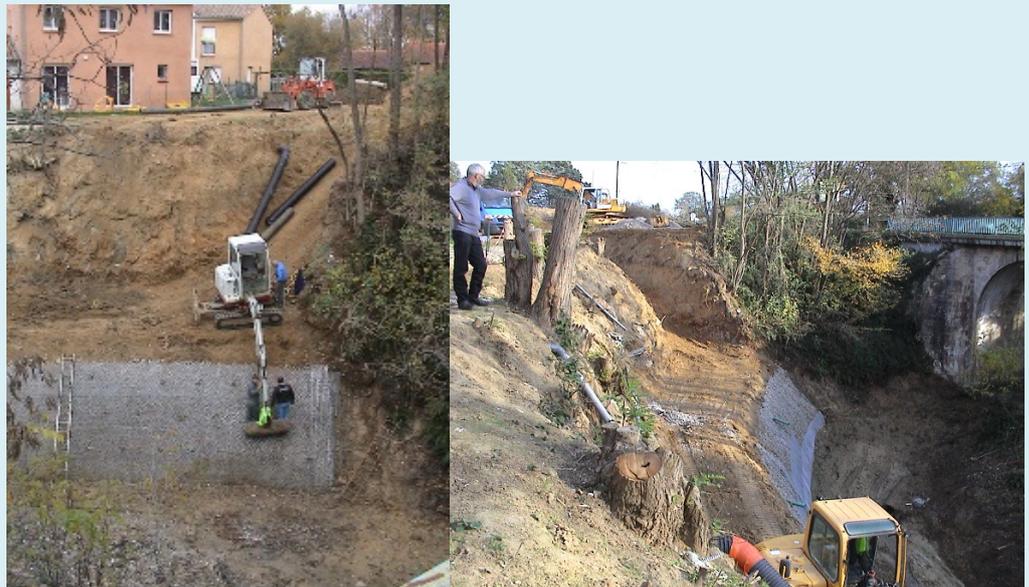
During construction stage

Problems/defects/issues recorded during the construction stage (information retrieved from the construction company):

Surveyor didn't receive geotechnical report related to the slope stability during construction stage

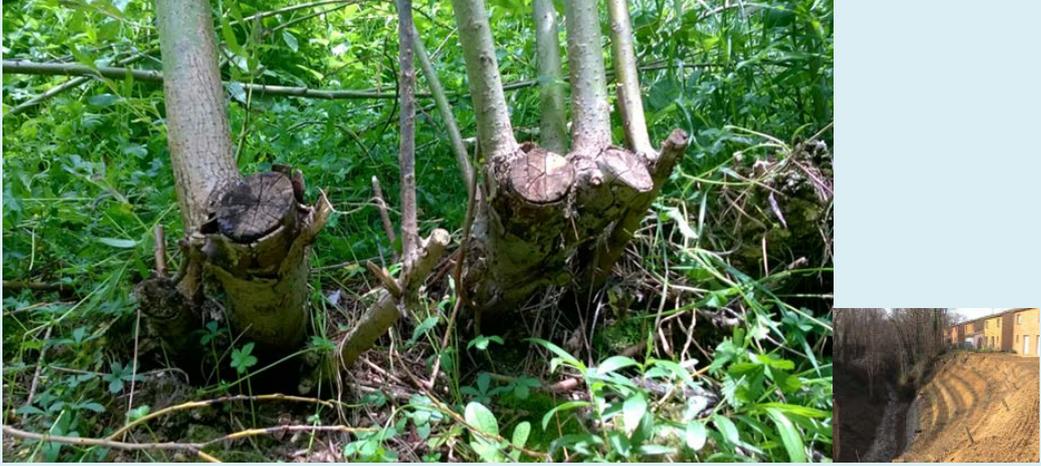
| <p>1 –Very successful evolution of the work (all the main objectives were achieved) <u>during 1 to 4 years</u> after final delivery date</p> | <p>No: failure by sagging Yes: subsequently refixing process successful 2 years after first delivering</p> | |

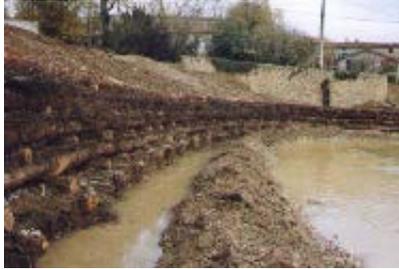
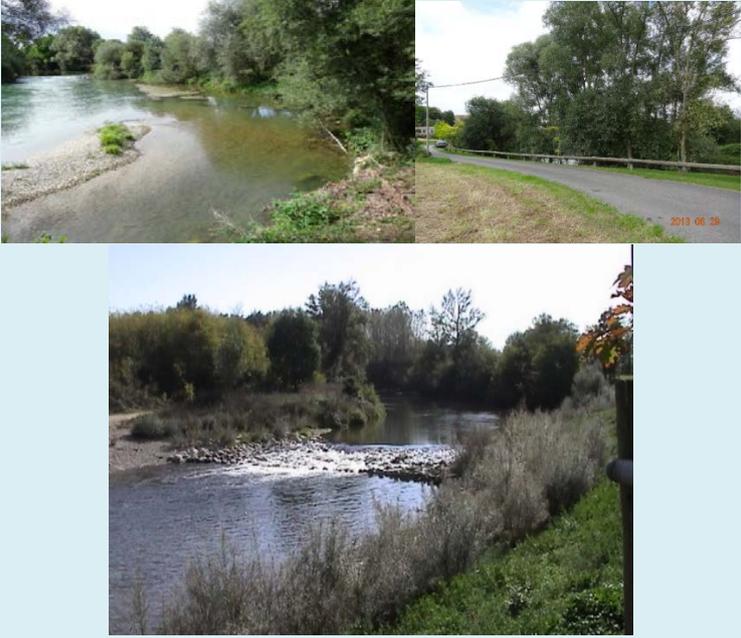
| <p>The bioengineering work failed due to ...</p> | <p>No failing but soil stability actually is decreasing due to absence of long term riparian forest managing</p> | | | |

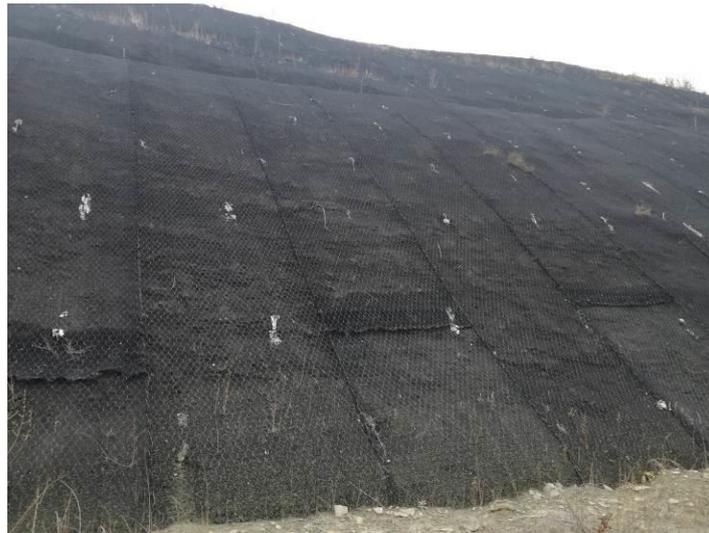
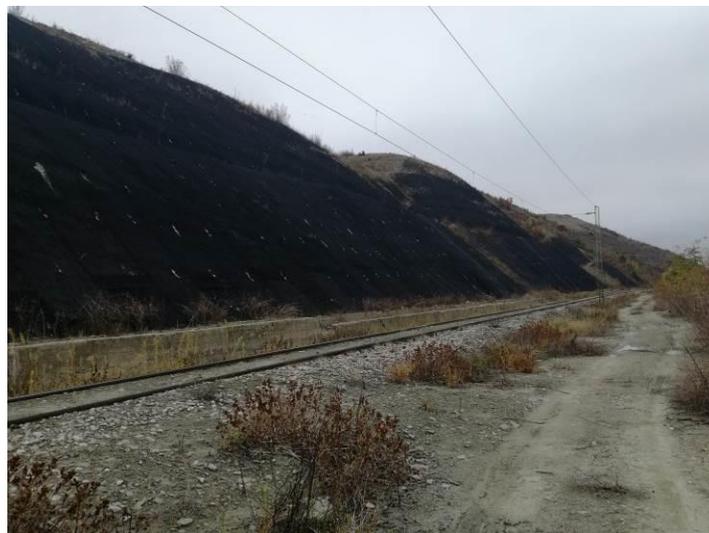
Figure 1a. Rehabilitated cut slopes

On 10th of November 2017 visual inspection on the project site was held. Most of cut slopes are rehabilitated and erosion control measures are successfully implemented (see Figure 1a and Figure 1b). The proposed erosion control measures were not fully implemented on the cut slopes. It was detected that the vegetation

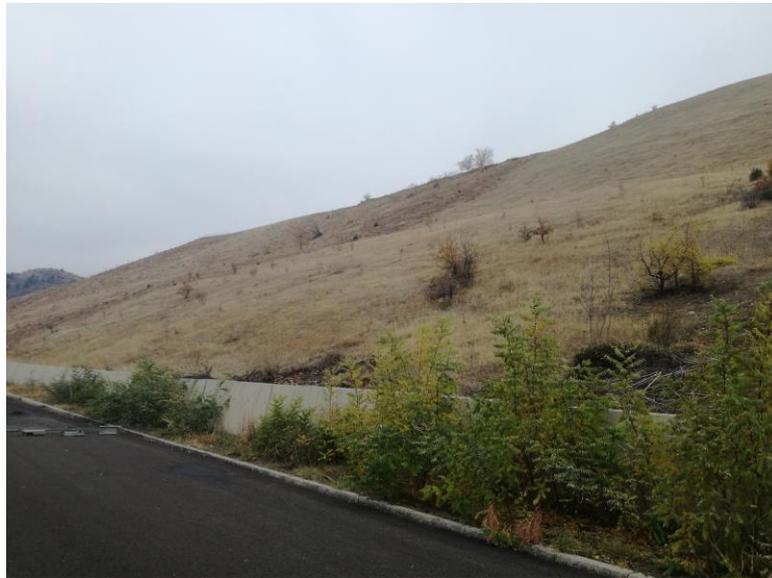
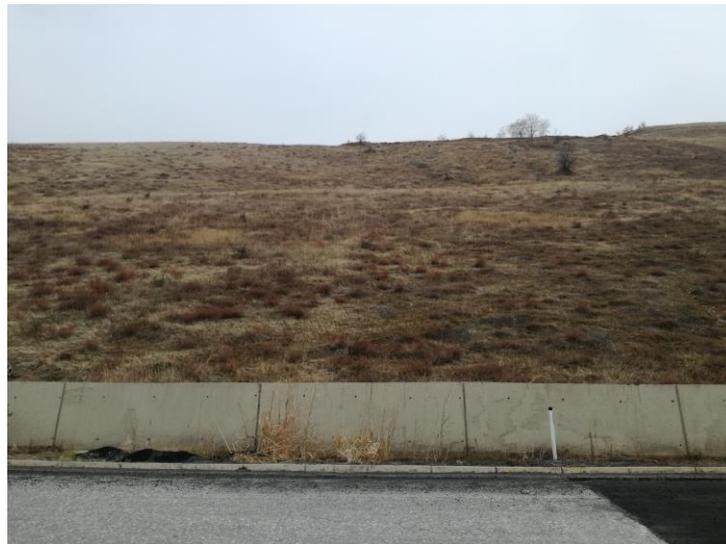
Figure 3a. Rehabilitated cut slopes

According to the findings from site inspection it was obvious that some of the designed measures are not fully implemented therefore on some sections local slope failures and erosion are detected.

On 10th of November 2017 visual inspection on the project site was held. Most of cut slopes are rehabilitated and erosion control measures are successfully implemented (see Figure 3a and Figure 3b). It seems that the proposed erosion control measures were not fully implemented on the cut slopes. The cover soil on some sections is washed out, so the vegetation is not fully developed and it should be regenerated in order to prevent further deterioration of the slopes. Also rehabilitation of the erosion gullies and local slope failures should be done. Considering the fact that the ground on some section is composed of high plasticity clays which are sensitive on variation of the moisture local failures very

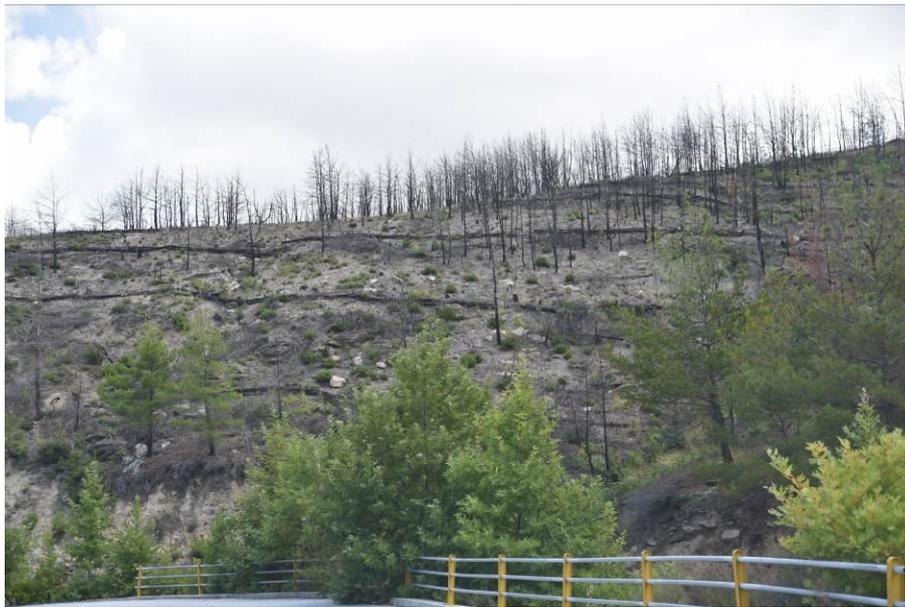
In the preceding picture, the following features can be seen:

- The log barriers cover the majority of slope
- Many dead trees have still been left and were not used.
- Only one technique was used.

- Detected flaws regarding the construction stage. E.g.
 - Not many large burned trees were present to be used as log barriers.

- Emphasis was given primarily on the downslope area and with minimal work done in the upslope areas of the burned area
- *Please give your opinion about disturbing/destabilizing elements present between the design stage and the construction stage:*

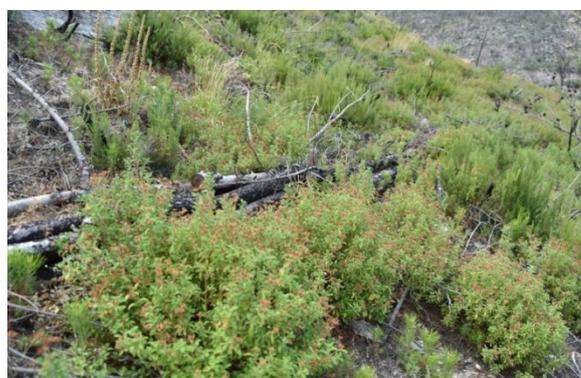
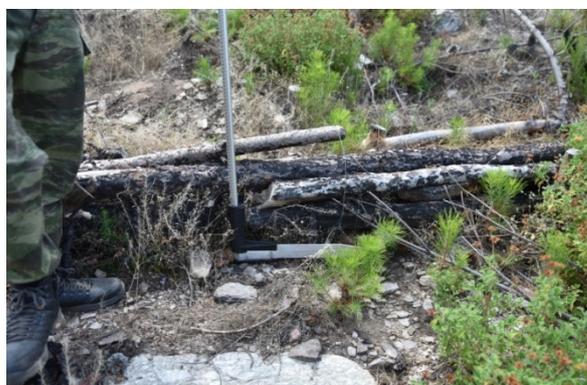
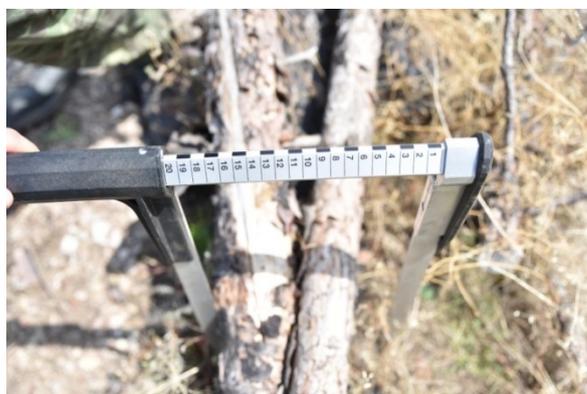
Photos of the log barrier measurements.

Based on the field measurements made in the study area, there were minimal changes in the environment around the erosion works (Log barriers). The Log Barriers were placed on the slopes of the drainage basins parallel to the contour lines. The logs average dimensions were: length 23 meters, height 0.50 meters and

wide 0.20 meters the distance between the logs is 6 - 10 meters. Overall, throughout the study area there was minimal erosion present and physical regeneration. This was also the situation throughout the entire burned area.

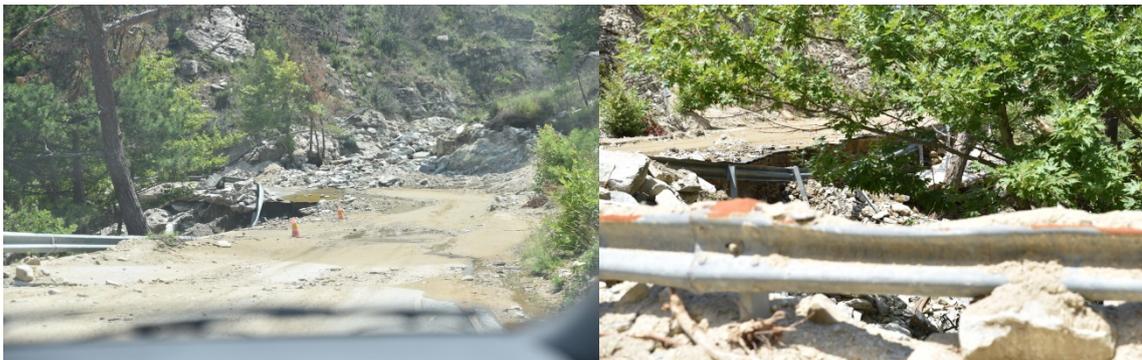
- Some roads are eroding despite the works that were implemented.
- PHOTO of road eroding

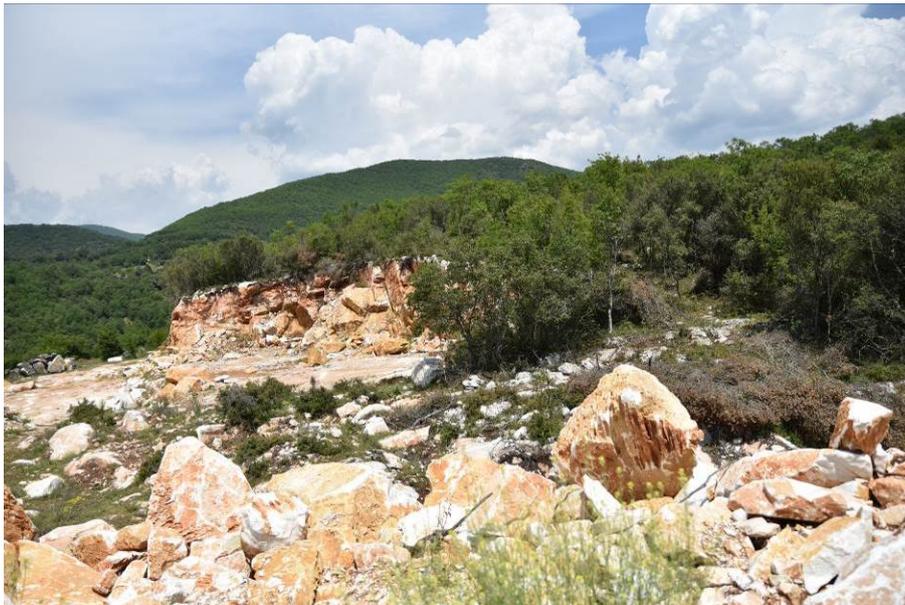
In the preceding picture, the following features can be seen:

- Many areas are still bare
- The seedlings have not developed and grown as much as expected.
- The aesthetics of the area have not significantly improved.

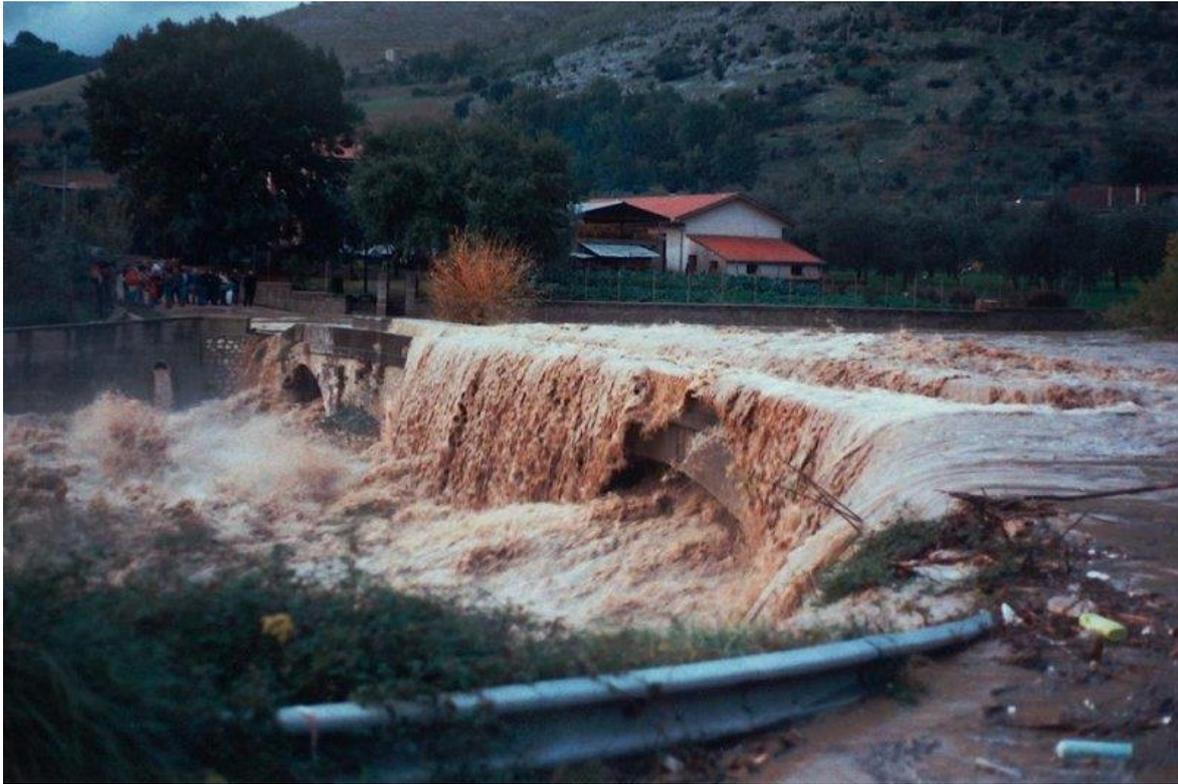
Photo taken by www.fiumemelfa.it . It represents a waterflood in 1992.

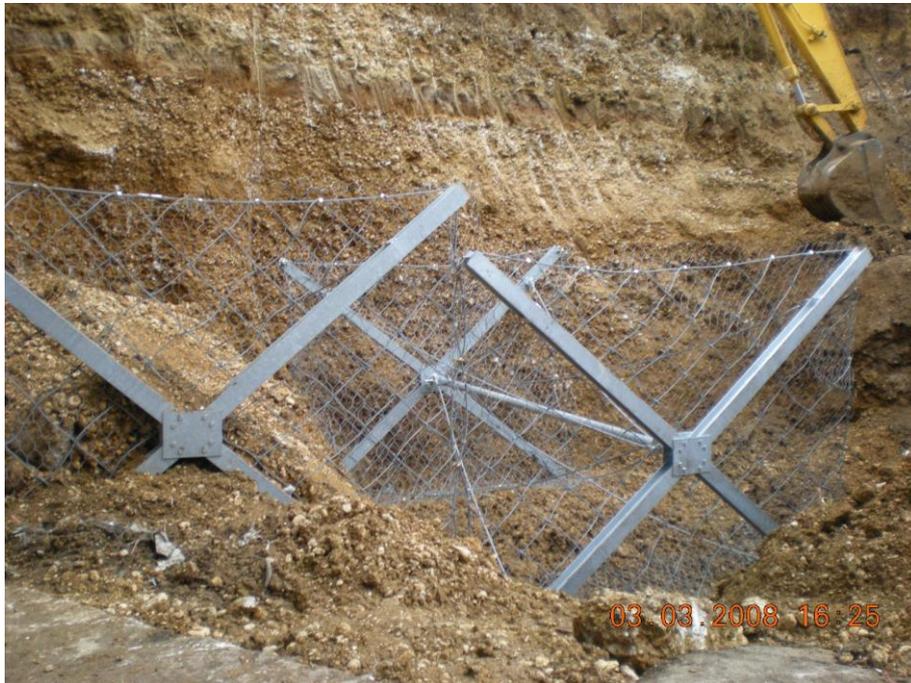
Structures put in an opposite manner

Proposed Improvements : In the construction stage the gabions and the reinforced earth have been substituted by metallic structures 3,60X3,10 meters. In the fundament of landslide the structures have been used with a structure opposed to

the other in the way to build solid fundamentals. They are refilled with autochthon earth but also with sandstones mixed to terrain.

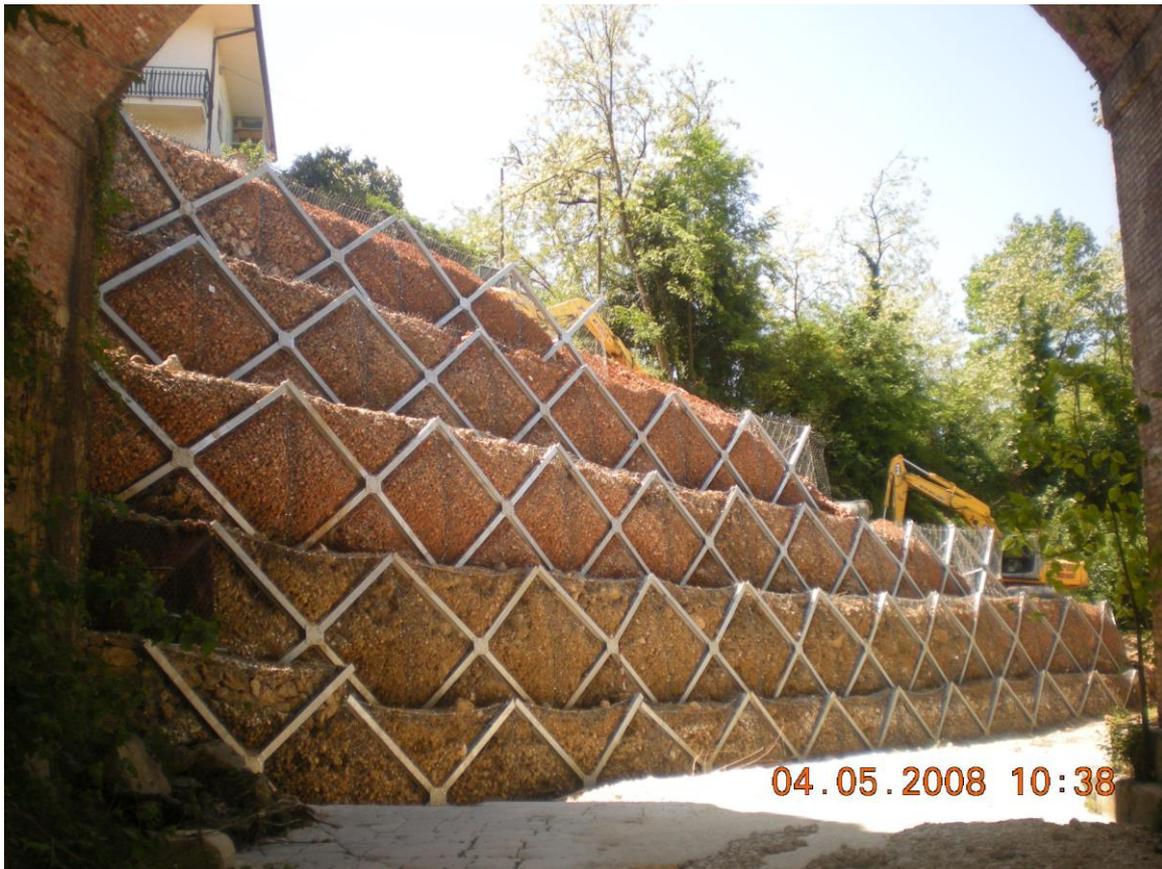
Final result without vegetation

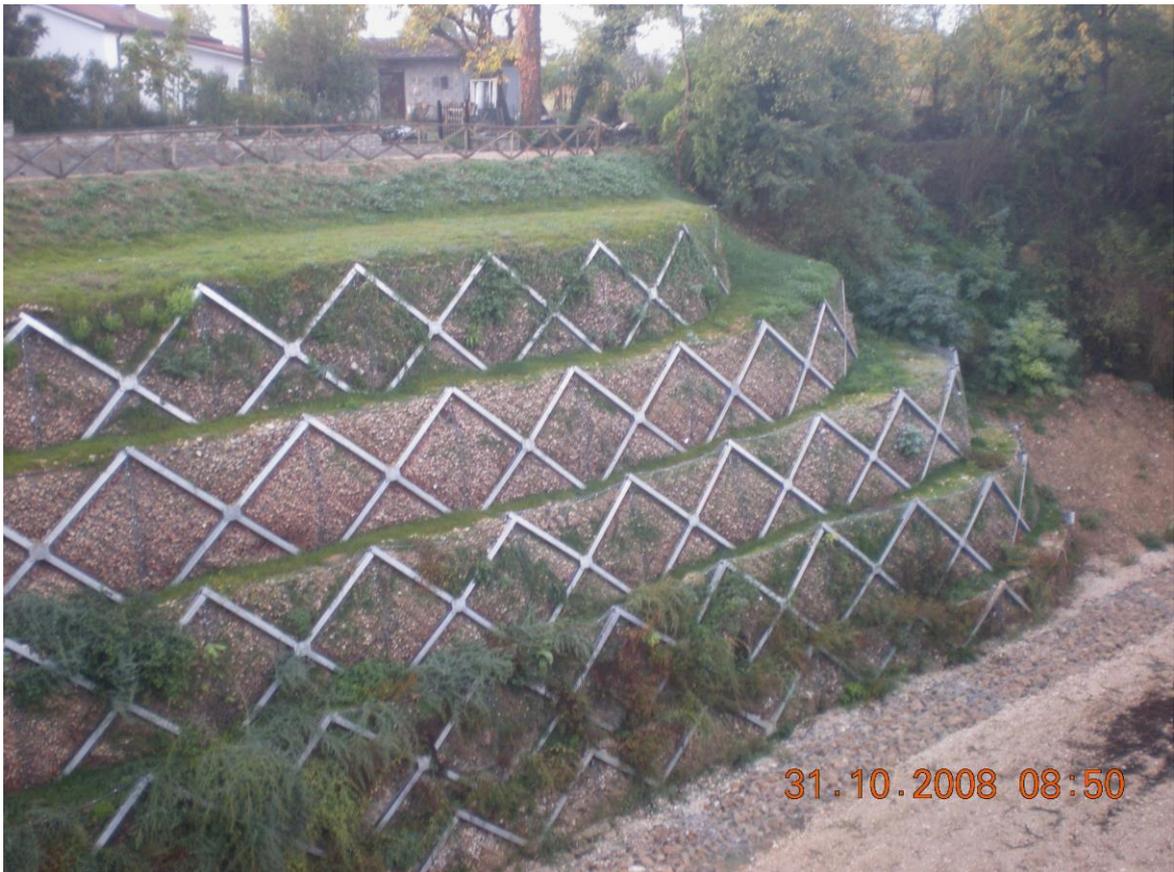
Vegetation put in the structures

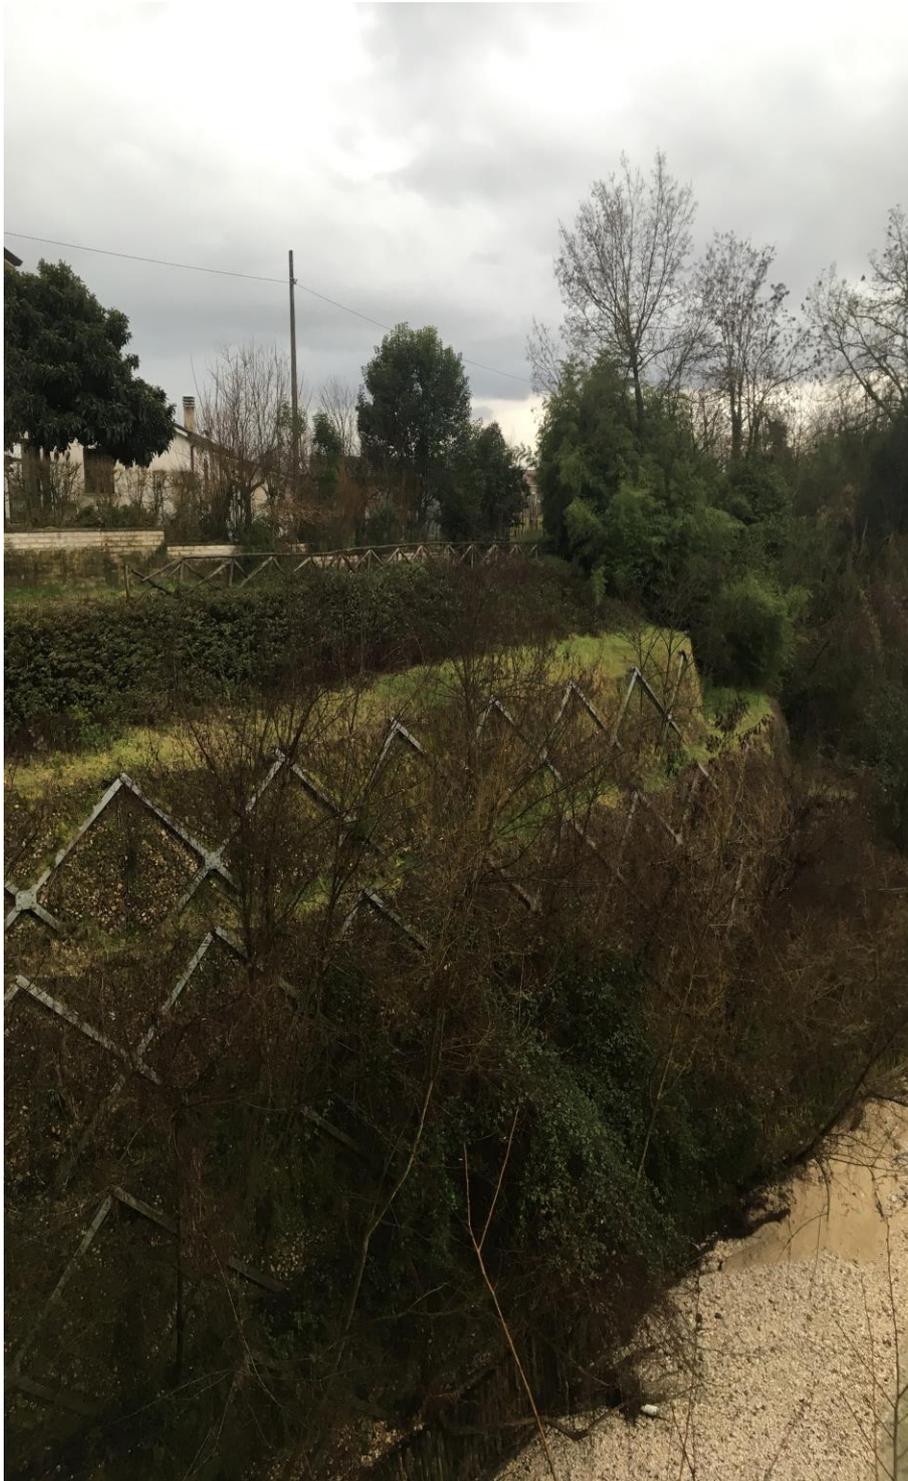
- Very successful evolution of the work after ten years and after several water flood.
- Climate change couldn't affect the present situation
- If there will be a rain storm with a violent quantity of water it should be resistant but only the time could give the right answers.
- All the initial risks which were present in the intervention are none
- . The vegetation has partially covered the work because the cuttings are inserted only in the down side of the work.

A photo detail of the slope and the growing of cuttings

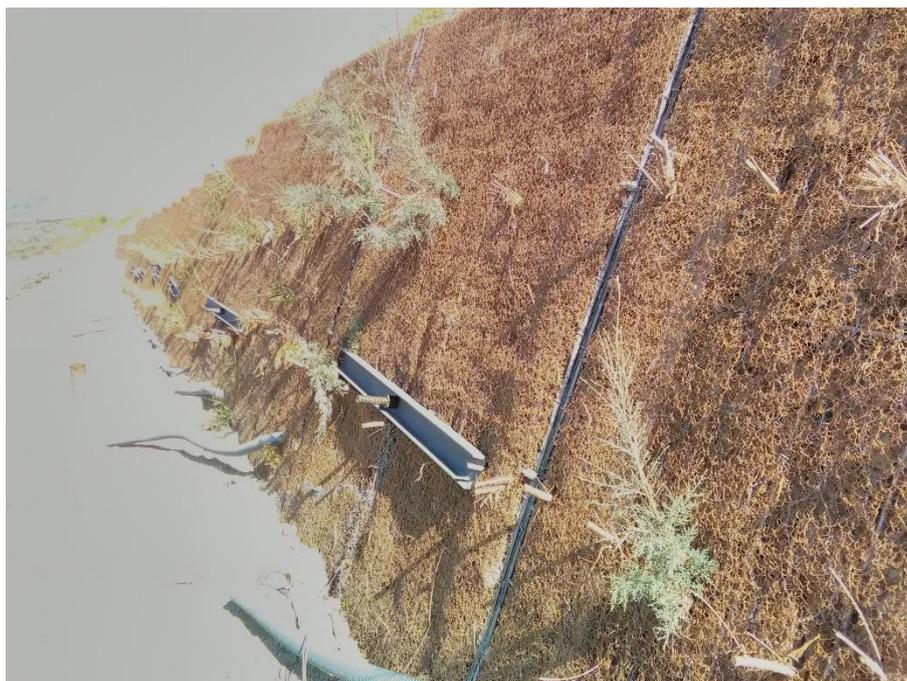
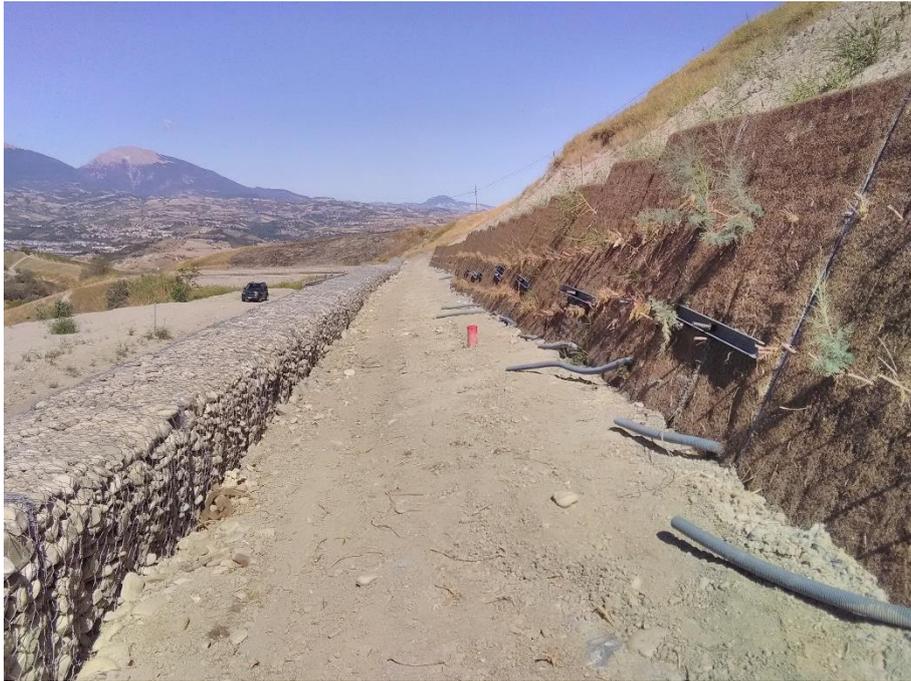
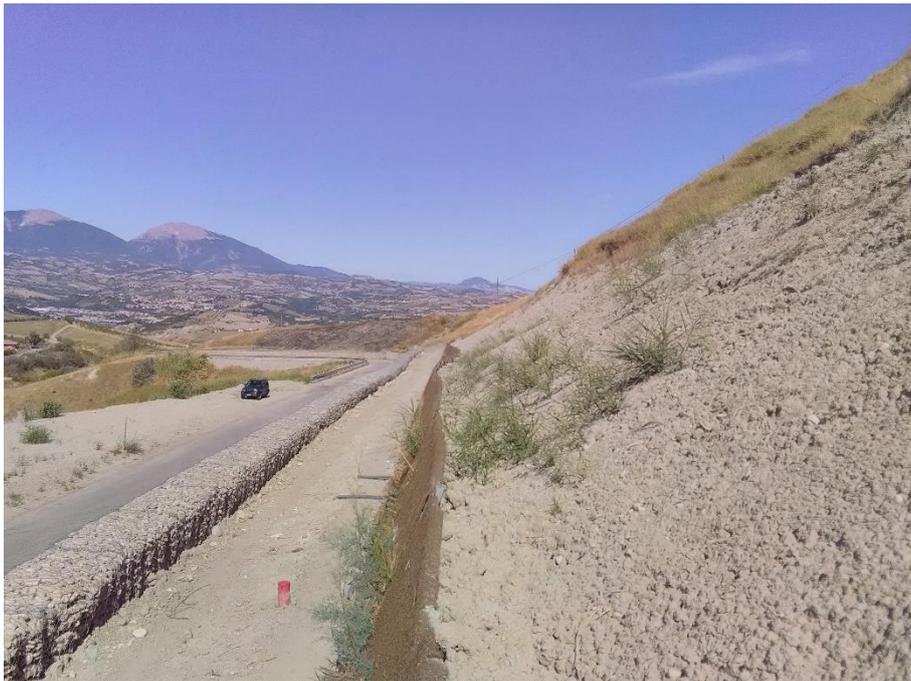
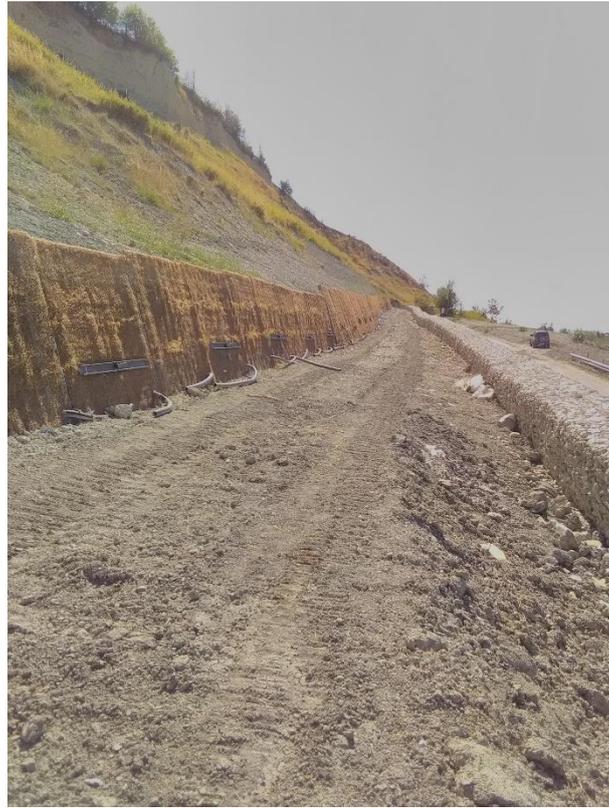
Suitability of the plant species utilised in the work: After eight months, vegetation is not yet covering the work but some plants have grown up through the structures. It is essential to put other plants in favourable condition of weather. So very early the intervention should disappear with the help of bioengineering.

Climate: Now the climate change is not affecting the performance of the bioengineering intervention (see photo below), the structures maintain the stability of land and no landslides are happened during these eight months.

Very successful evolution of the work (all the main objectives were achieved) because now the stability is completely reached and climate conditions doesn't affect the security of the place.

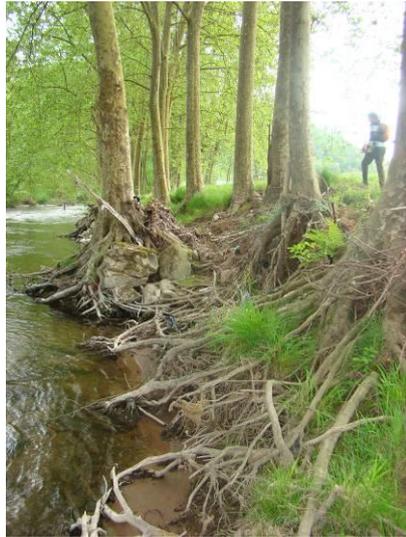
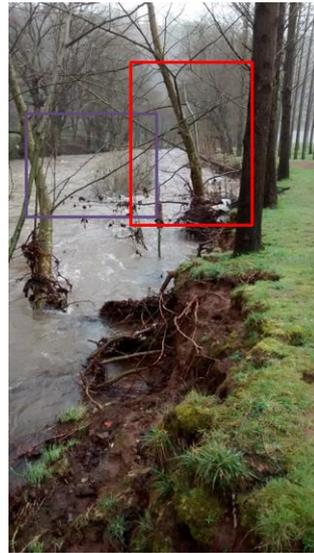
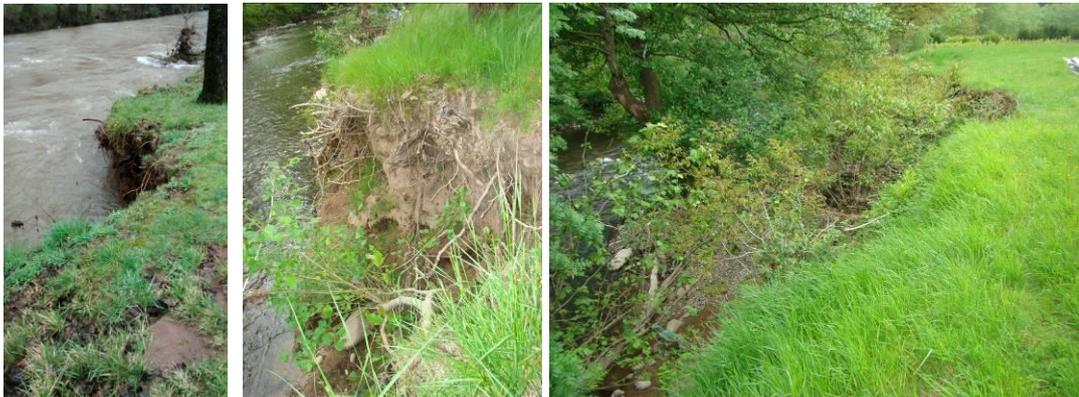
It is concluded that high discharge scenarios are getting higher frequencies. The combination of high intensity rains with short duration and long and soft rainfall scenarios generates critical situations in the study area. The latter saturates the soils while the former produces toe slope soil losses. The combination of the preceding two features triggers the massive slope failures existing in the intervention area.

In the following images, the current state of the study area is shown:

The position of the vegetation clearly shows the original shoreline location.
The preceding photographs reflect the before mentioned phenomena.

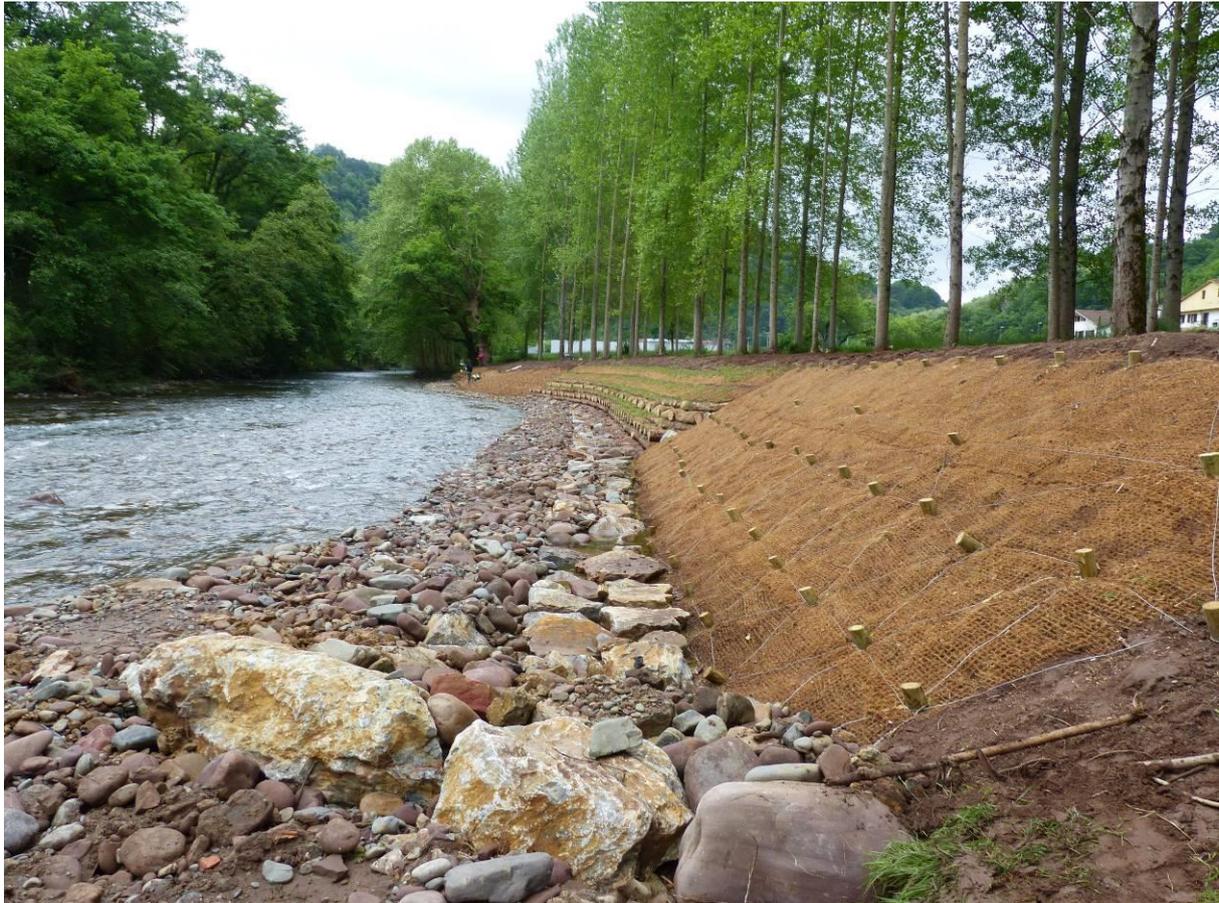
Brush mattress with organic mat and rock toe protection. Live log crib wall can be seen in the photograph background

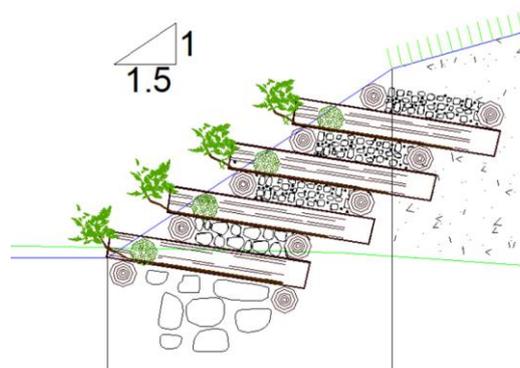
Double crib wall drawing detail (source: Artia project)

The trunks in ground contact are much deteriorated. The logs are no longer fulfilling any stabilising function. The remaining function is the fertilisation of the surrounding soil. Actually, nowadays the logs just work as a slow release organic fertilizer. The vegetation has already taken over the stabilization function. The volume occupied by the logs is now occupied by the roots and by the formed soil. The soil and water bioengineering approach and strategy has been successfully developed.

The wooden material utilised during the construction stage were green and barked logs. Because of this situation, the logs had a high water content level and the moisture loss process was very low. Hence, the logs were very vulnerable to the fungi attack from the very beginning of the bioengineering work service life. A minimum seasoning is recommendable to decrease the log water contents before their use in bioengineering works.

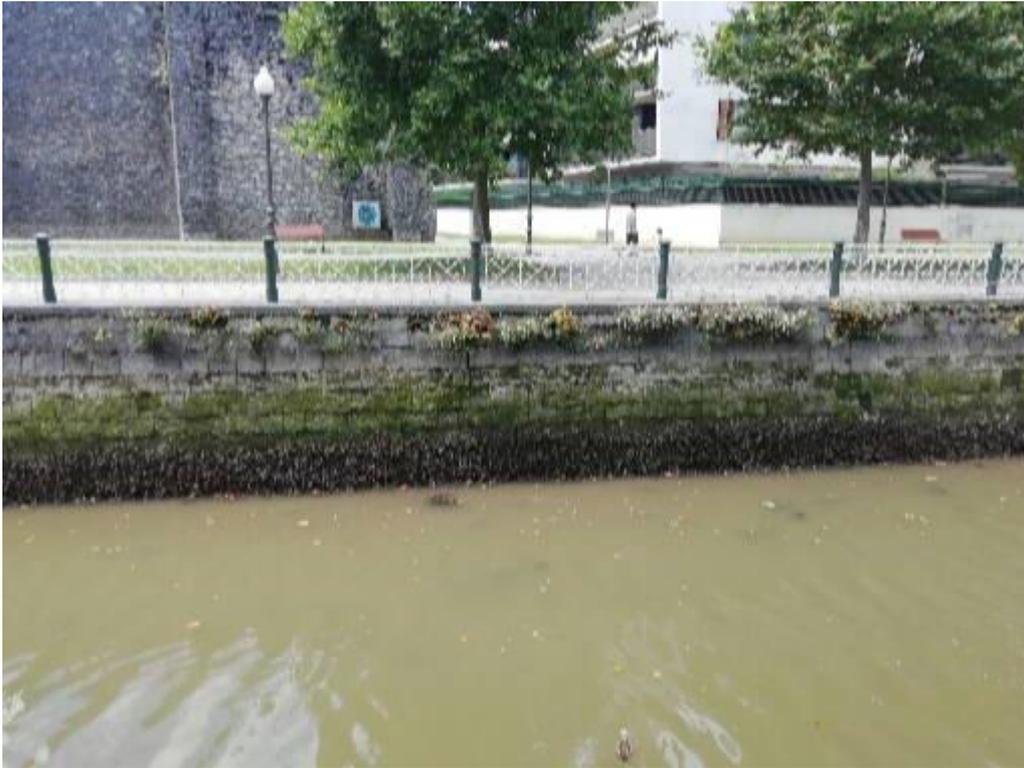
Another upstream stretch of the Artia channel was treated with a non vegetated rock wall. As it was checked out, after 16 years after the end of construction stage, no vegetation has been developed. Therefore, a simple rock wall technique (which, in turn, is a very common civil engineering technique in fluvial scenarios) does not trigger ecological processes. The scenario is very static and no ecosystem services are developed.

Pre-operational scenario. Reach of the Artia creek that is still channelized (upstream from the intervention area)

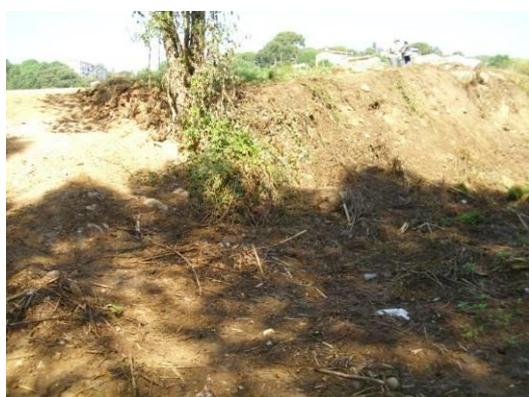
As a general overview, industrial and general waste was detected in the riverbank all along the area due to its proximity to the industrial area and the village of Santa Eulàlia. Specifically the areas close to the walkway Campinya and Can Magre, soil piles and waste were detected permanently.

General waste (asbestos) and soil movements
in the area of Can Magre

As a conclusion of the fieldwork, preliminary maintenance tasks along the riverbank were suggested. They were focused on waste cleaning and reed removal (*Arundo donax*) through mechanical treatment (grind the reed and dig out the surface layer of the terrain extracting rhizomes to avoid the re-sprout). Afterwards the areas were planted with autochthonous species of riparian forest with shrubbery and halophyte plants. Besides selective pruning and regeneration of existing riparian vegetation and plantation for the recovery of the autochthonous vegetation in different parts of the Tenes river was also suggested.

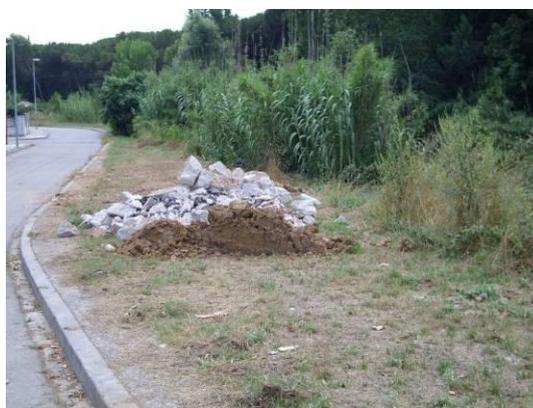
Soil and rubble 6m³ next to the industrial area

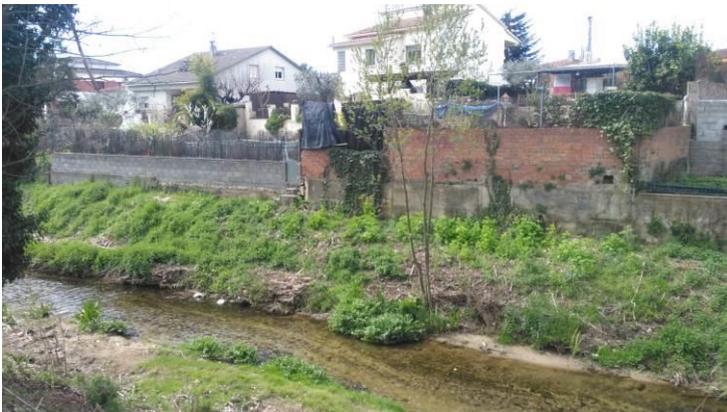
Outcome: permanent mat is working well but the willow presence is very low.

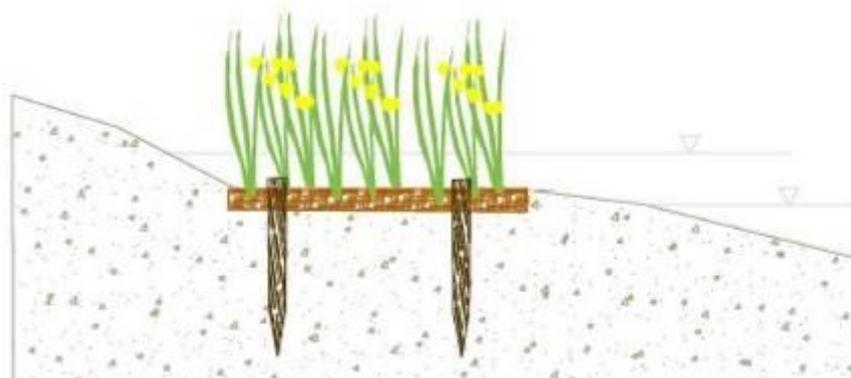
Sketch of the technique

Outcome: The technique was applied in a very active part of the river, hence, the river shape has changed and so did some plant species from their initial location. In spite of all, an excellent dispersion factor has been achieved.

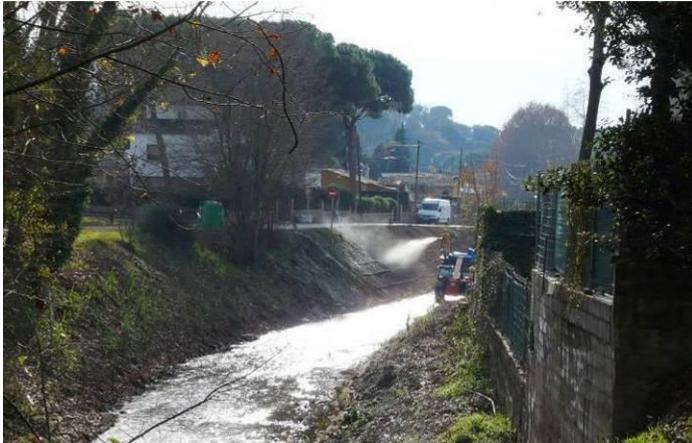
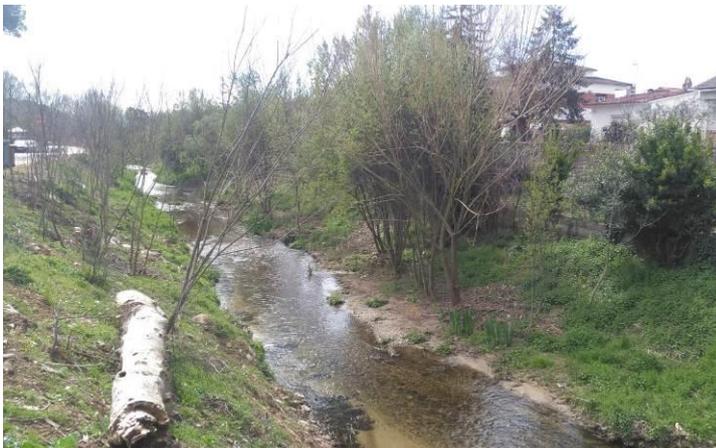
Outcome: objectives reached

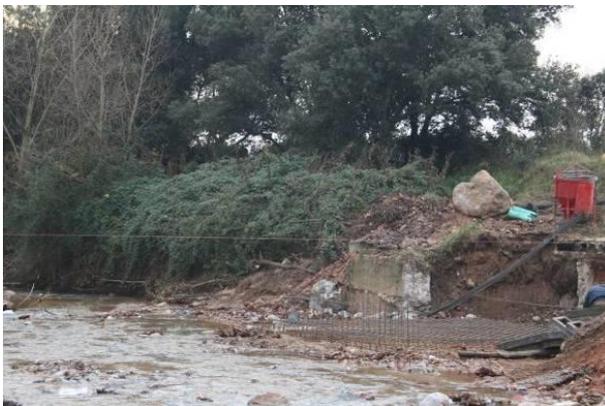
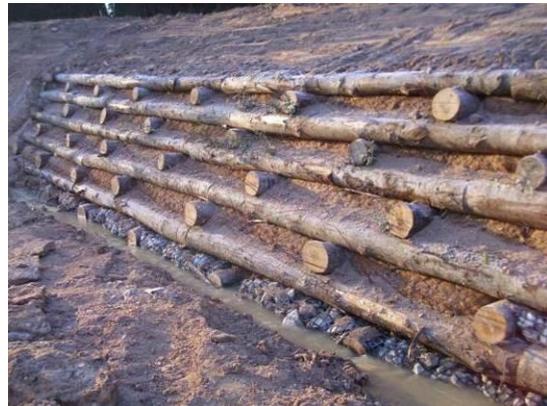
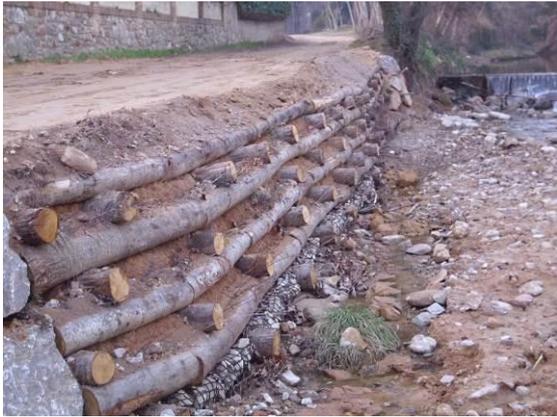
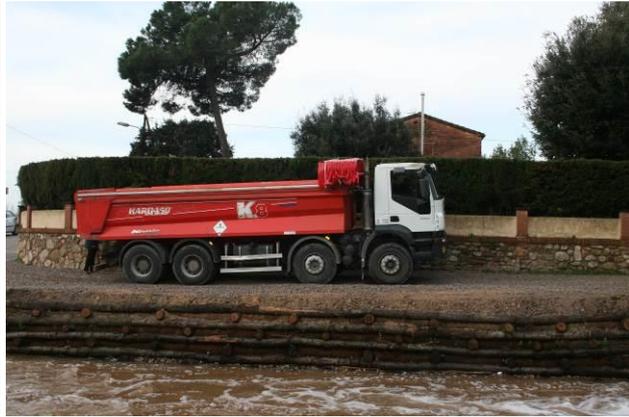
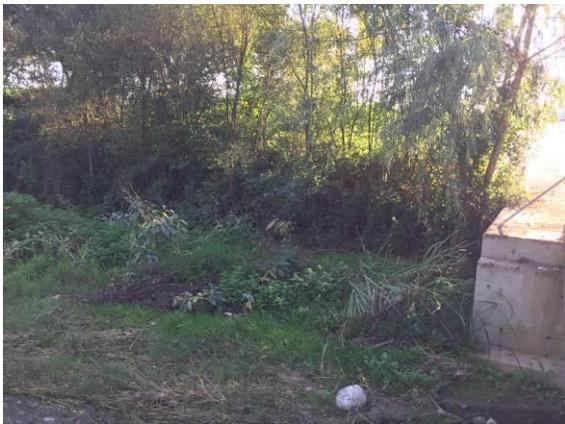
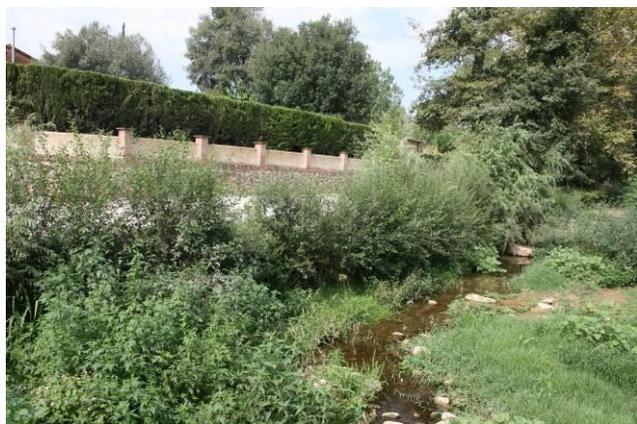
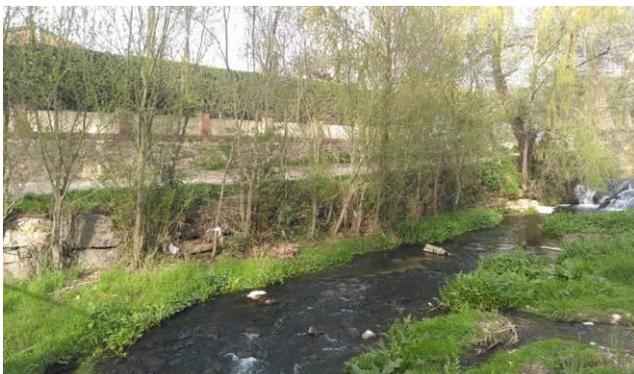
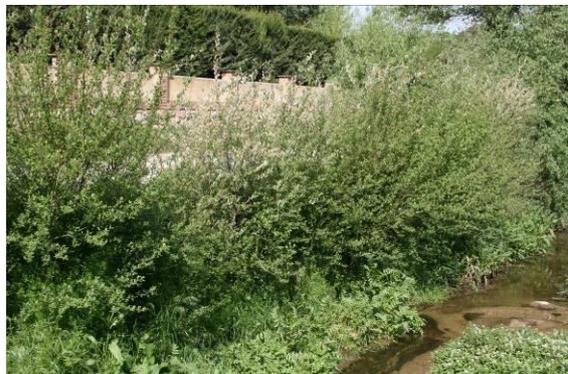
Outcome: objectives reached

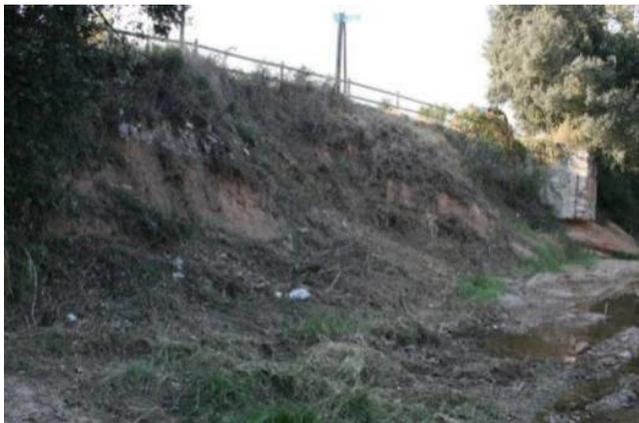
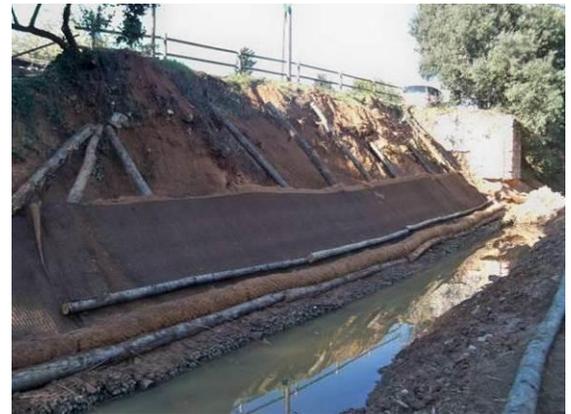
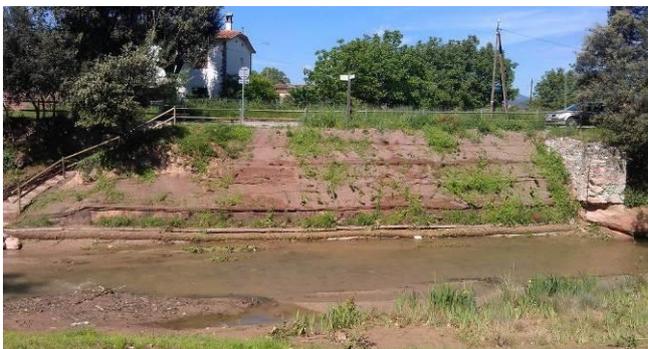
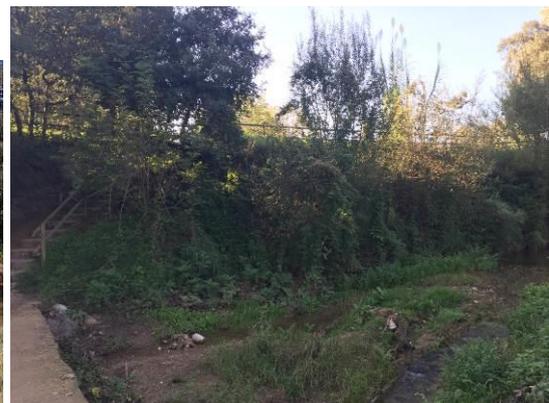
Outcome: objectives reached
