SPECIALIZATION PROCESS FOR THE BIOENGINEERING SECTOR IN THE MEDITERRANEAN ENVIRONMENT. ECOMED PROJECT

SPECIALIZATION PROCESS FOR THE BIOENGINEERING SECTOR IN THE MEDITERRANEAN ENVIRONMENT. ECOMED PROJECT PART II. PROTOCOLS AND CASE STUDIES

PART II. PROTOCOLS AND CASE STUDIES

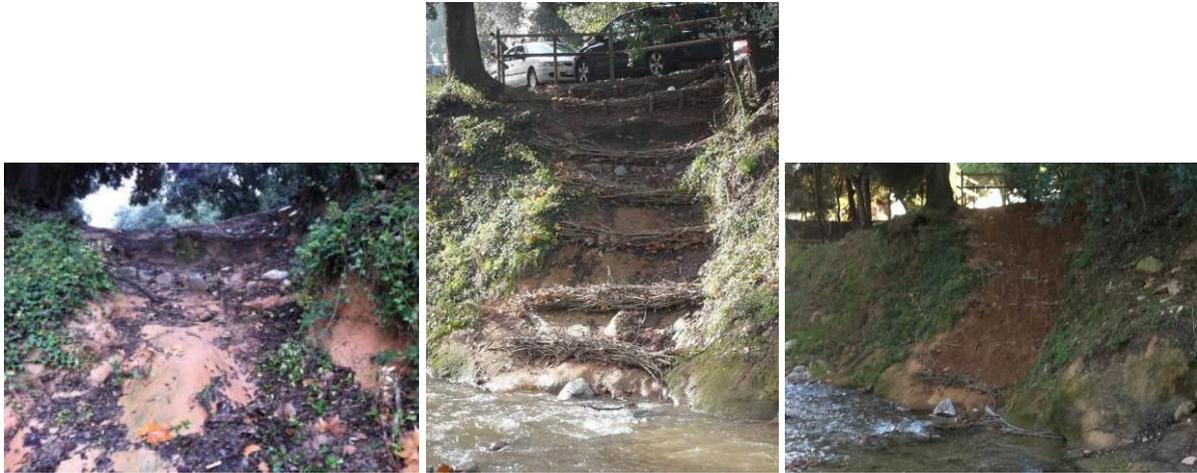
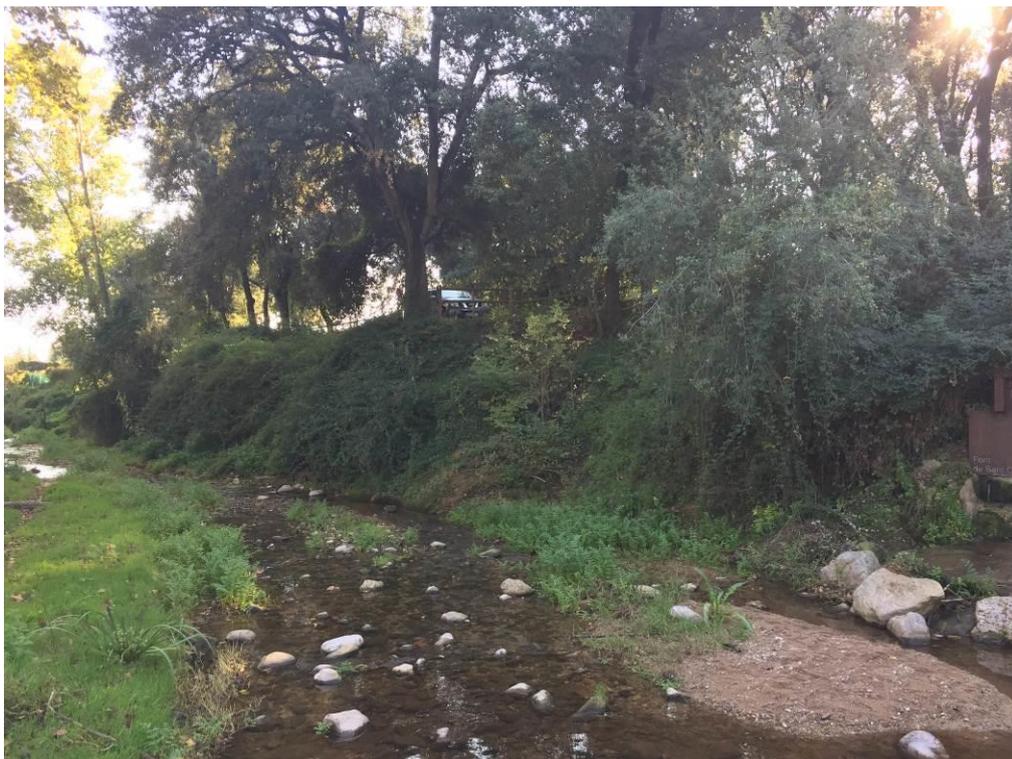
Outcome: Objectives reached

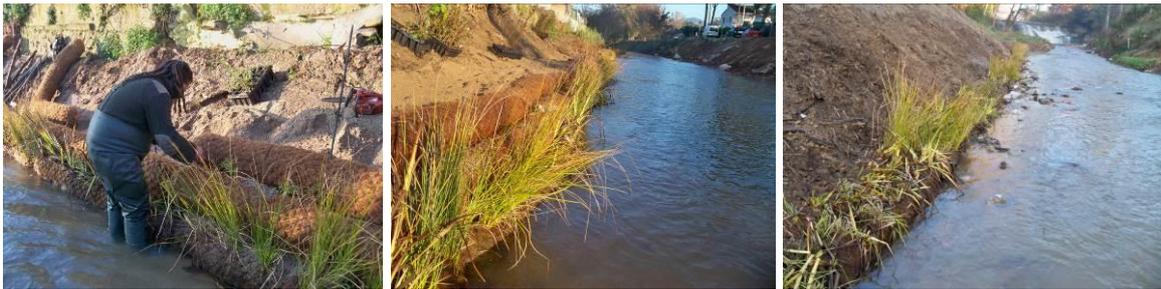
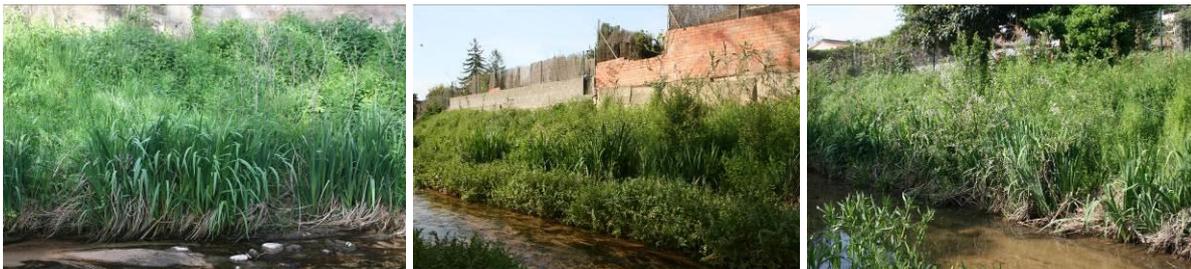
Outcome: With the years there have been different stages of vegetation development, depending on the site. Some areas had greater success than others, but in general terms the technique worked.

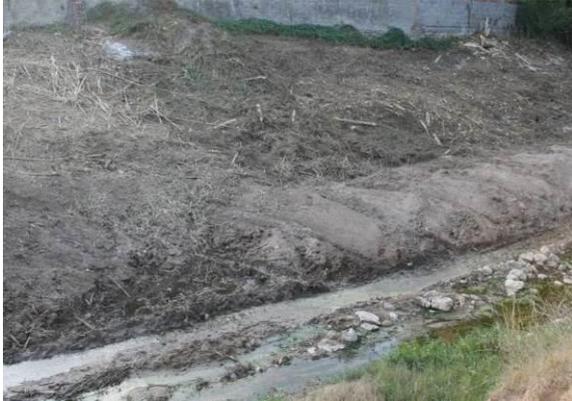
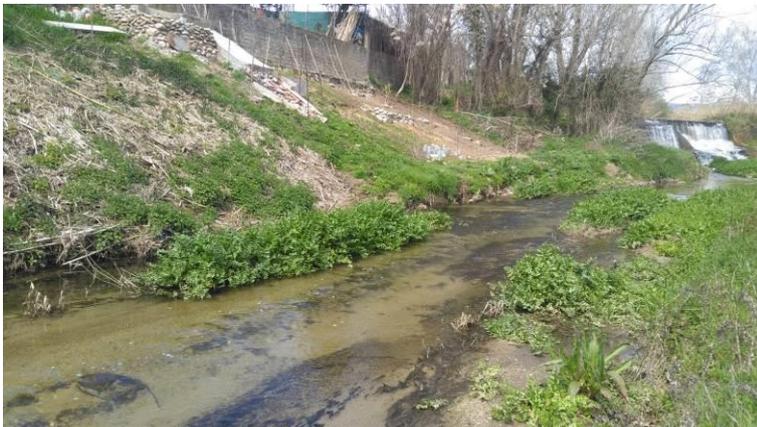
Outcome: Objectives reached

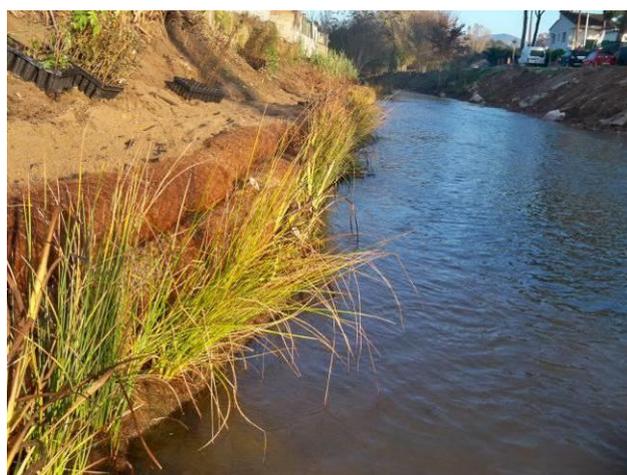
Detail of the Rollada viva riparial

The technique of Rollada viva riparial was defined at a working meeting with Paolo Cornellini,, Paola Sangalli and Albert Sorolla during a visit of the AEIP-AIPIN for works in Switzerland and it was applied for the first time at this case, at the Tenes river in Santa Eulalia de Ronçana in 2011. Years later can be stated that the technique was a success as well as the kind of plants selected for the technique.

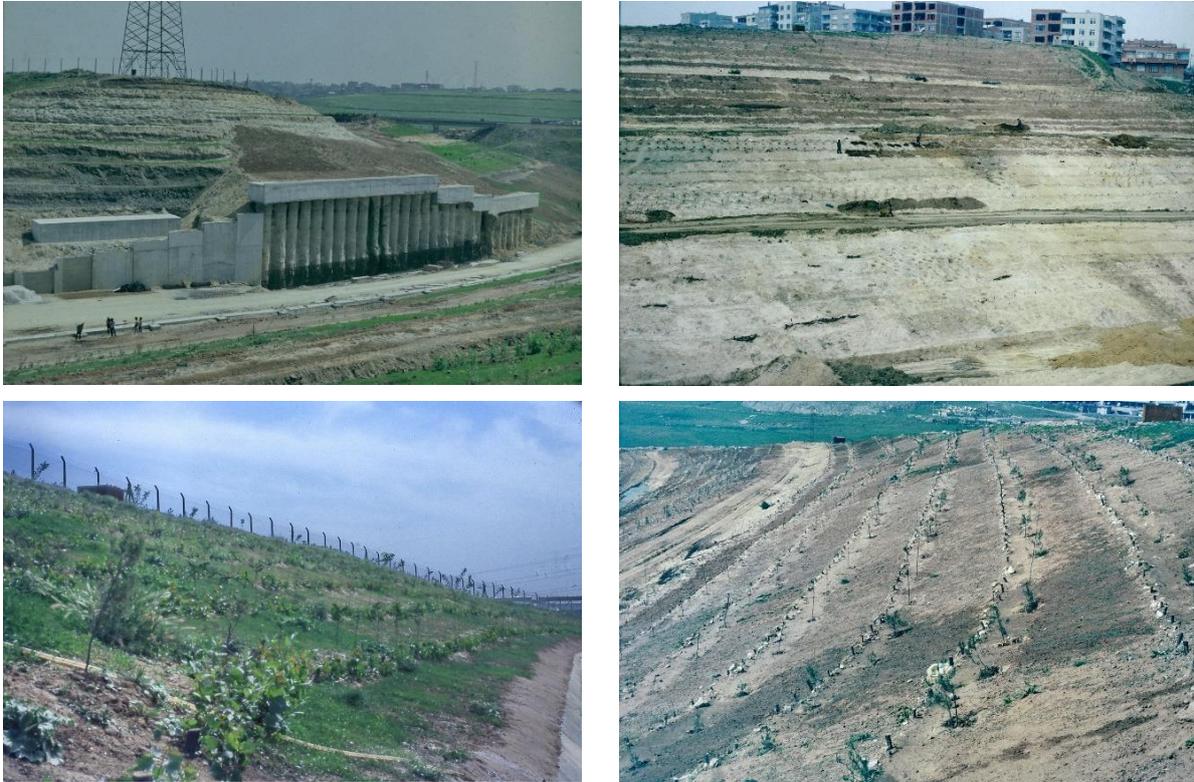
There was surface and gully erosion before the works and now there is 15-20% canopy cover by trees and lawn cover nearly whole area (Fig. 3 and 4).

Fig. 3. General views just beginning of the the rehabilitation works (1998).

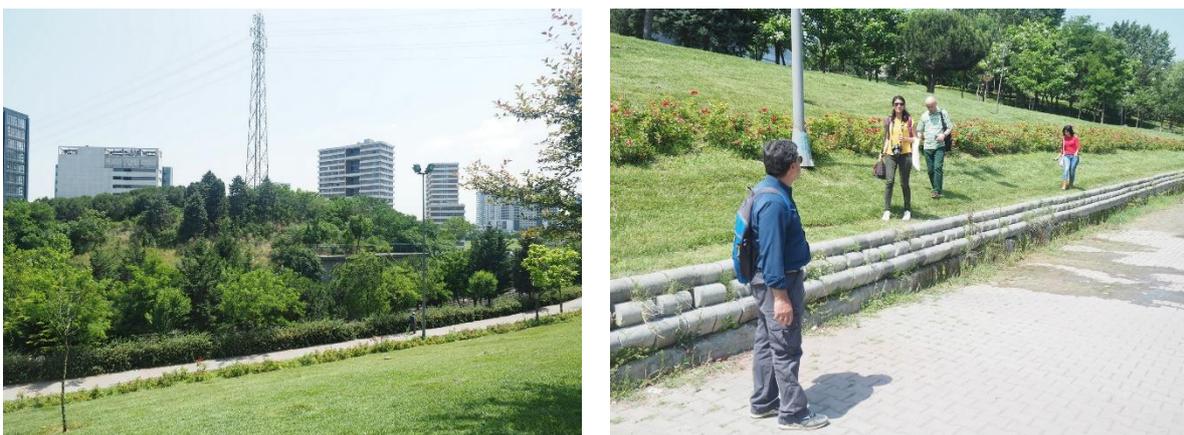
Fig. 4. General views after the rehabilitation and maintenance works (2018).

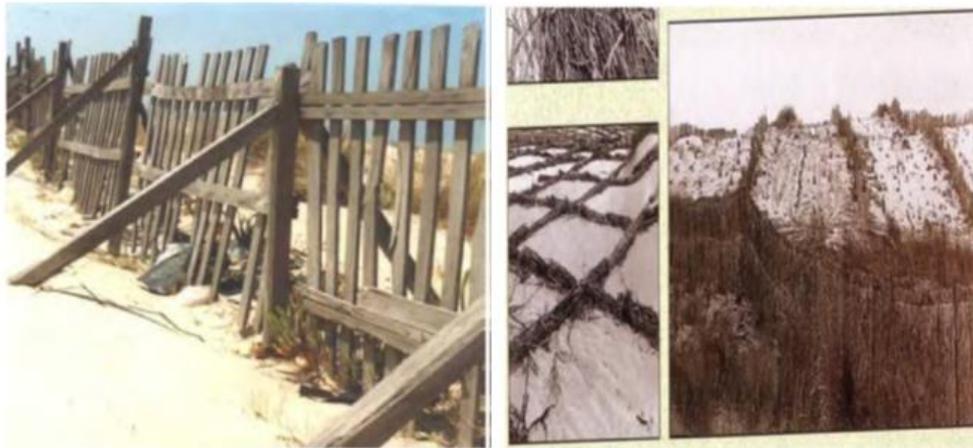
A view of wooden fences (on the left side) and the grid system (in the middle) and fences with dead plant materials rows (on the right side) which were constructed in the site in term of sand dune stabilization

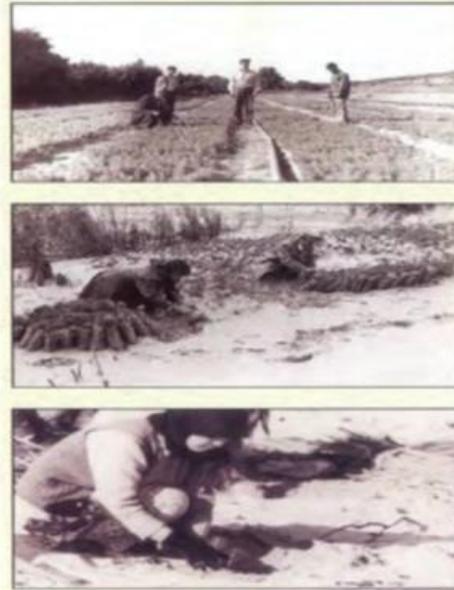
Revegetation processes in the site by planting of saplings of some tree and shrub species

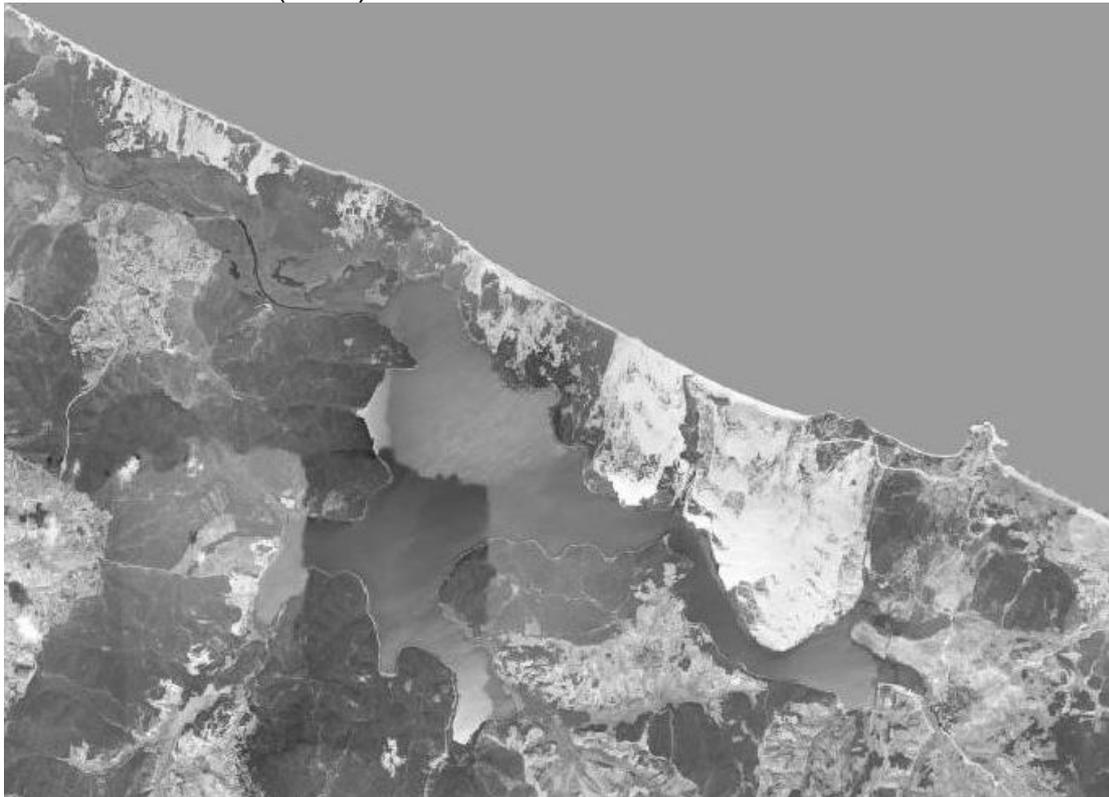
BEFORE WORKS (1970)

The main problem in the project site was the movement of wave- and windbornsands from Black Sea coast into the lake. In other words, sand dune movement into Terkos Lake had threatened fresh water sources storage capacity of Terkos Lake. There was no plant at the site to prevent sand dune movement into Terkos Lake. Therefore, it was aimed to stabilize the sand movement and revegetate the site by soil bioengineering works. However, soil conditions in the site were not appropriate for revegetation because of extremely poor and harshsand conditions. Also, there was a problem in terms of soil moisture since there was just pure sand in the site. In addition, water holding capacity of the sand was also low.

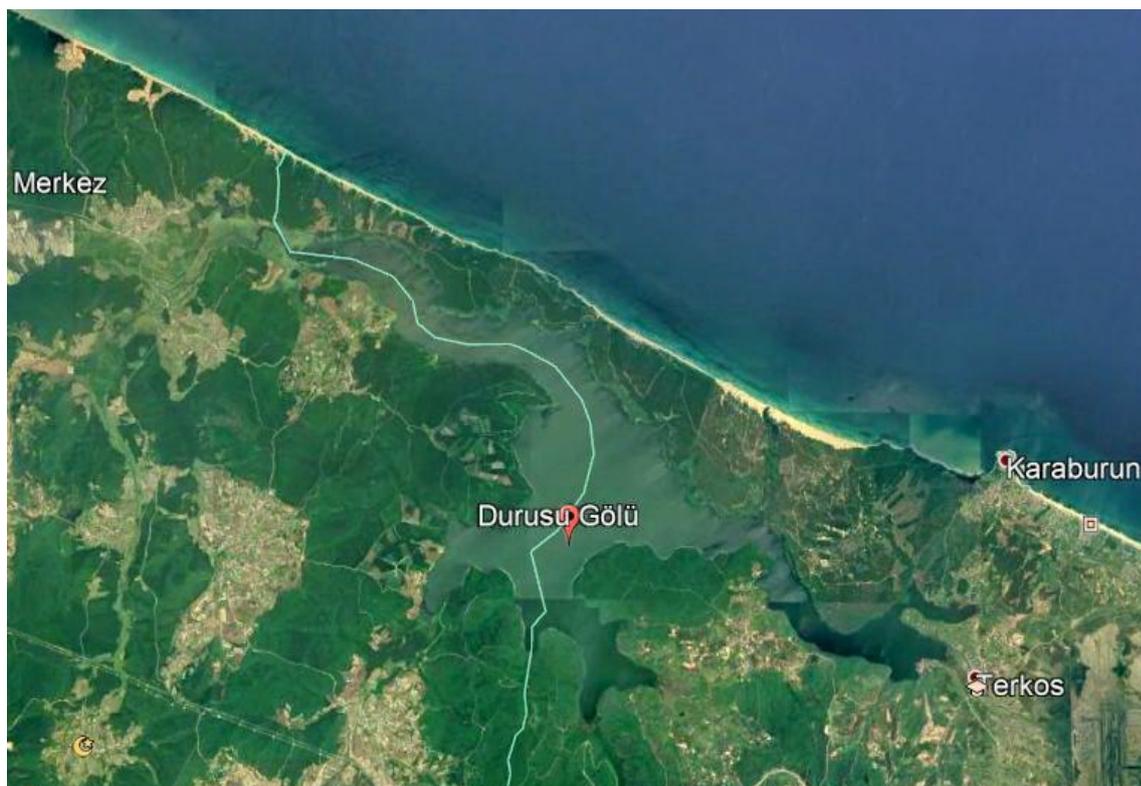
AFTER WORKS (2018)

Wooden materials were degraded and some parts left on the site after completing their functions. And dimensions of the wooden materials were changed due to degradation as a result of environmental factors from climate conditions of the Black Sea coast. This situation and the time-consuming due to lack of enough labor and/or money can be accepted as the flaw of this project.
